Aquatic weeds: Water waste or water wise?

Dr. John D. Madsen, Research Biologist
USDA ARS Exotic and Invasive Weed
Research Unit, UC-Davis, Davis, CA
jmadsen@ucdavis.edu

Invasive Aquatic Plants and Water

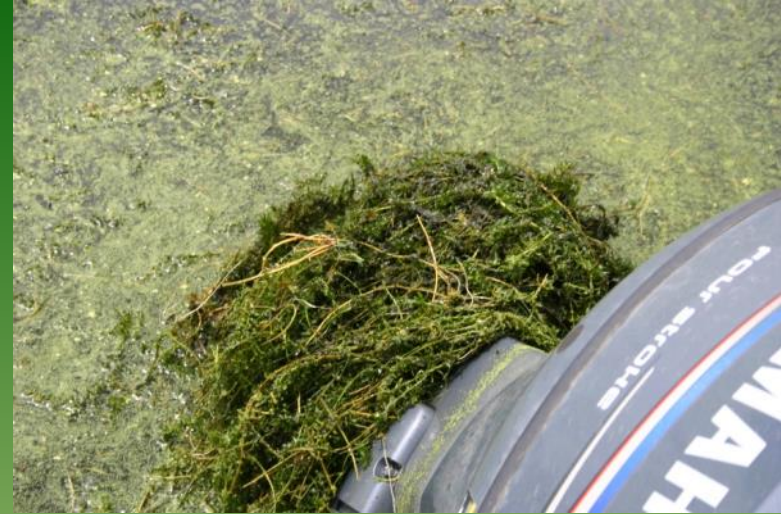
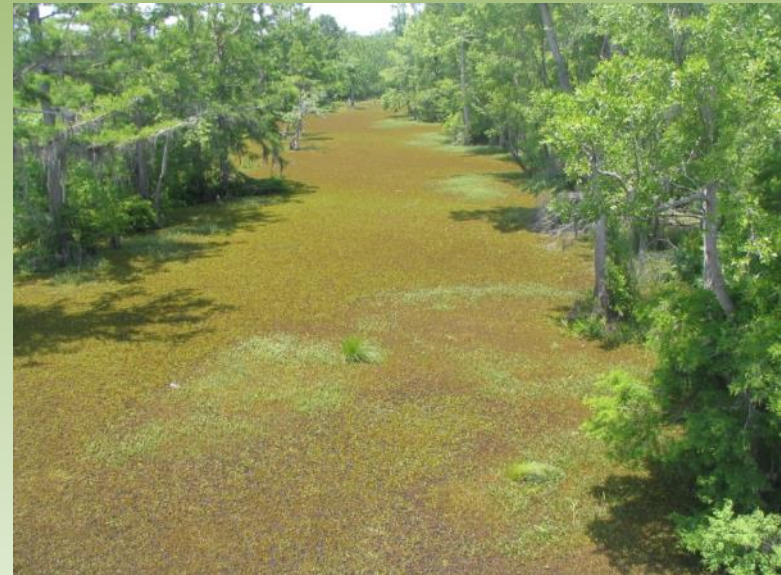
(Top) Hydrilla mat entangles outboard motor on Lake Gainesville, MS.

(Bottom) Giant salvinia completely covers bayou along Pascagoula River, MS. Photos by W. Robles.

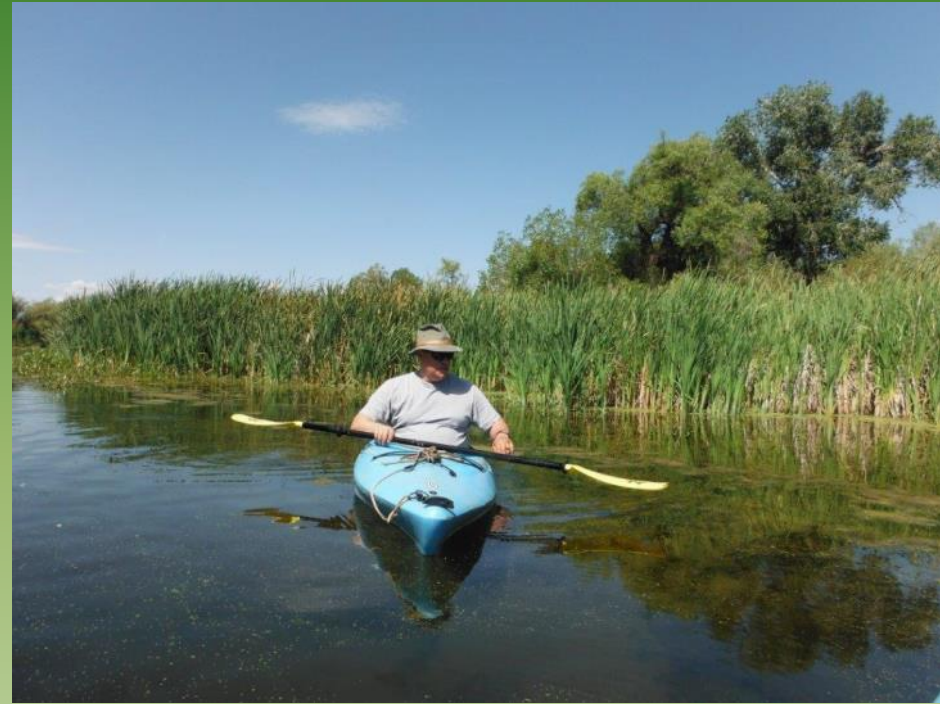
Madsen on Jefferson Slough, MT. Invasive hybrid cattail and Eurasian watermilfoil have altered the flow pattern to create shallow channel, reduced flow, and increased sedimentation. Reduced flows have encouraged channel widening. Photo by Celestine Duncan.

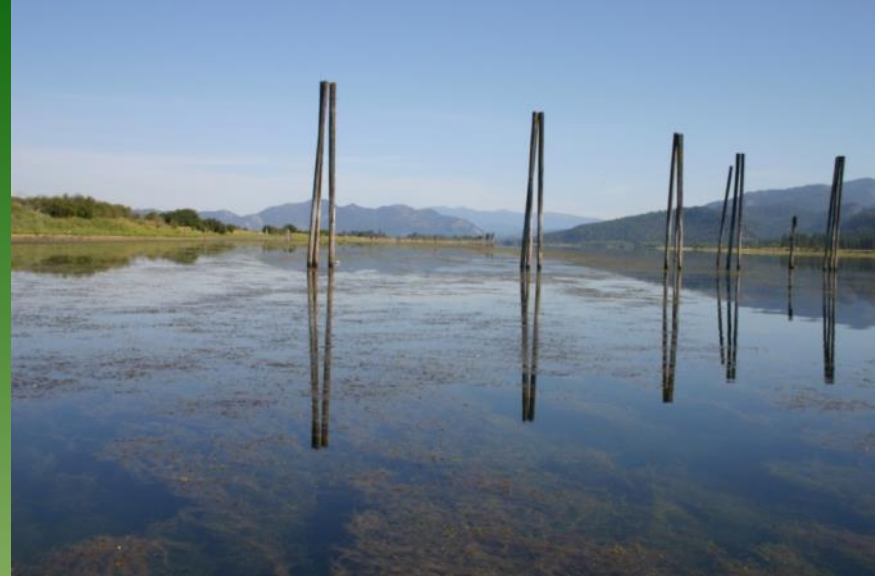
(Top) Channel of Pend Oreille River filled with Eurasian watermilfoil. (Bottom) Underwater view of Eurasian watermilfoil. Photos by John Madsen.

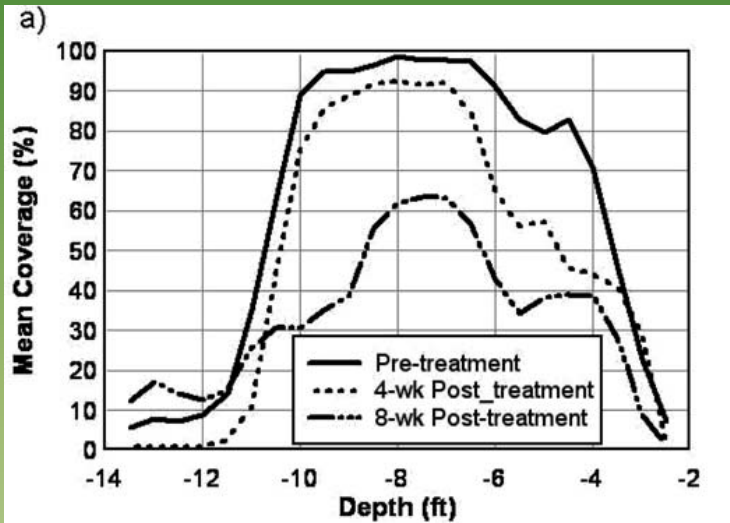
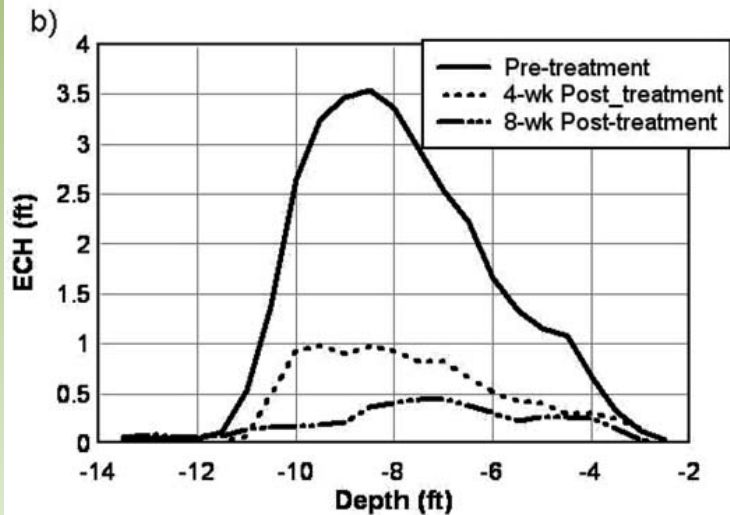
Figure 4. Mean coverage (a) and mean ECH (b) by depth increments of 0.5 ft.

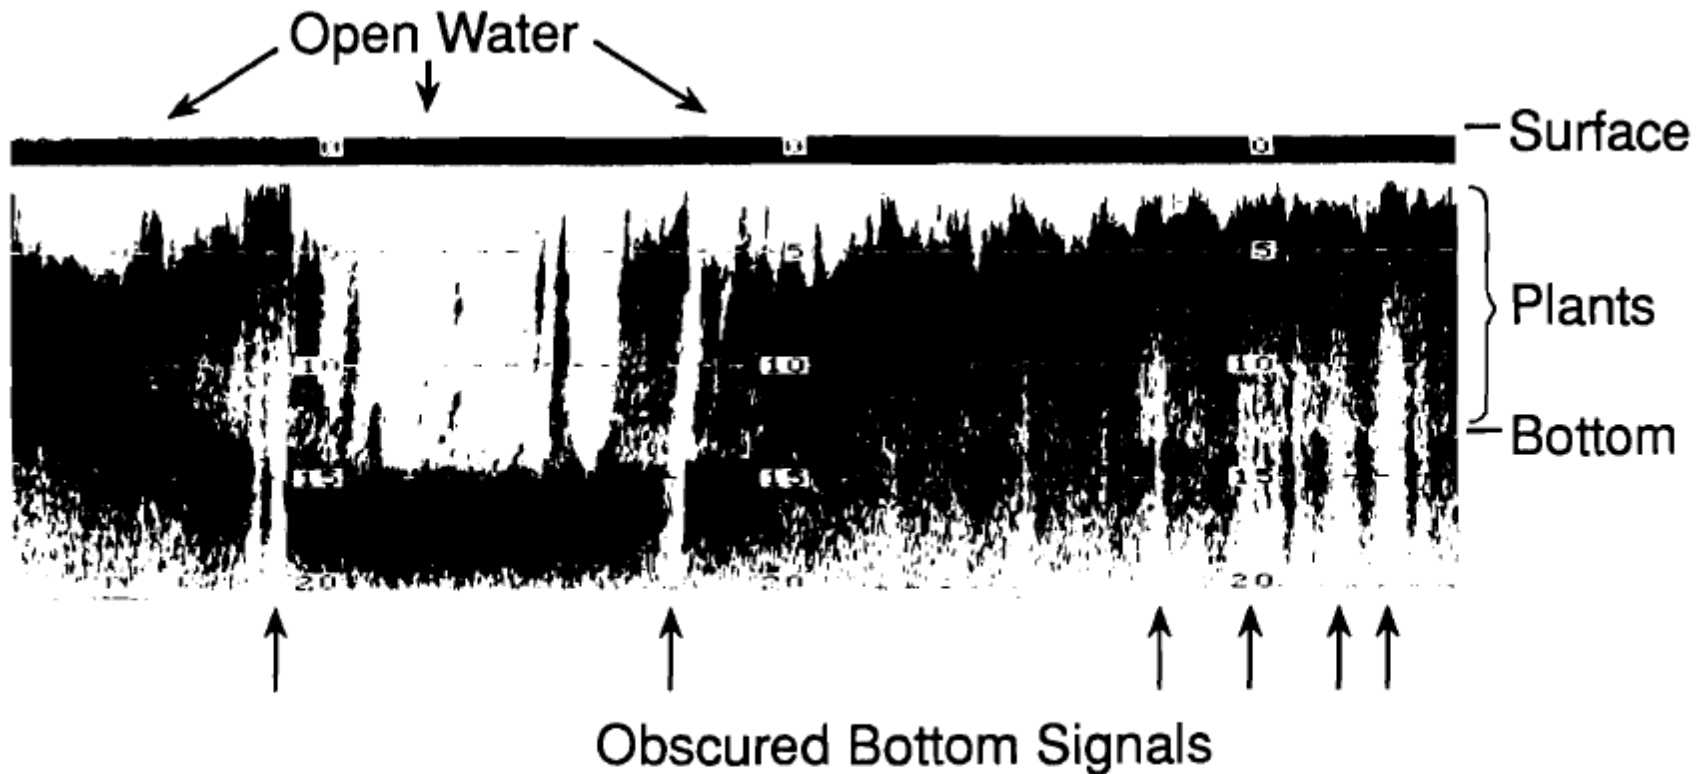
FIG. 2. Echogram showing cross sectional area of water column showing the open water and the water occupied by aquatic plants, and the areas under the plant beds where bottom detection is partially or totally obscured.

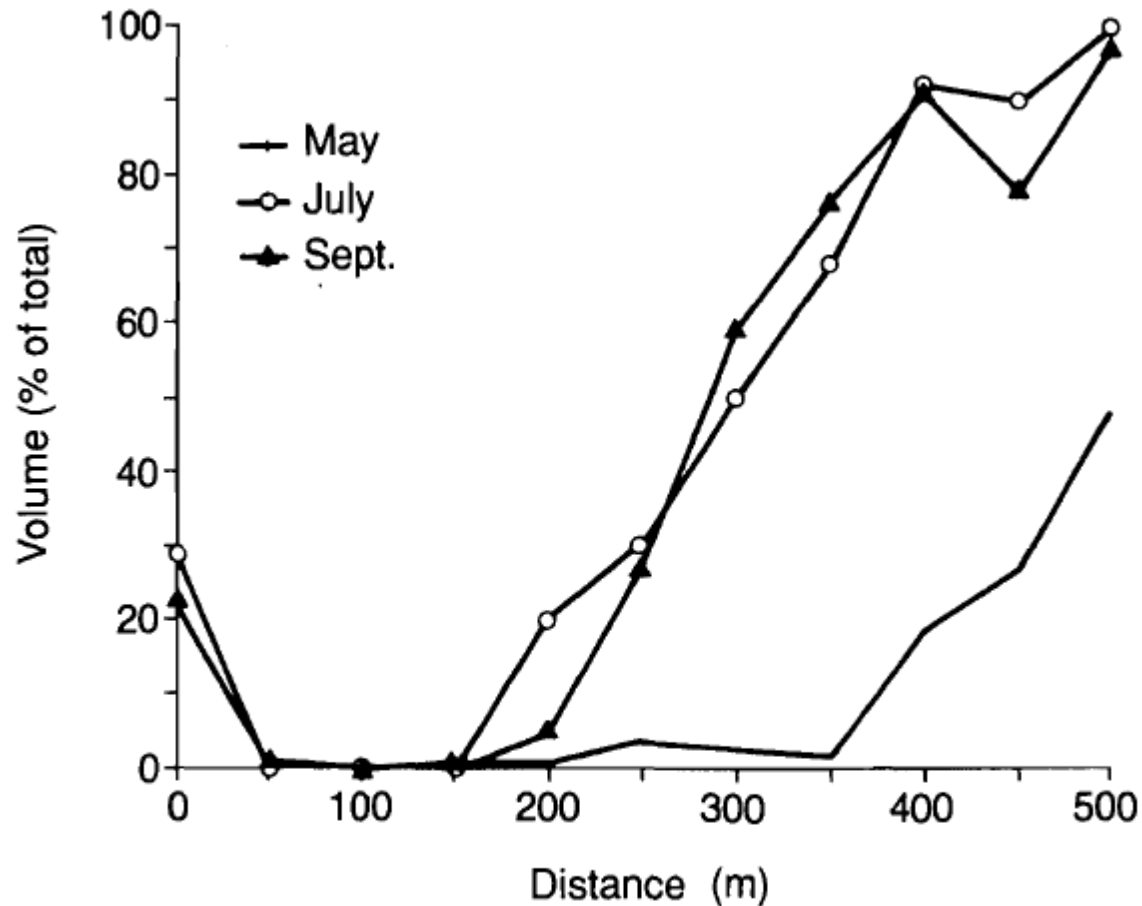
FIG. 5. Distribution of aquatic plants (by percent volume of water column) across Devils Lake in May, July, and September 1986 (Transect 7).

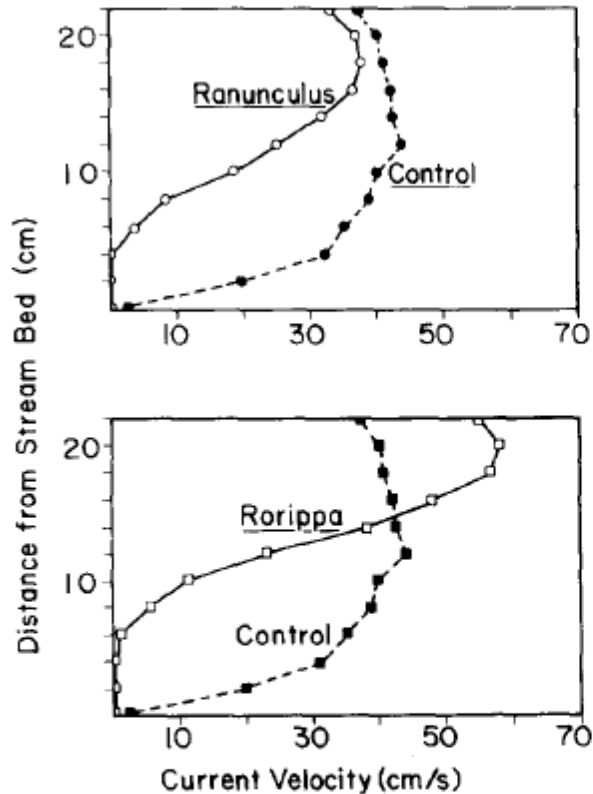
Fig. 2. Mean current velocities at 2 cm intervals over substrate trays from the stream bed to the surface: (a) comparison of current velocities in and over *Ranunculus aquatilis* trays to those over control trays; (b) comparison of current velocities in and over *Rorippa nasturtium-aquaticum* trays to those over the control.

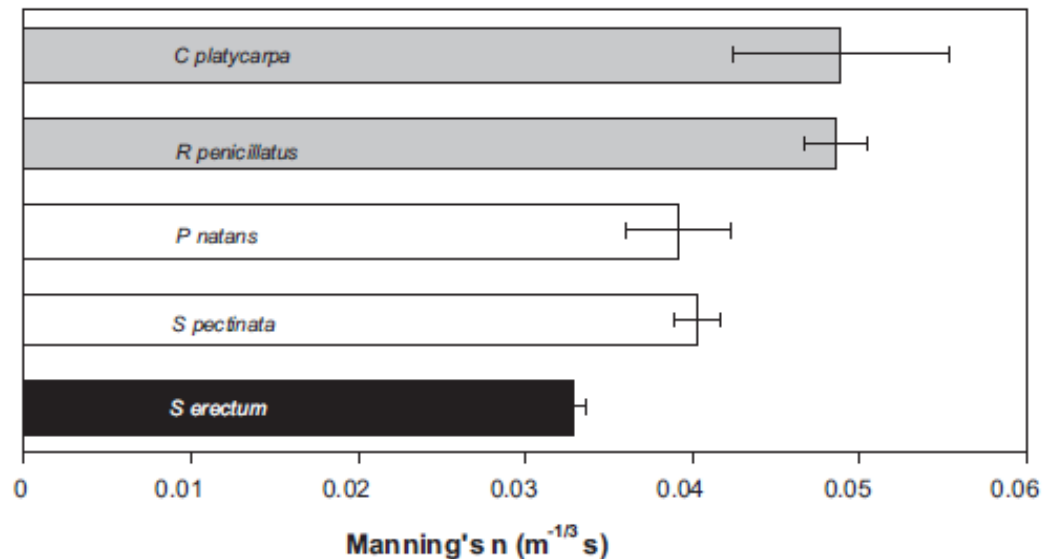
Fig. 3. The average Manning's n (averaged for discharge and vegetation distribution pattern) of 5 macrophyte species (*C. platycarpa*, *R. penicillatus*, *P. natans*, *S. pectinata*, *S. erectum*). Species differing ($p < 0.05$) from each other are shown in different colours.

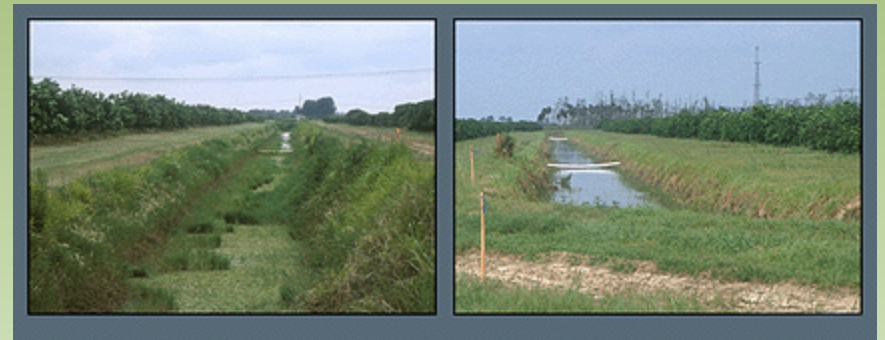
Irrigation

- Invasive aquatic plants can reduce the water flow and holding capacity of irrigation canals by 75%
- Weed control in canals is often difficult due to flowing water environment and water use restrictions

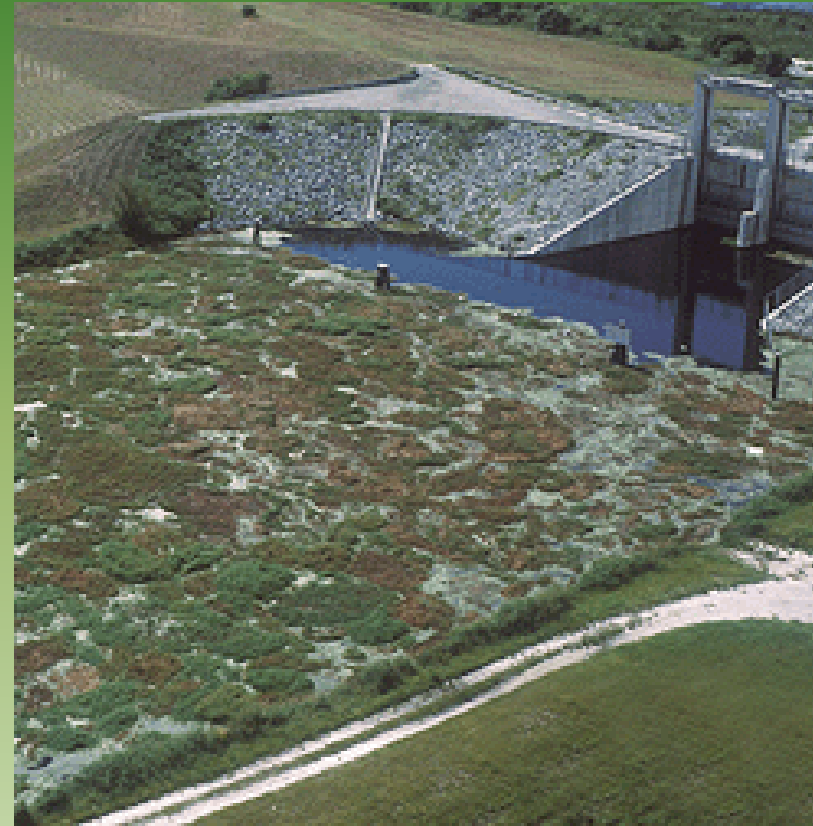
Flood Control

- Invasive aquatic plants increase the amplitude, duration, and probability of flooding
- Aquatic plant control in Florida saves an estimated \$300M in potential property damage

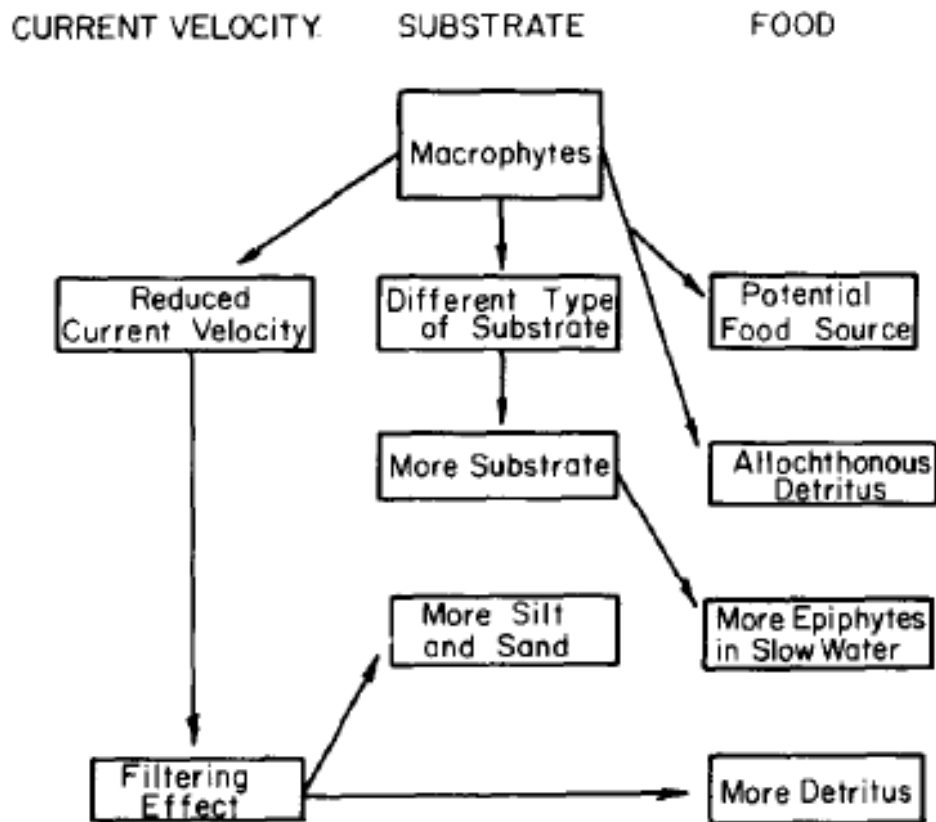
Fig. 3. Diagram of the effects of macrophytes on conditions in the stream microenvironment, with emphasis on current velocity, substrate, and potential food availability. Arrows indicate direct causal relationships.

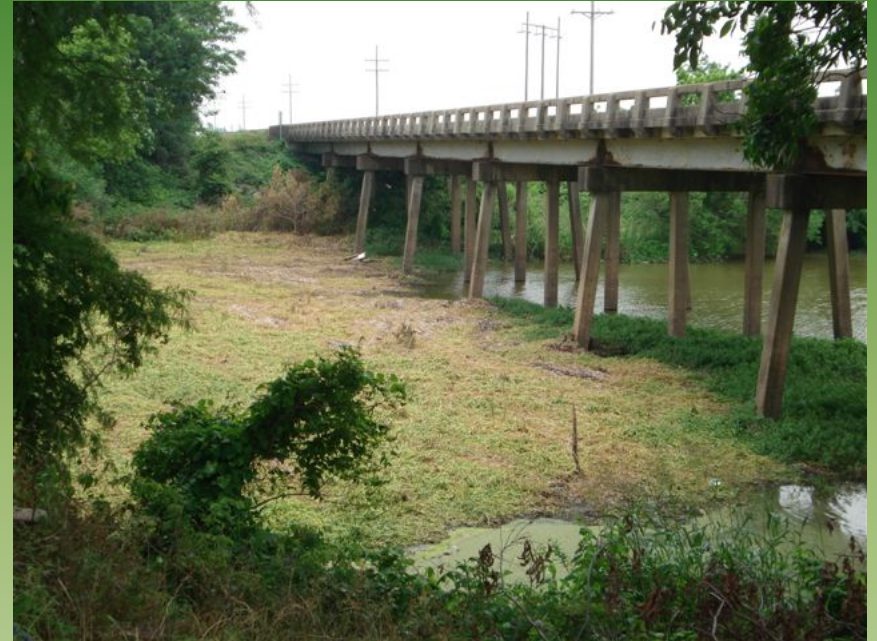
Blockage

- Aquatic plants can break free, clogging water intakes, narrow areas in channel, and other structures
- May interfere with flow or use of water
- Irrigation, consumption, or cooling applications

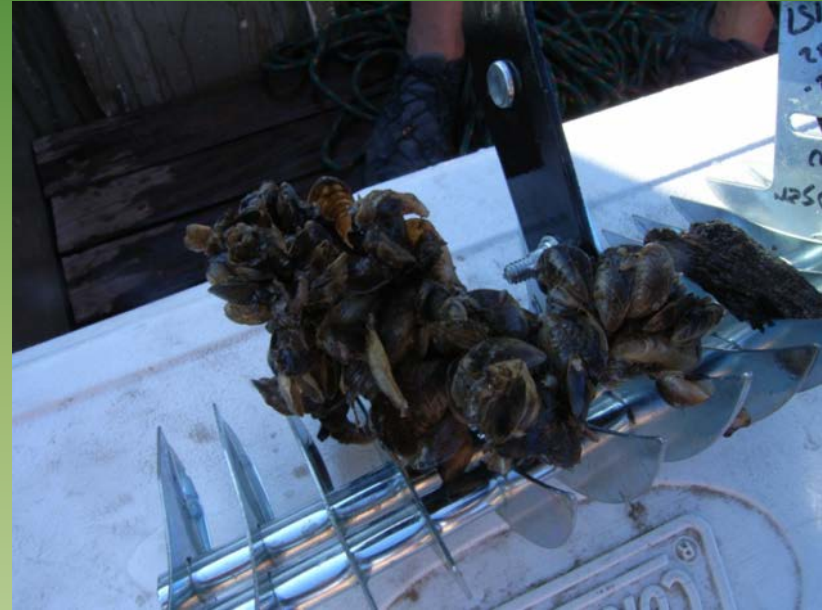
Problem

- Quagga mussels invaded in recent years, greatly increasing water clarity
- Predictably, plant growth expanded
- Rafts of native plants break off and clog water intake structure

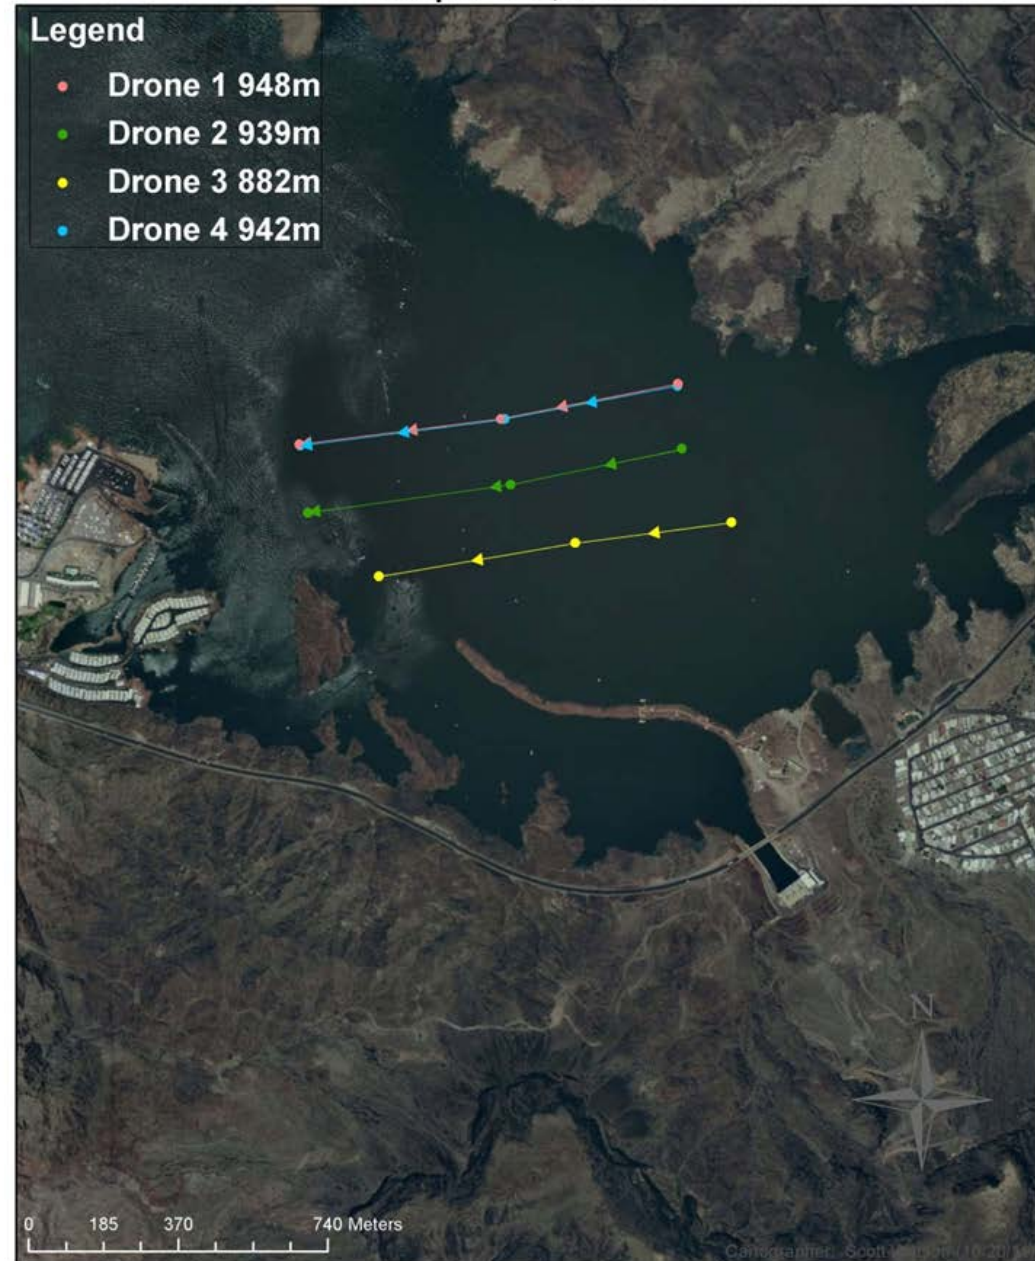
Mats of senesced plants move quickly from source sites with proper wind direction

Pumping draws plants to the inlet

Lake Havasu Drift Study Sept. 10, 2011

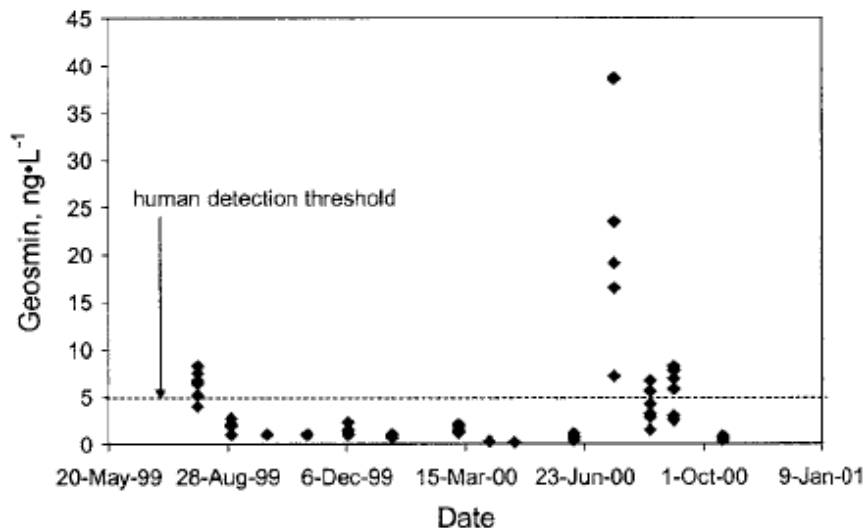
Figure 2.-Trends in geosmin at all six sampling stations in Cheney Reservoir, USA.

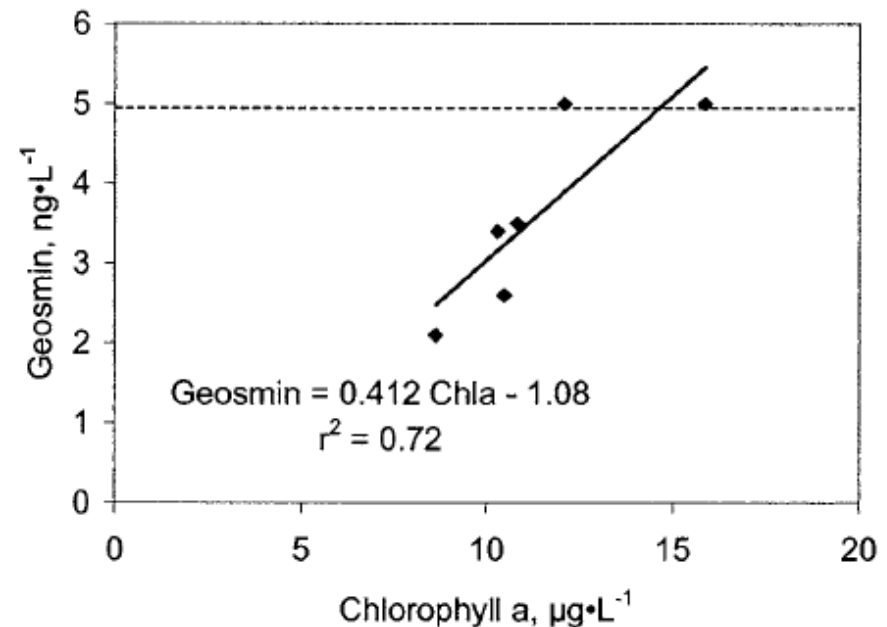
Figure 4.-Relationship between station mean concentrations of geosmin and chlorophyll a in Cheney Reservoir, USA. The horizontal dotted line indicates an approximate threshold concentration of geosmin for human detection of $5 \text{ ng} \cdot \text{L}^{-1}$.

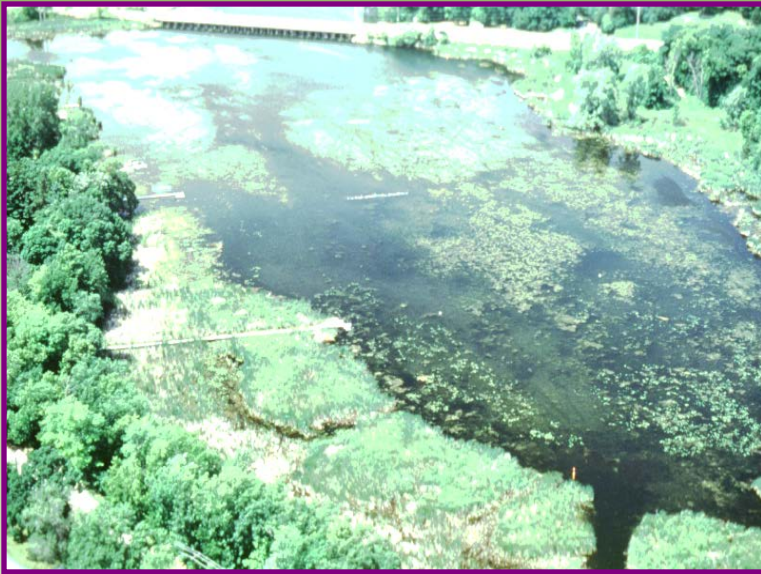
Carsons Bay, MN before treatment

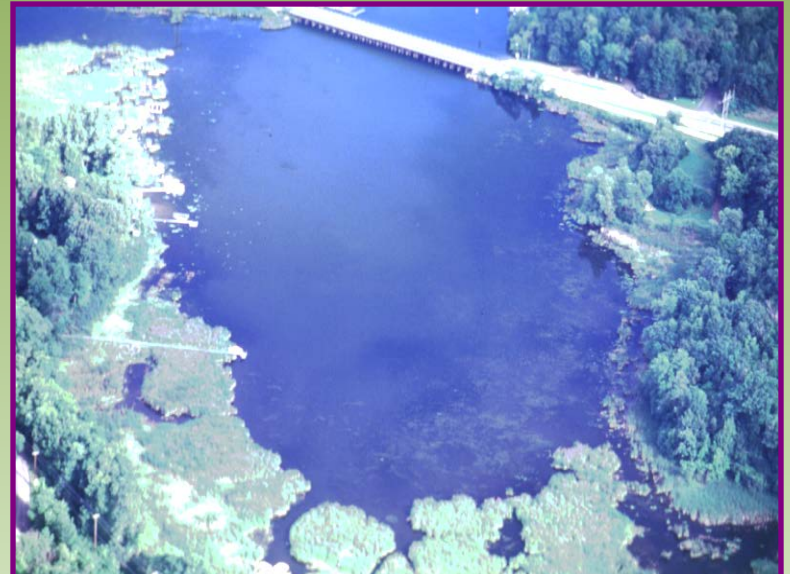
Carsons Bay, MN after treatment
