**The Salinas River Watershed**  
***Arundo* control program- lots of**  
**farmers, lots of *Arundo*: 12 miles**  
**in two years**

Emily Zefferman and Paul Robins  
RCD Monterey County

California Invasive Plant Council  
November 3, 2016

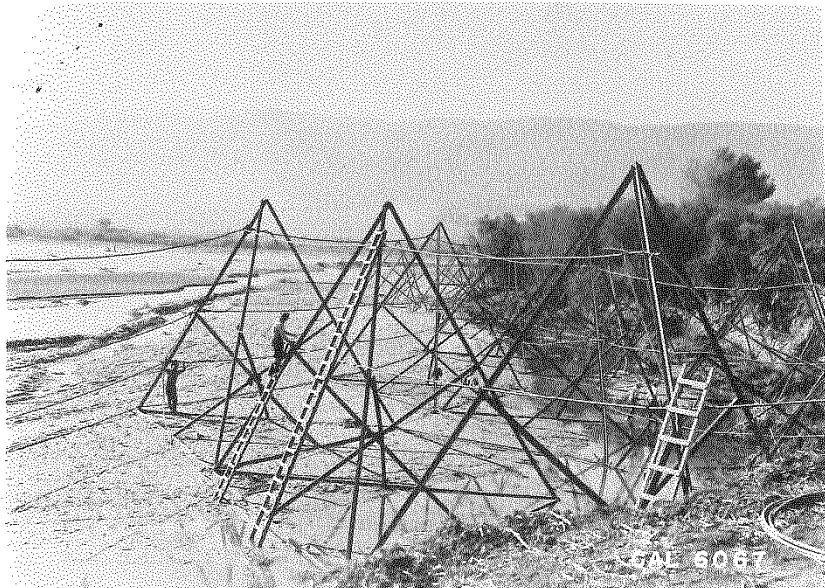
CAL 6087

Plate 2. Tetrahedrons being installed to protect the river bank on the Salinas River. Photograph taken in October, 1941.

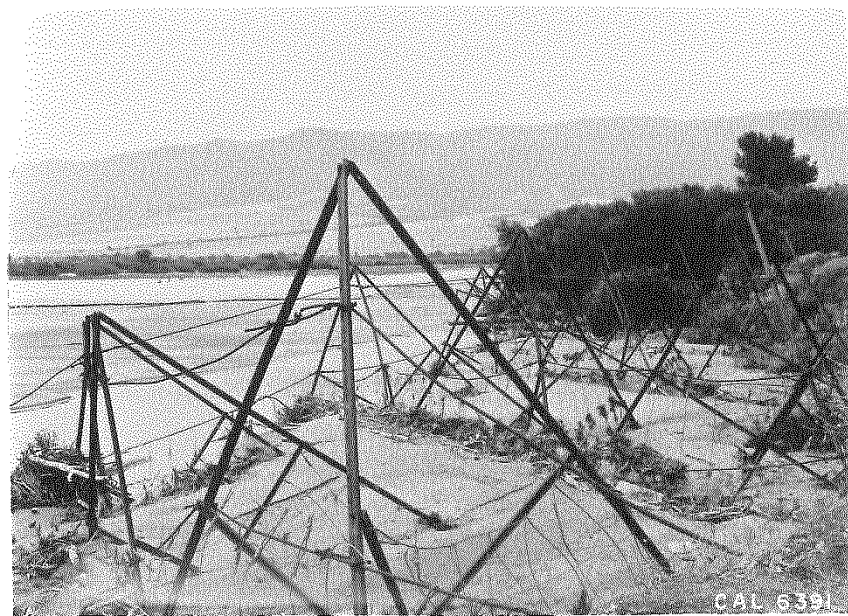
CAL 6391

Plate 3. Same site as plate 2 but taken in August, 1942. Note the silt deposition behind the tetrahedrons, and that the area is beginning to be revegetated. Note also settling of the tetrahedrons indicating the unstable condition of the stream channel.

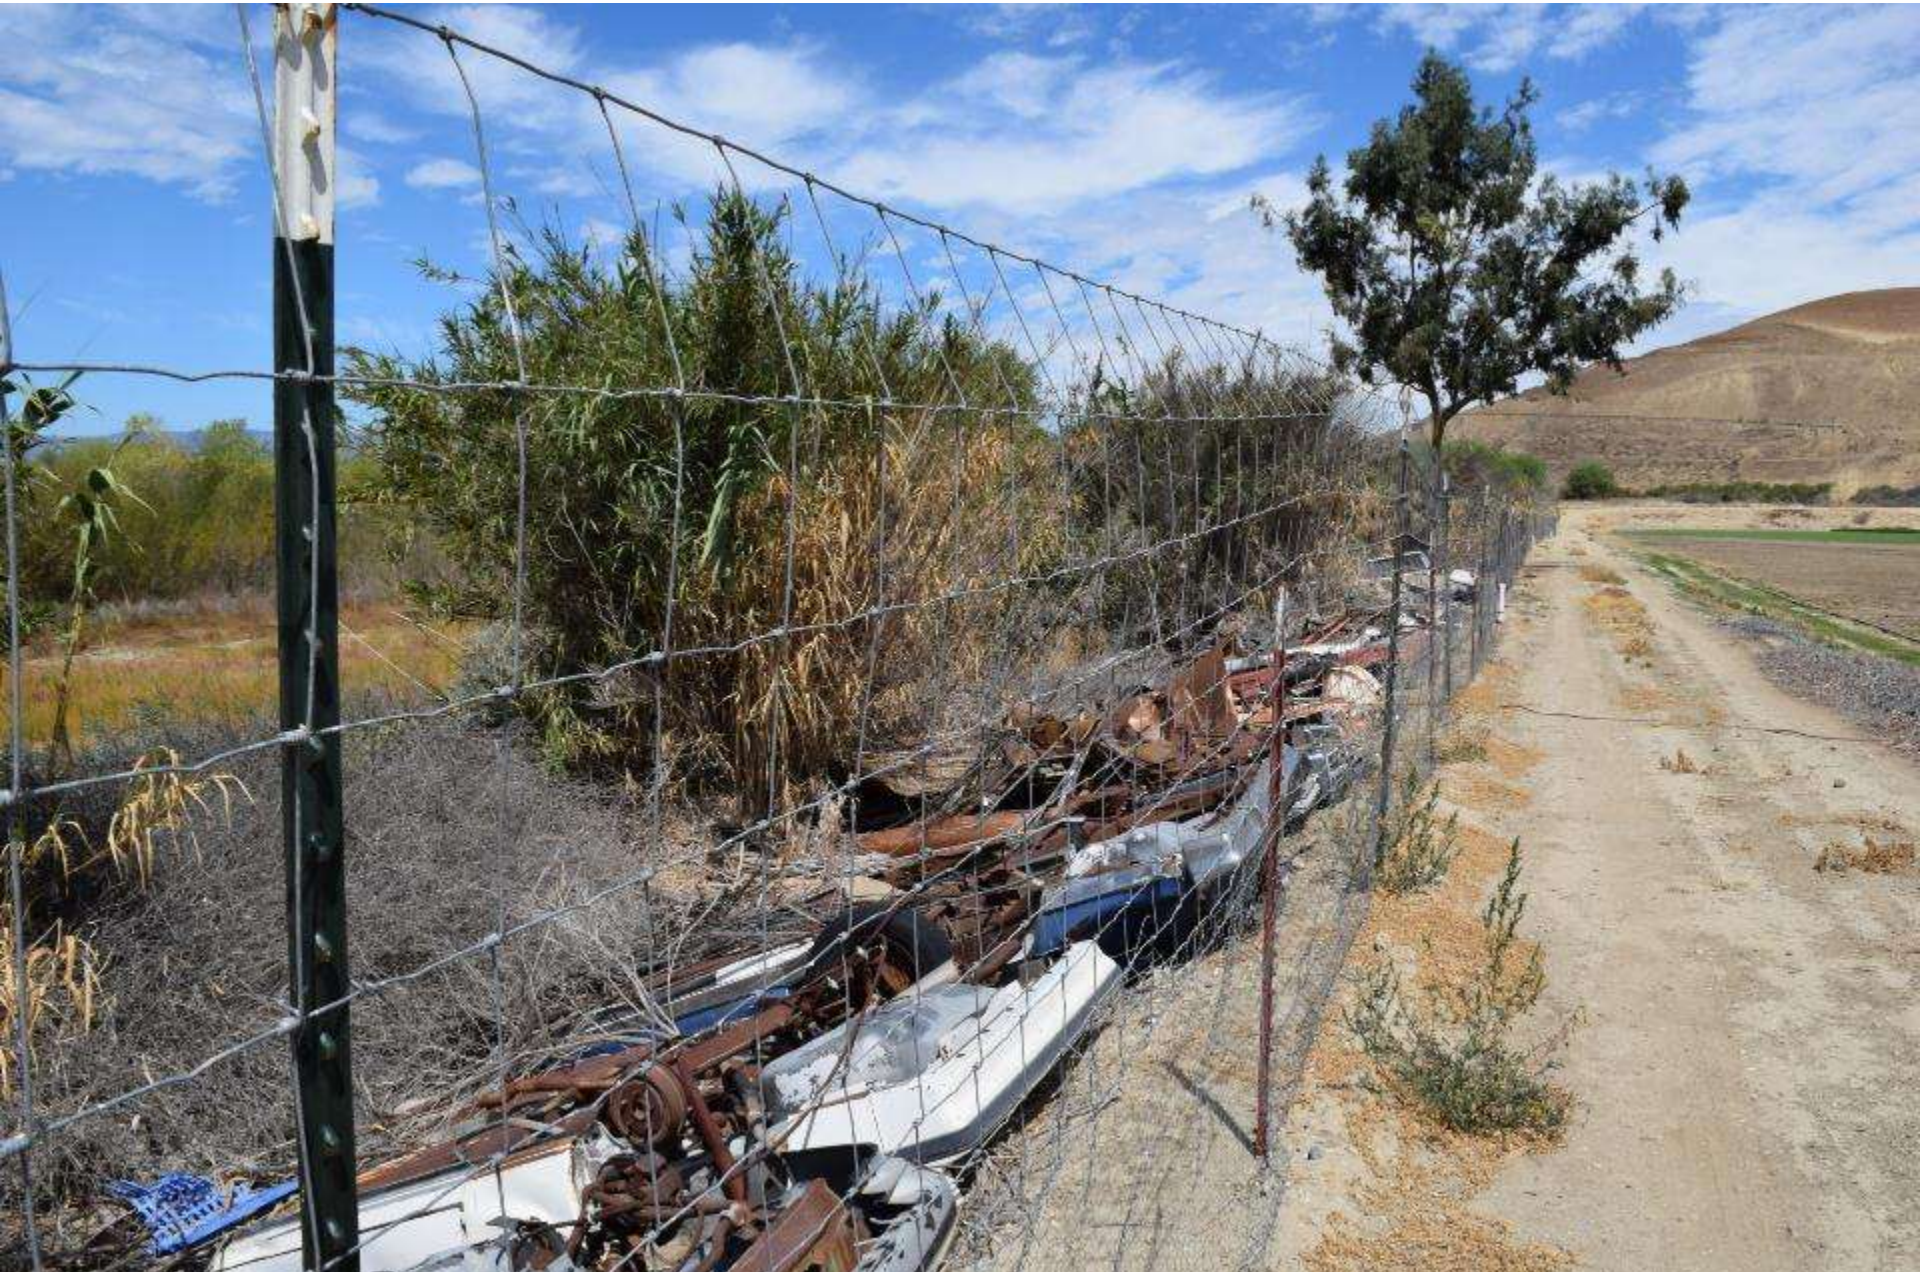
# Bank protection: “Detroit riprap” + *Arundo*!

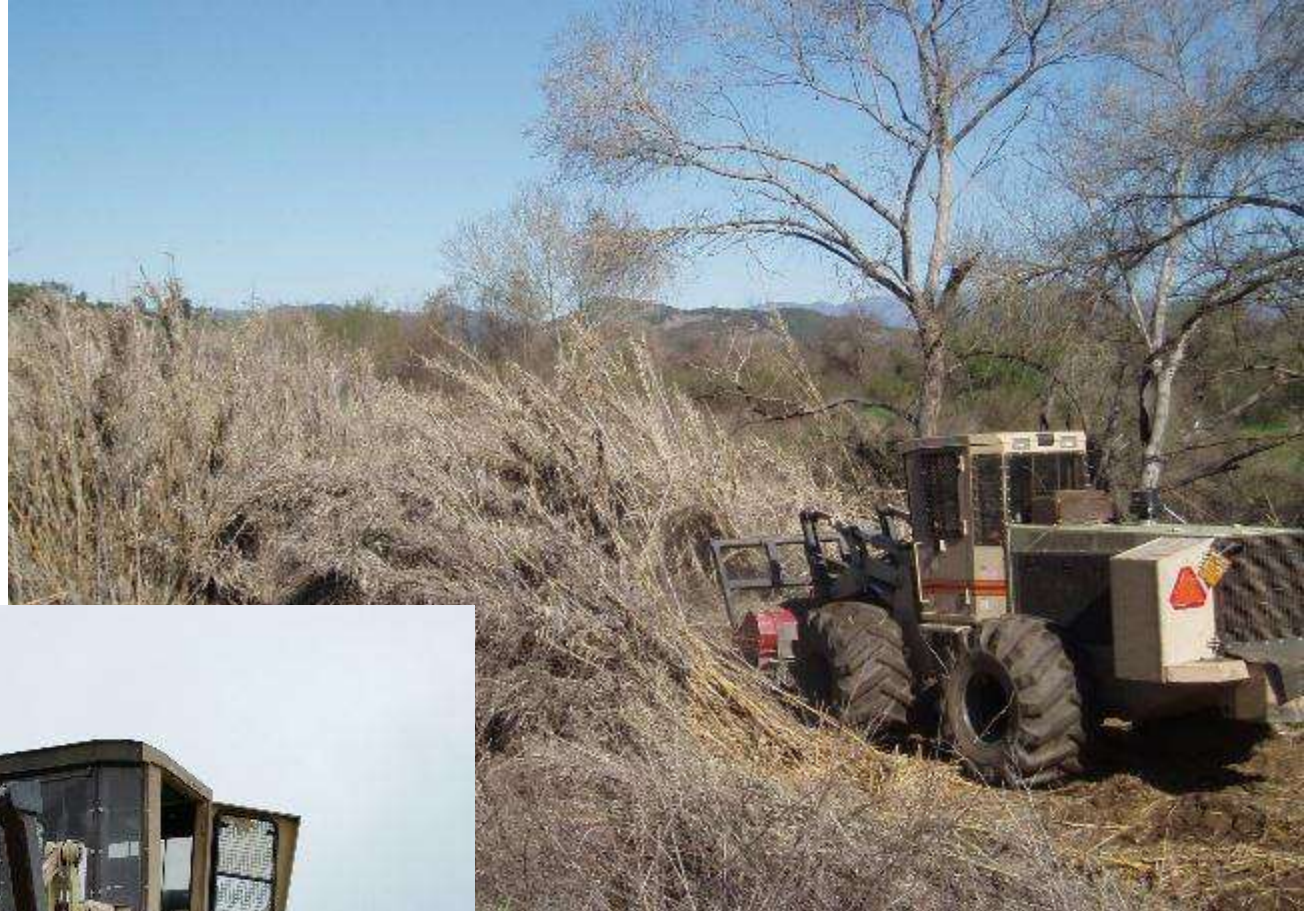
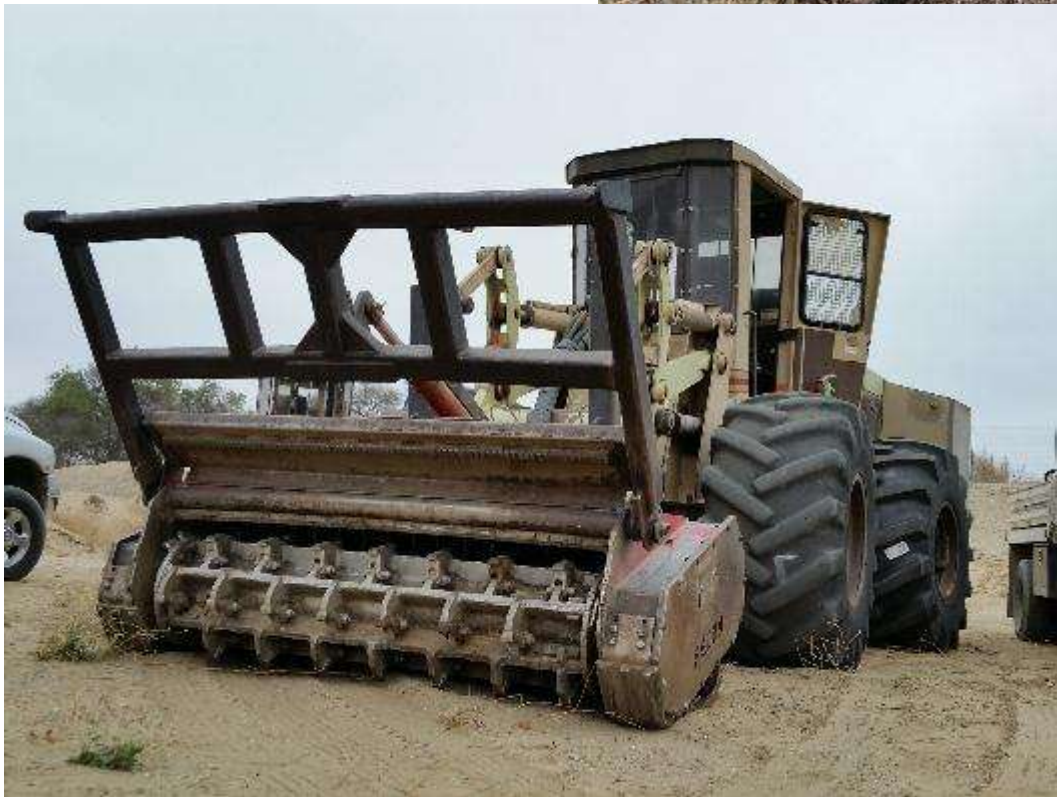
Barco mowers with fixed tooth attachment

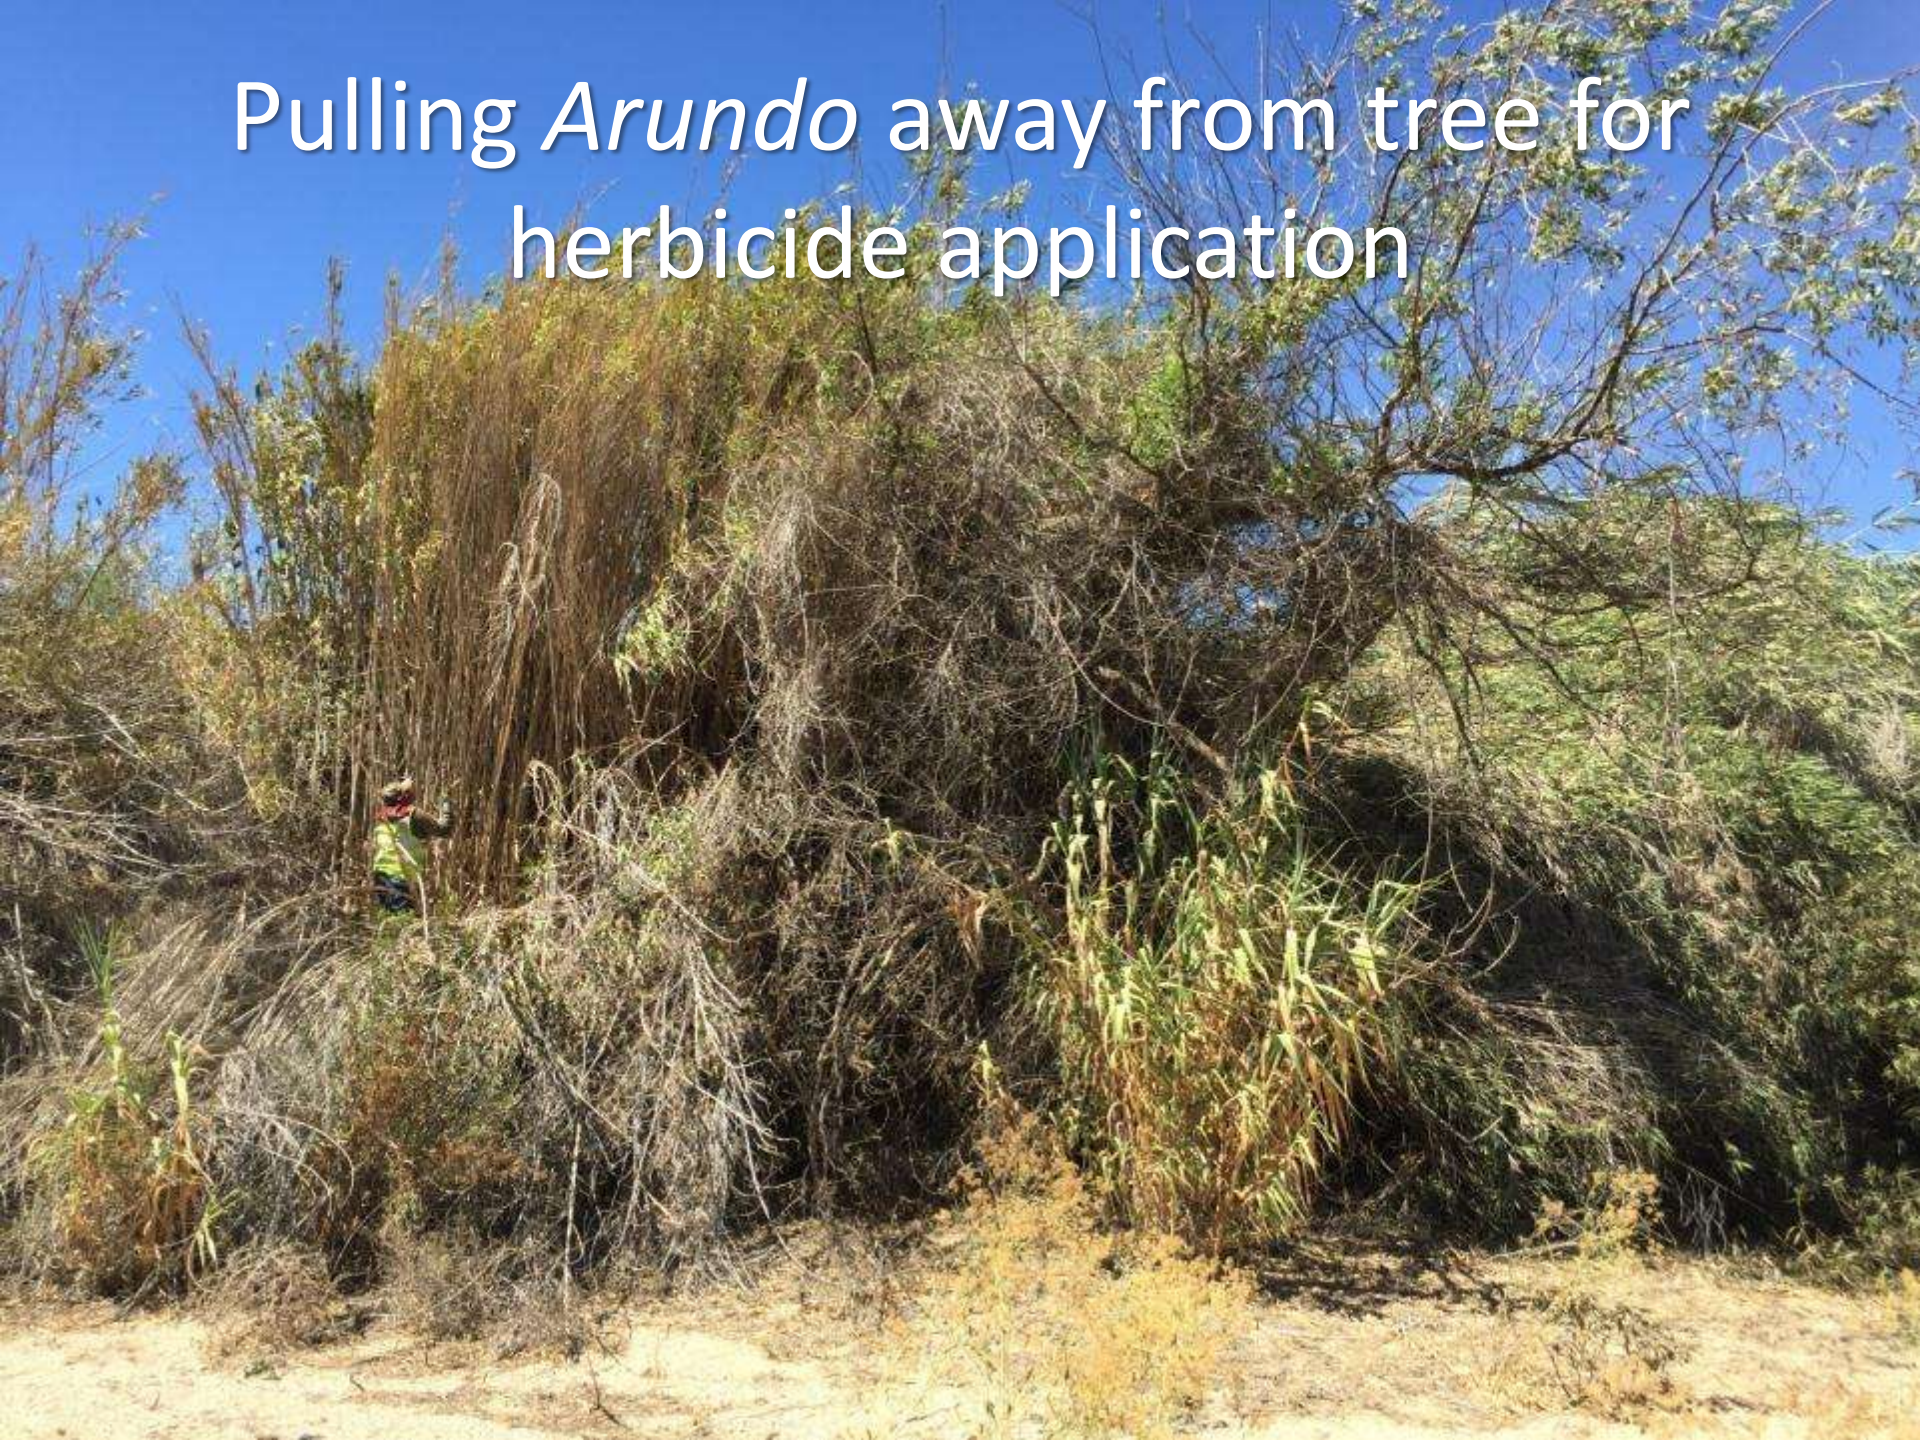
Pulling *Arundo* away from tree for  
herbicide application

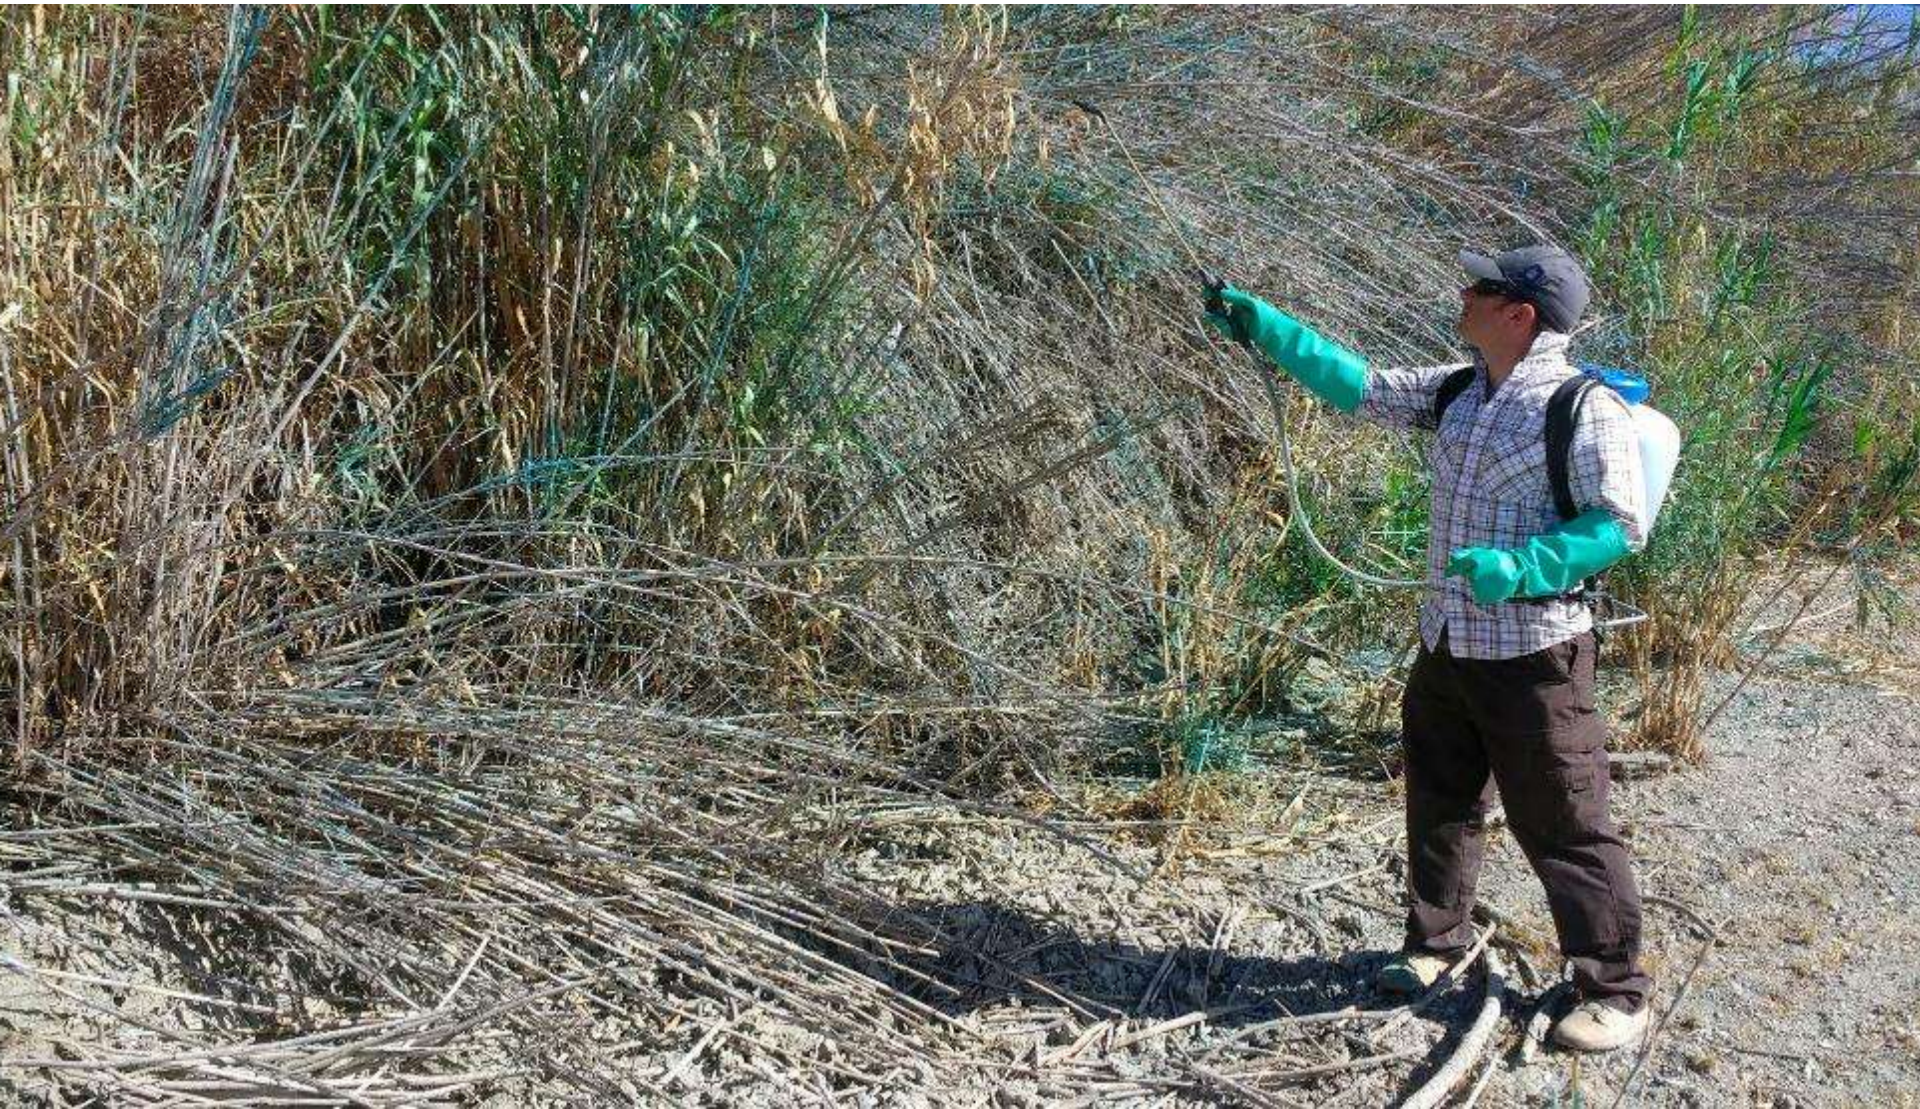
# Treating *Arundo* and tamarisk with backpack sprayer in upper watershed

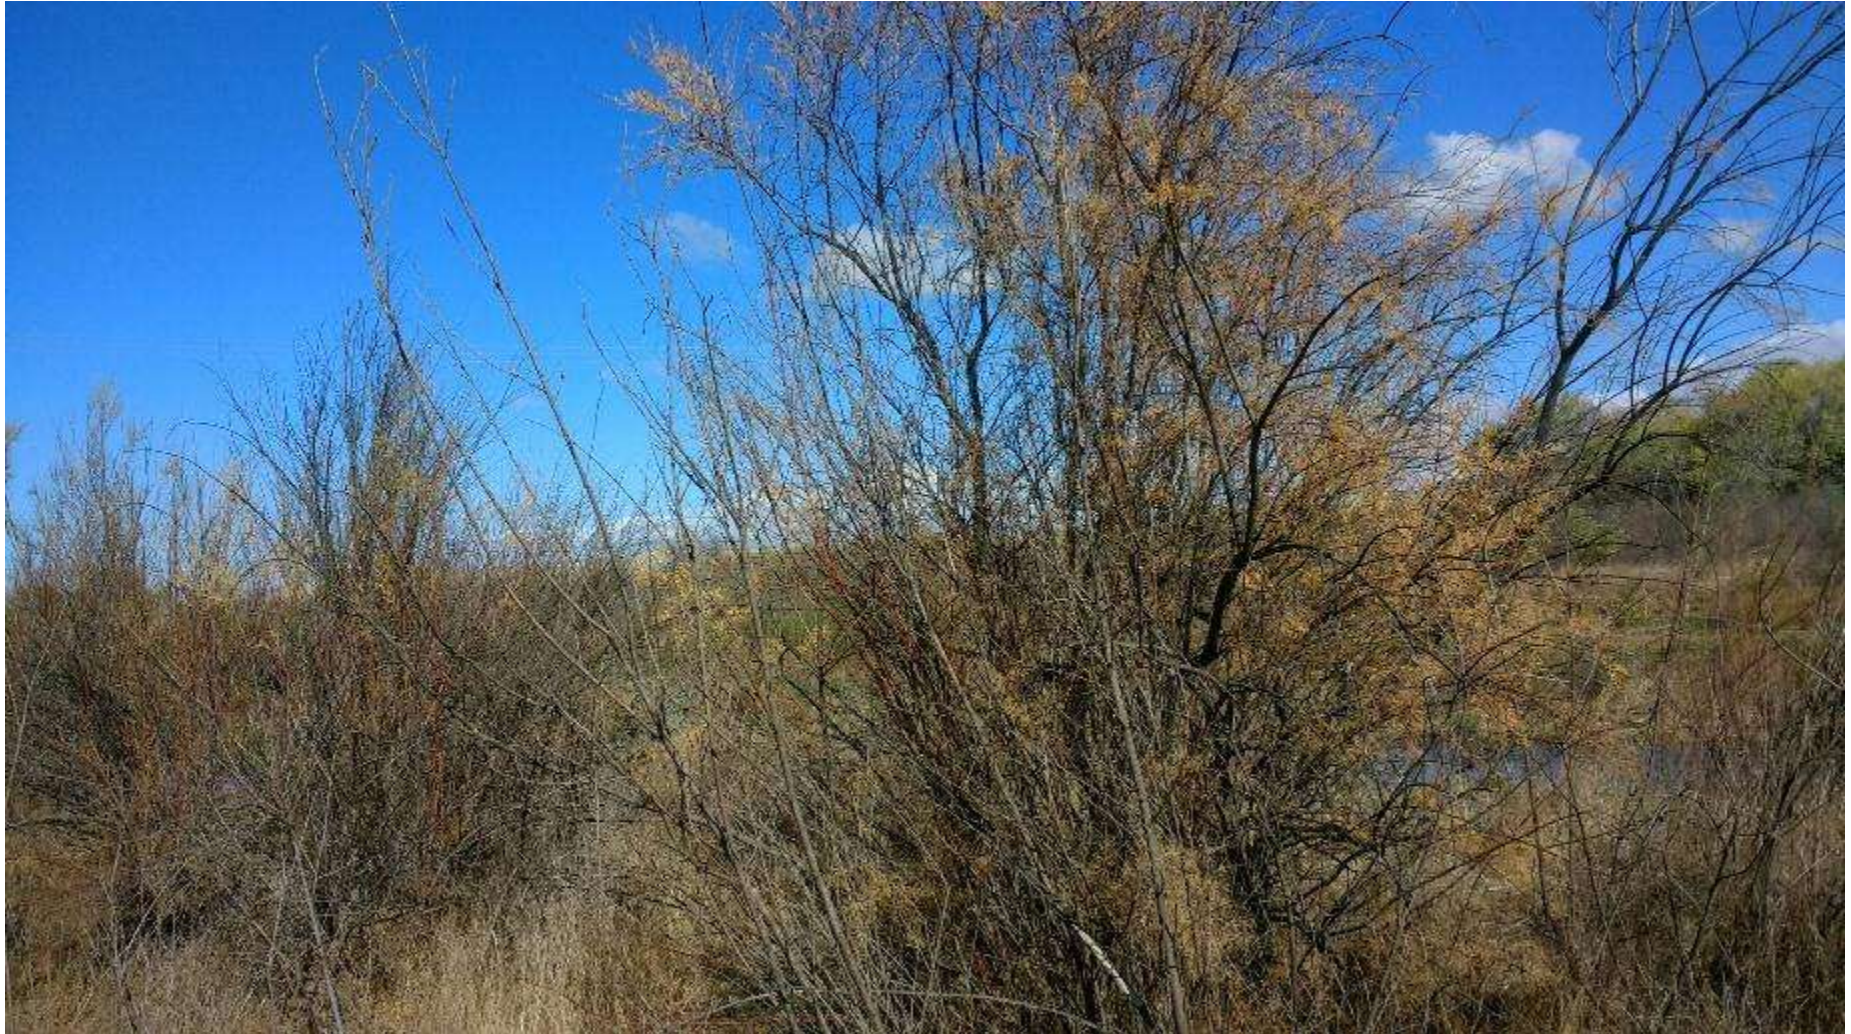
# Dead tamarisk, one month after spraying
