# Effectiveness of Aquatic Invasive Plant Control In Emerald Bay, Lake Tahoe

Zach Hymanson – CA Tahoe Conservancy

Kim Boyd – Tahoe RCD

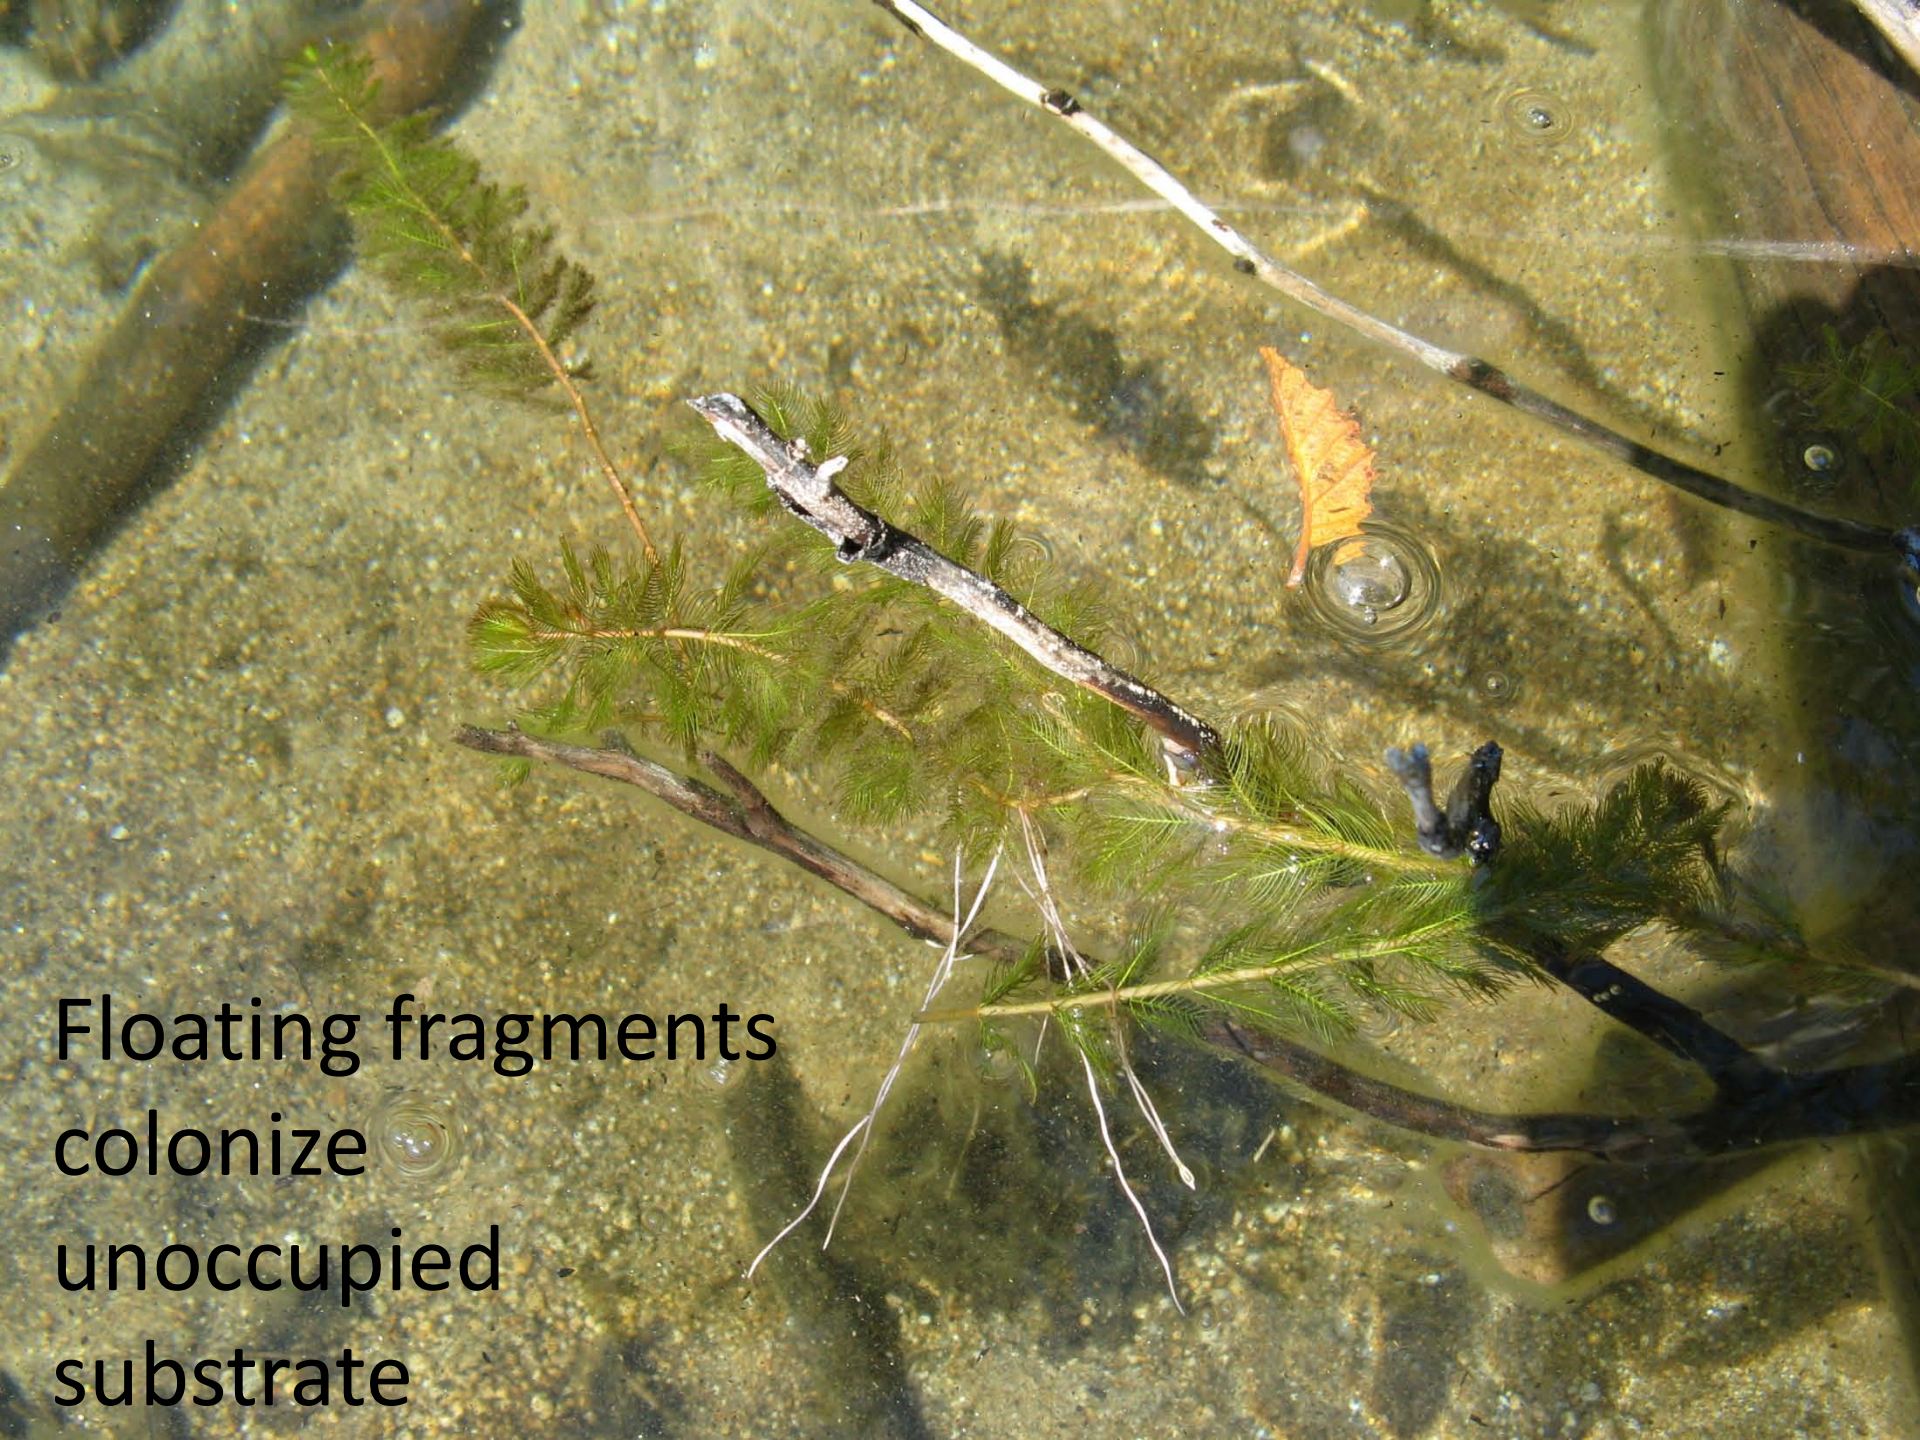
Floating fragments  
colonize  
unoccupied  
substrate

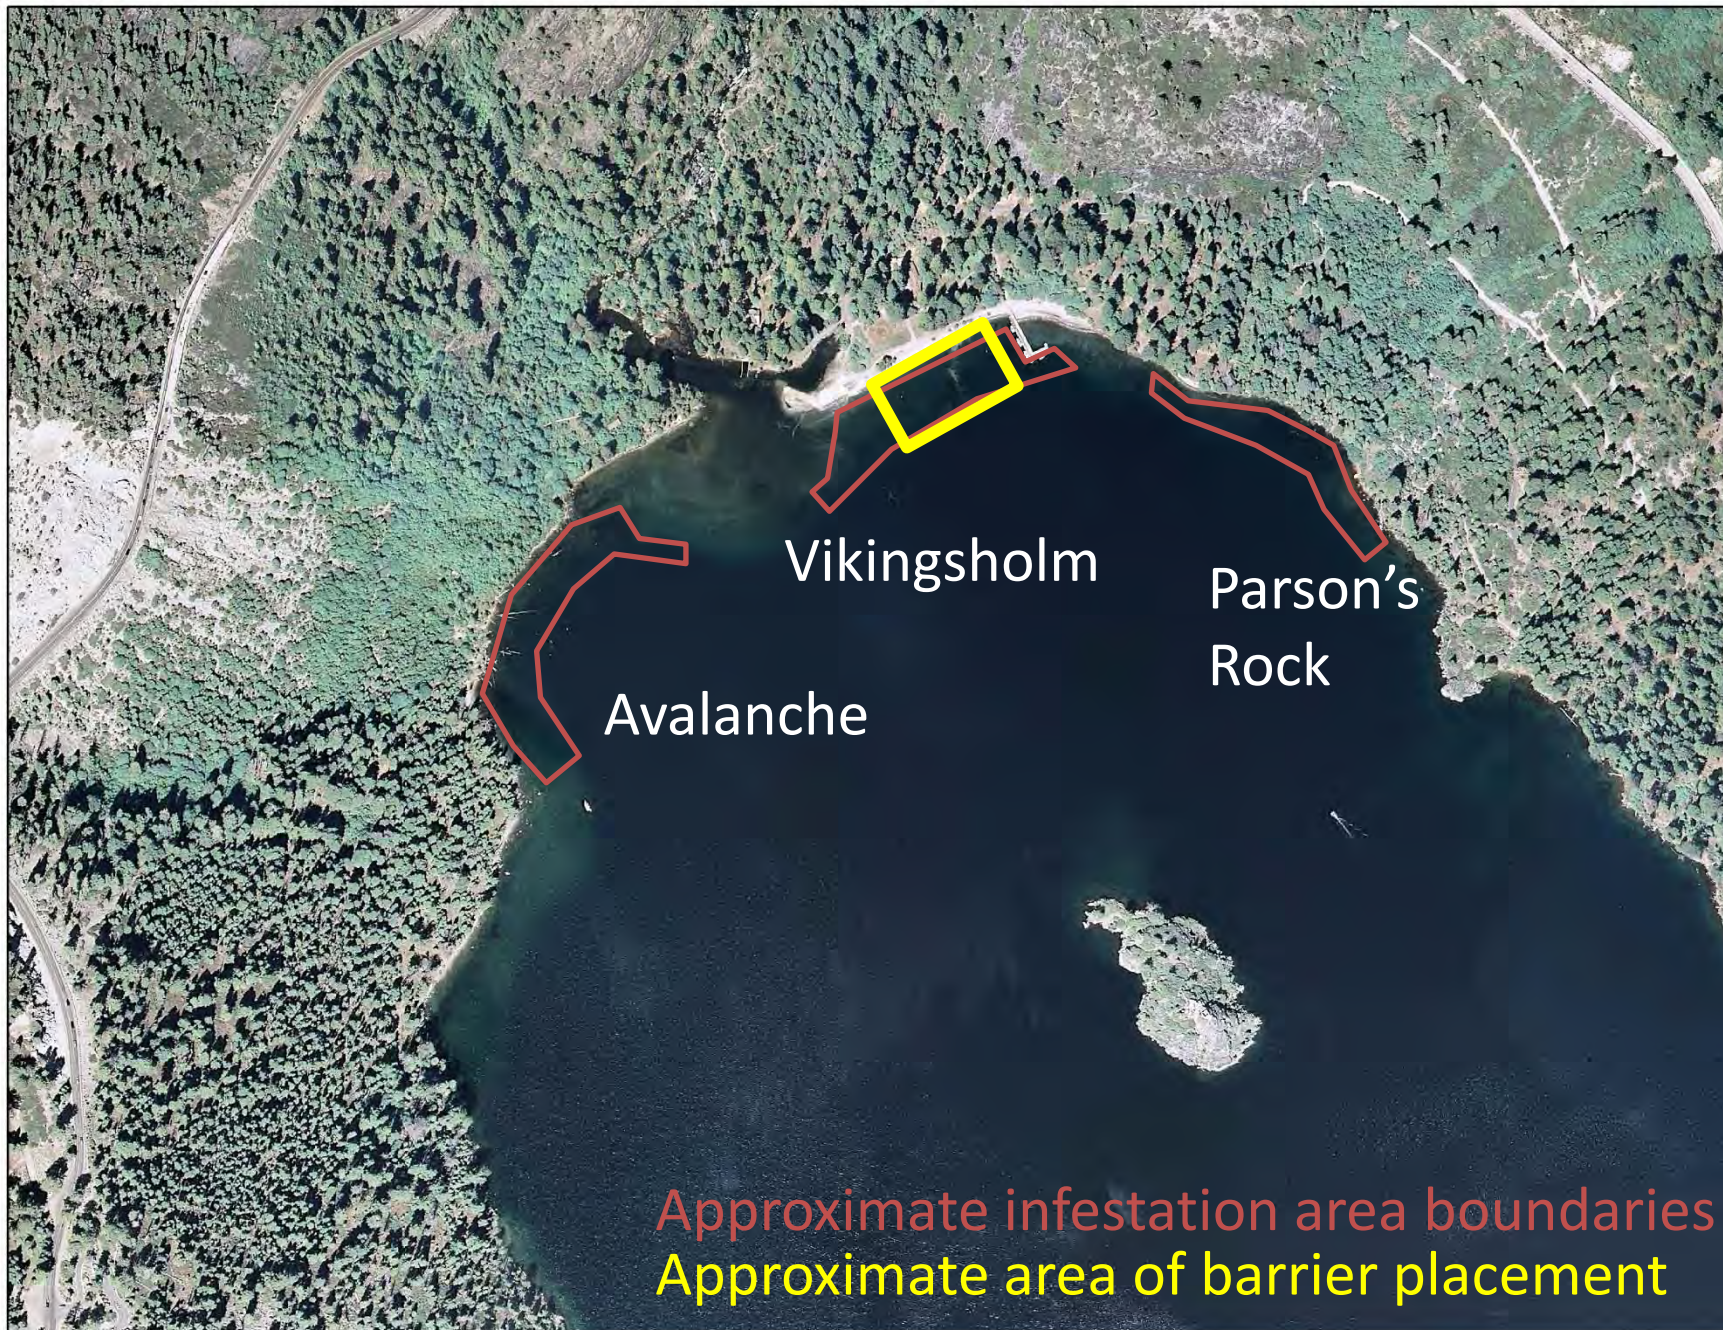
Approximate infestation area boundaries  
Approximate area of barrier placement

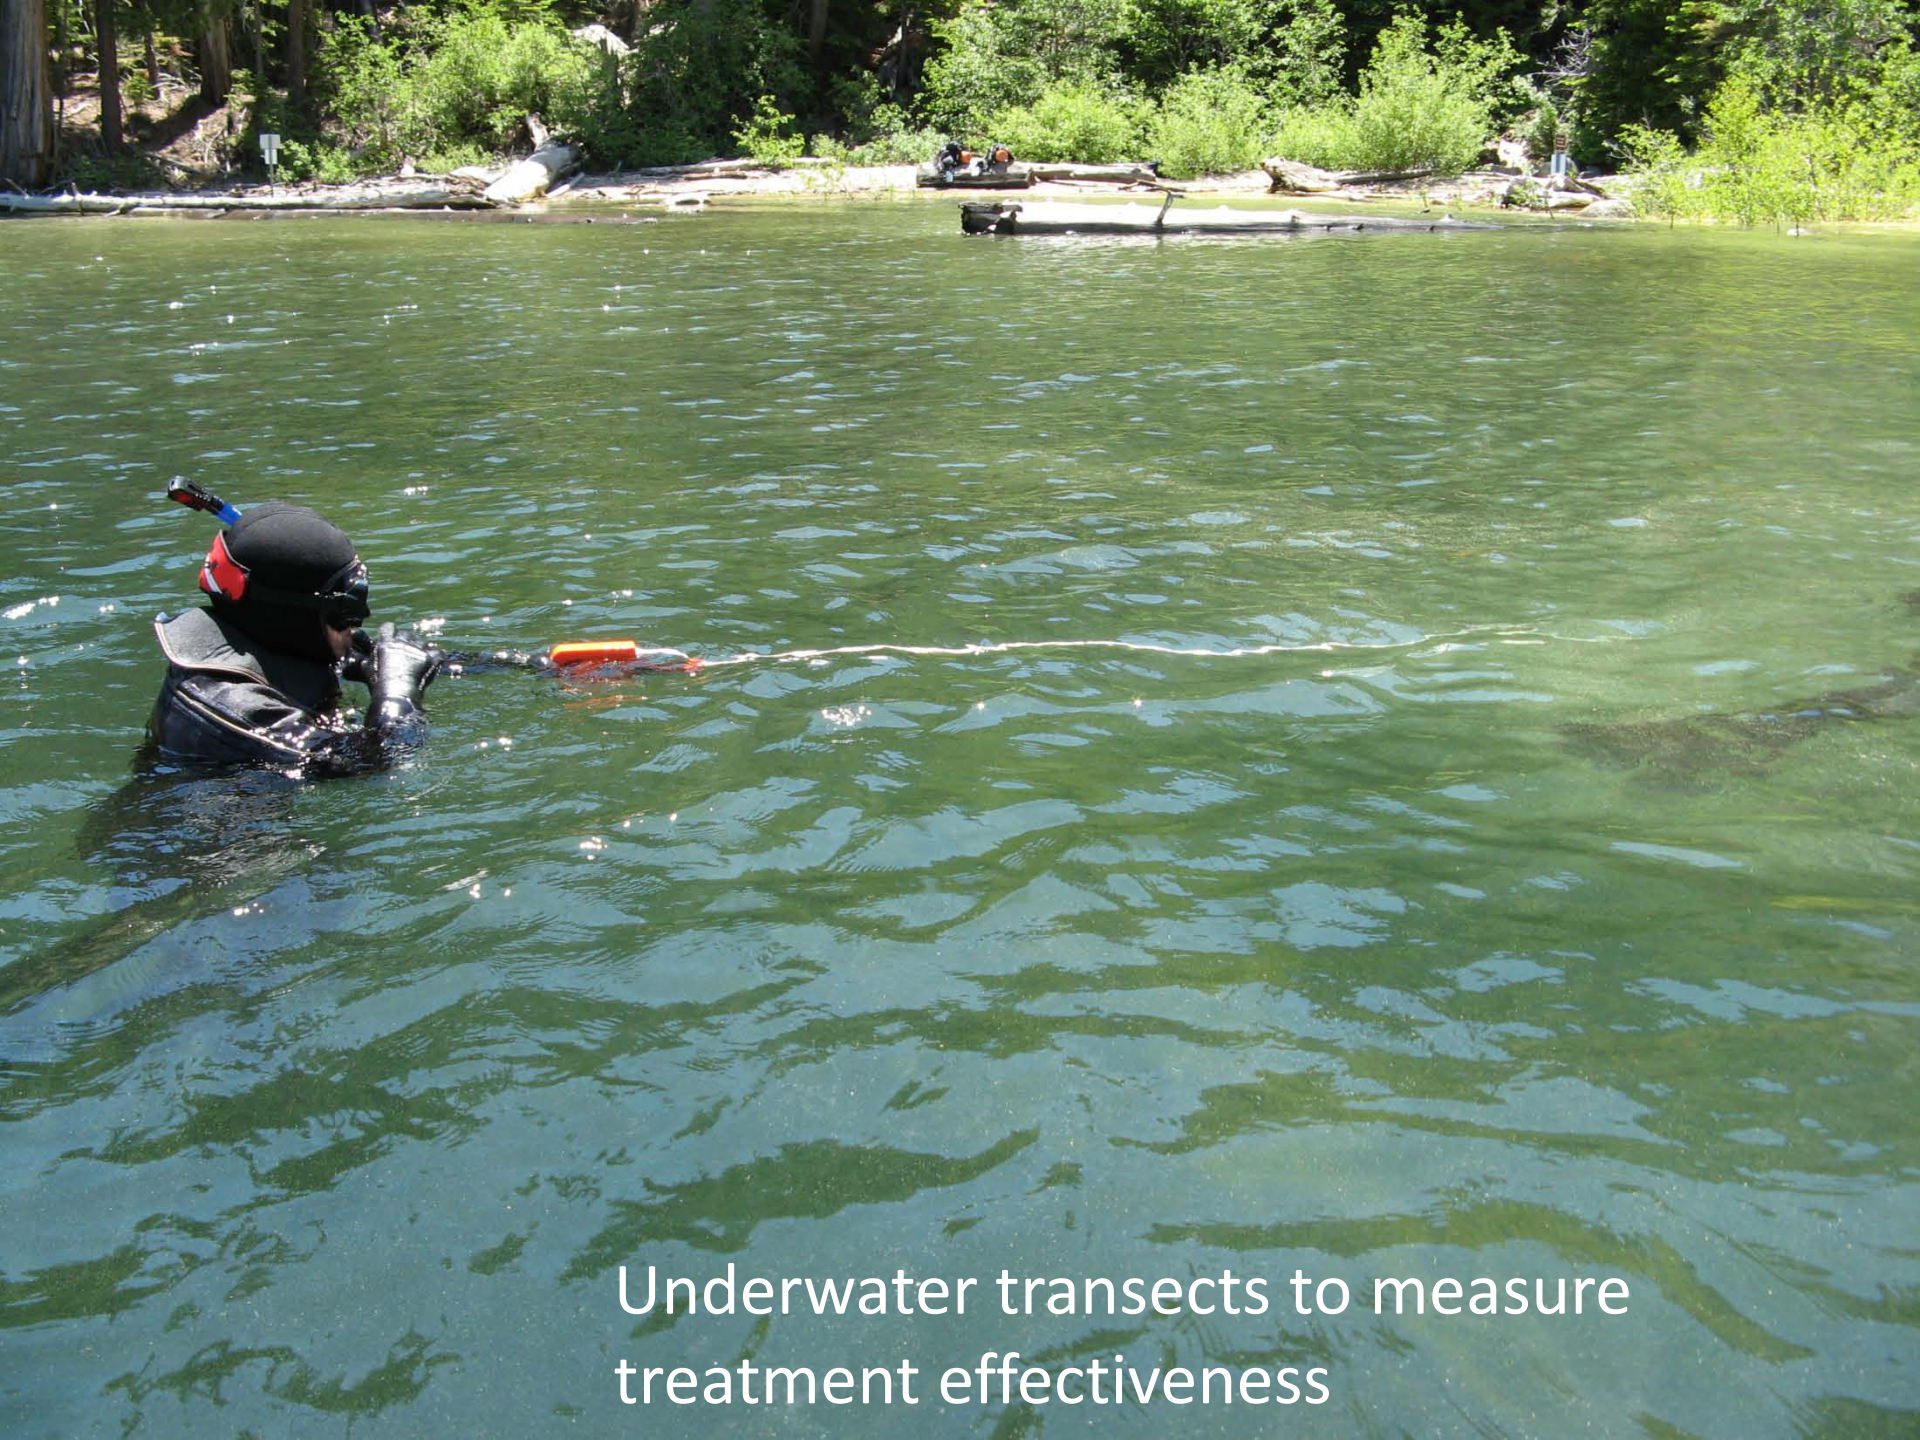
Underwater transects to measure treatment effectiveness

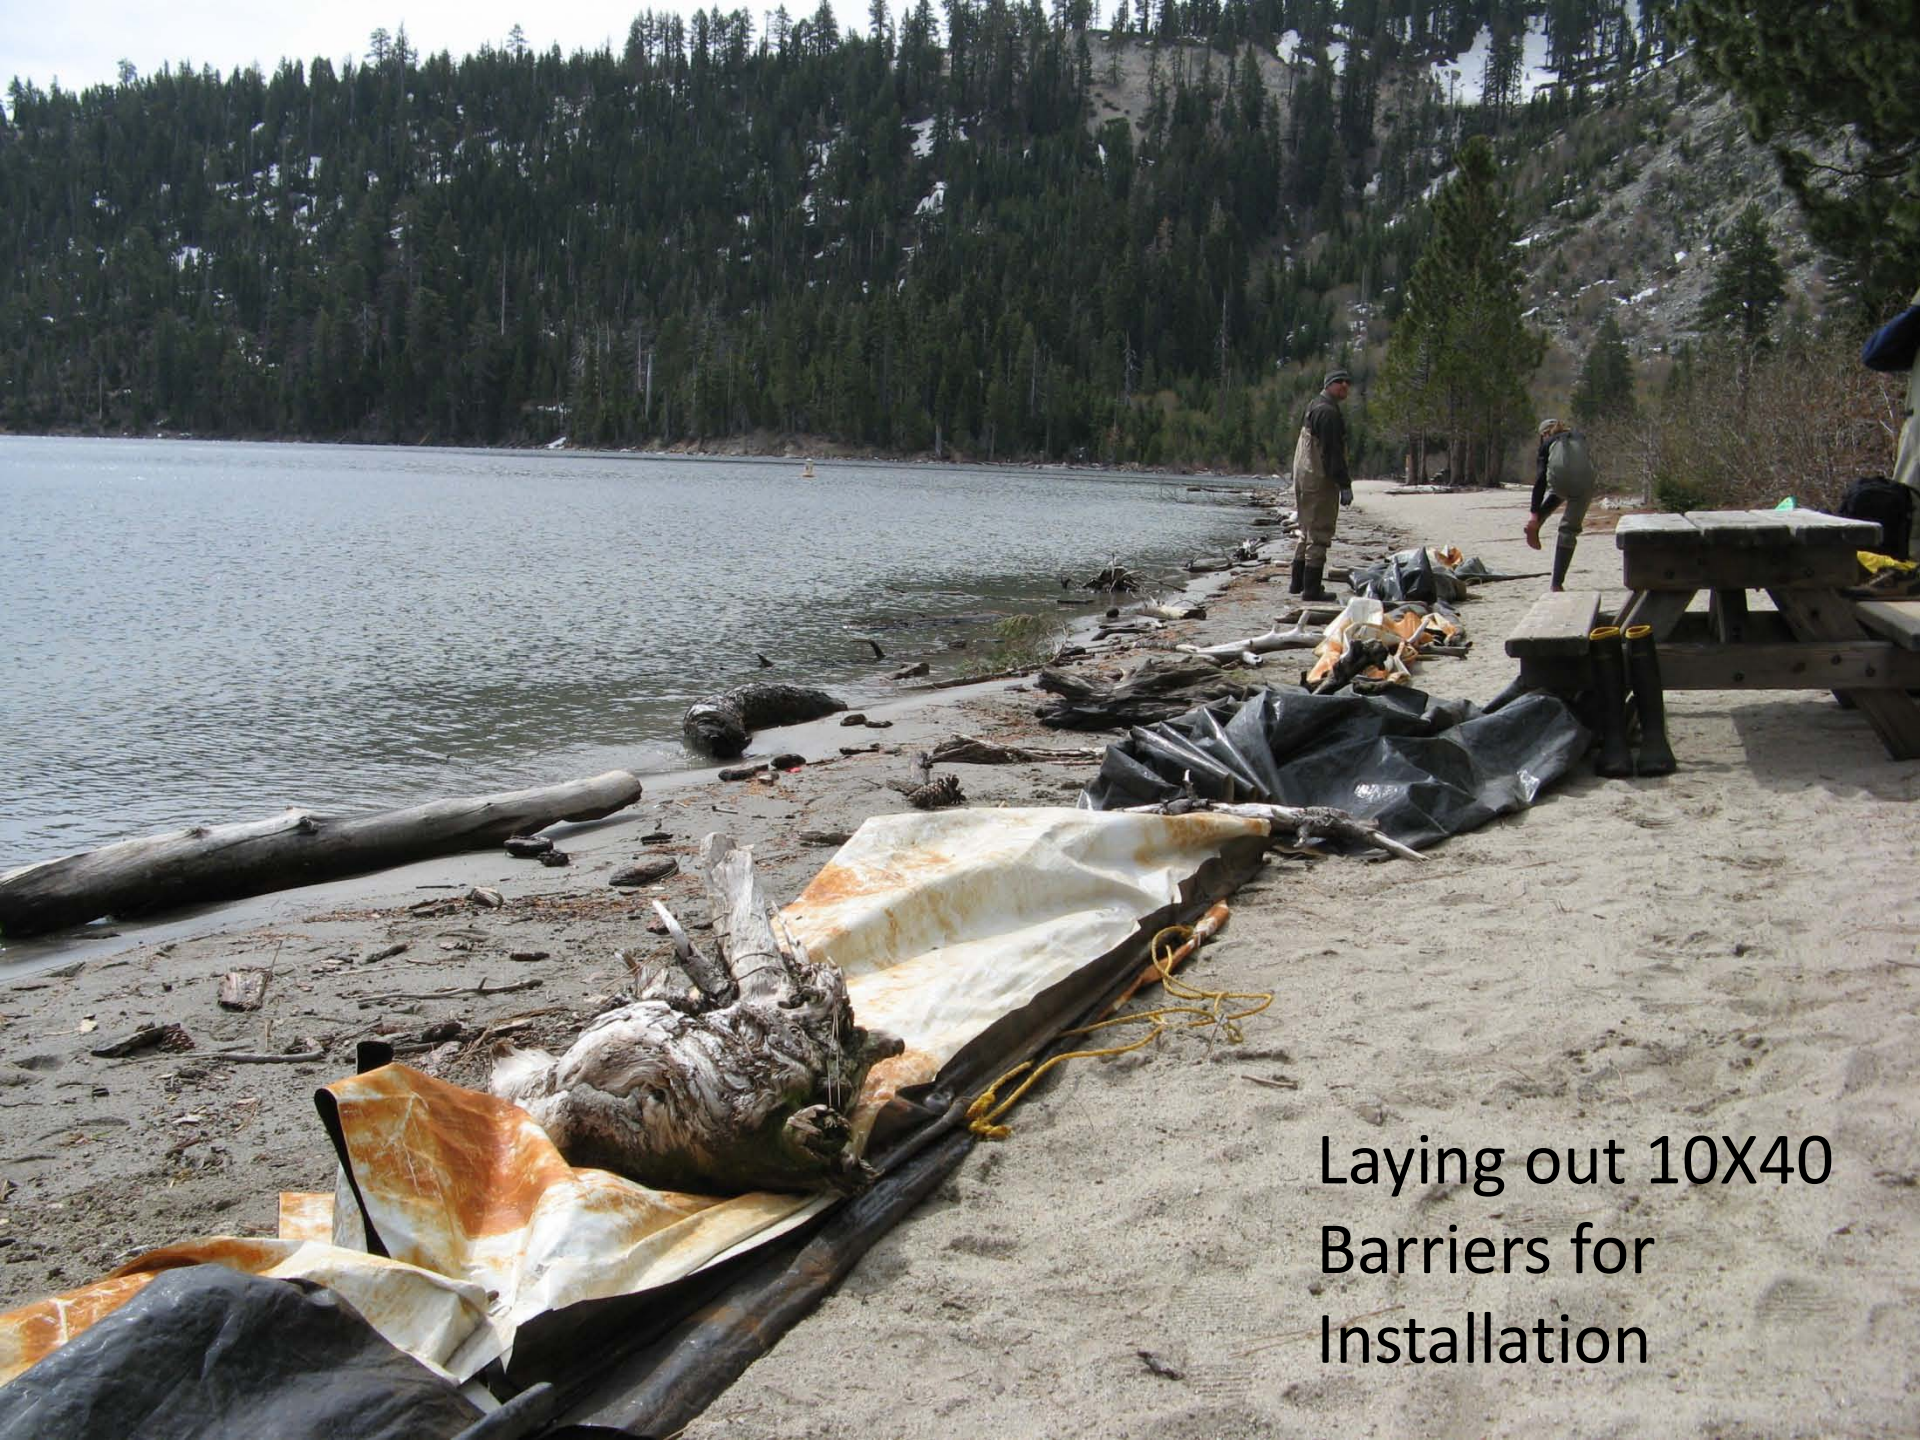
Laying out 10X40  
Barriers for  
Installation

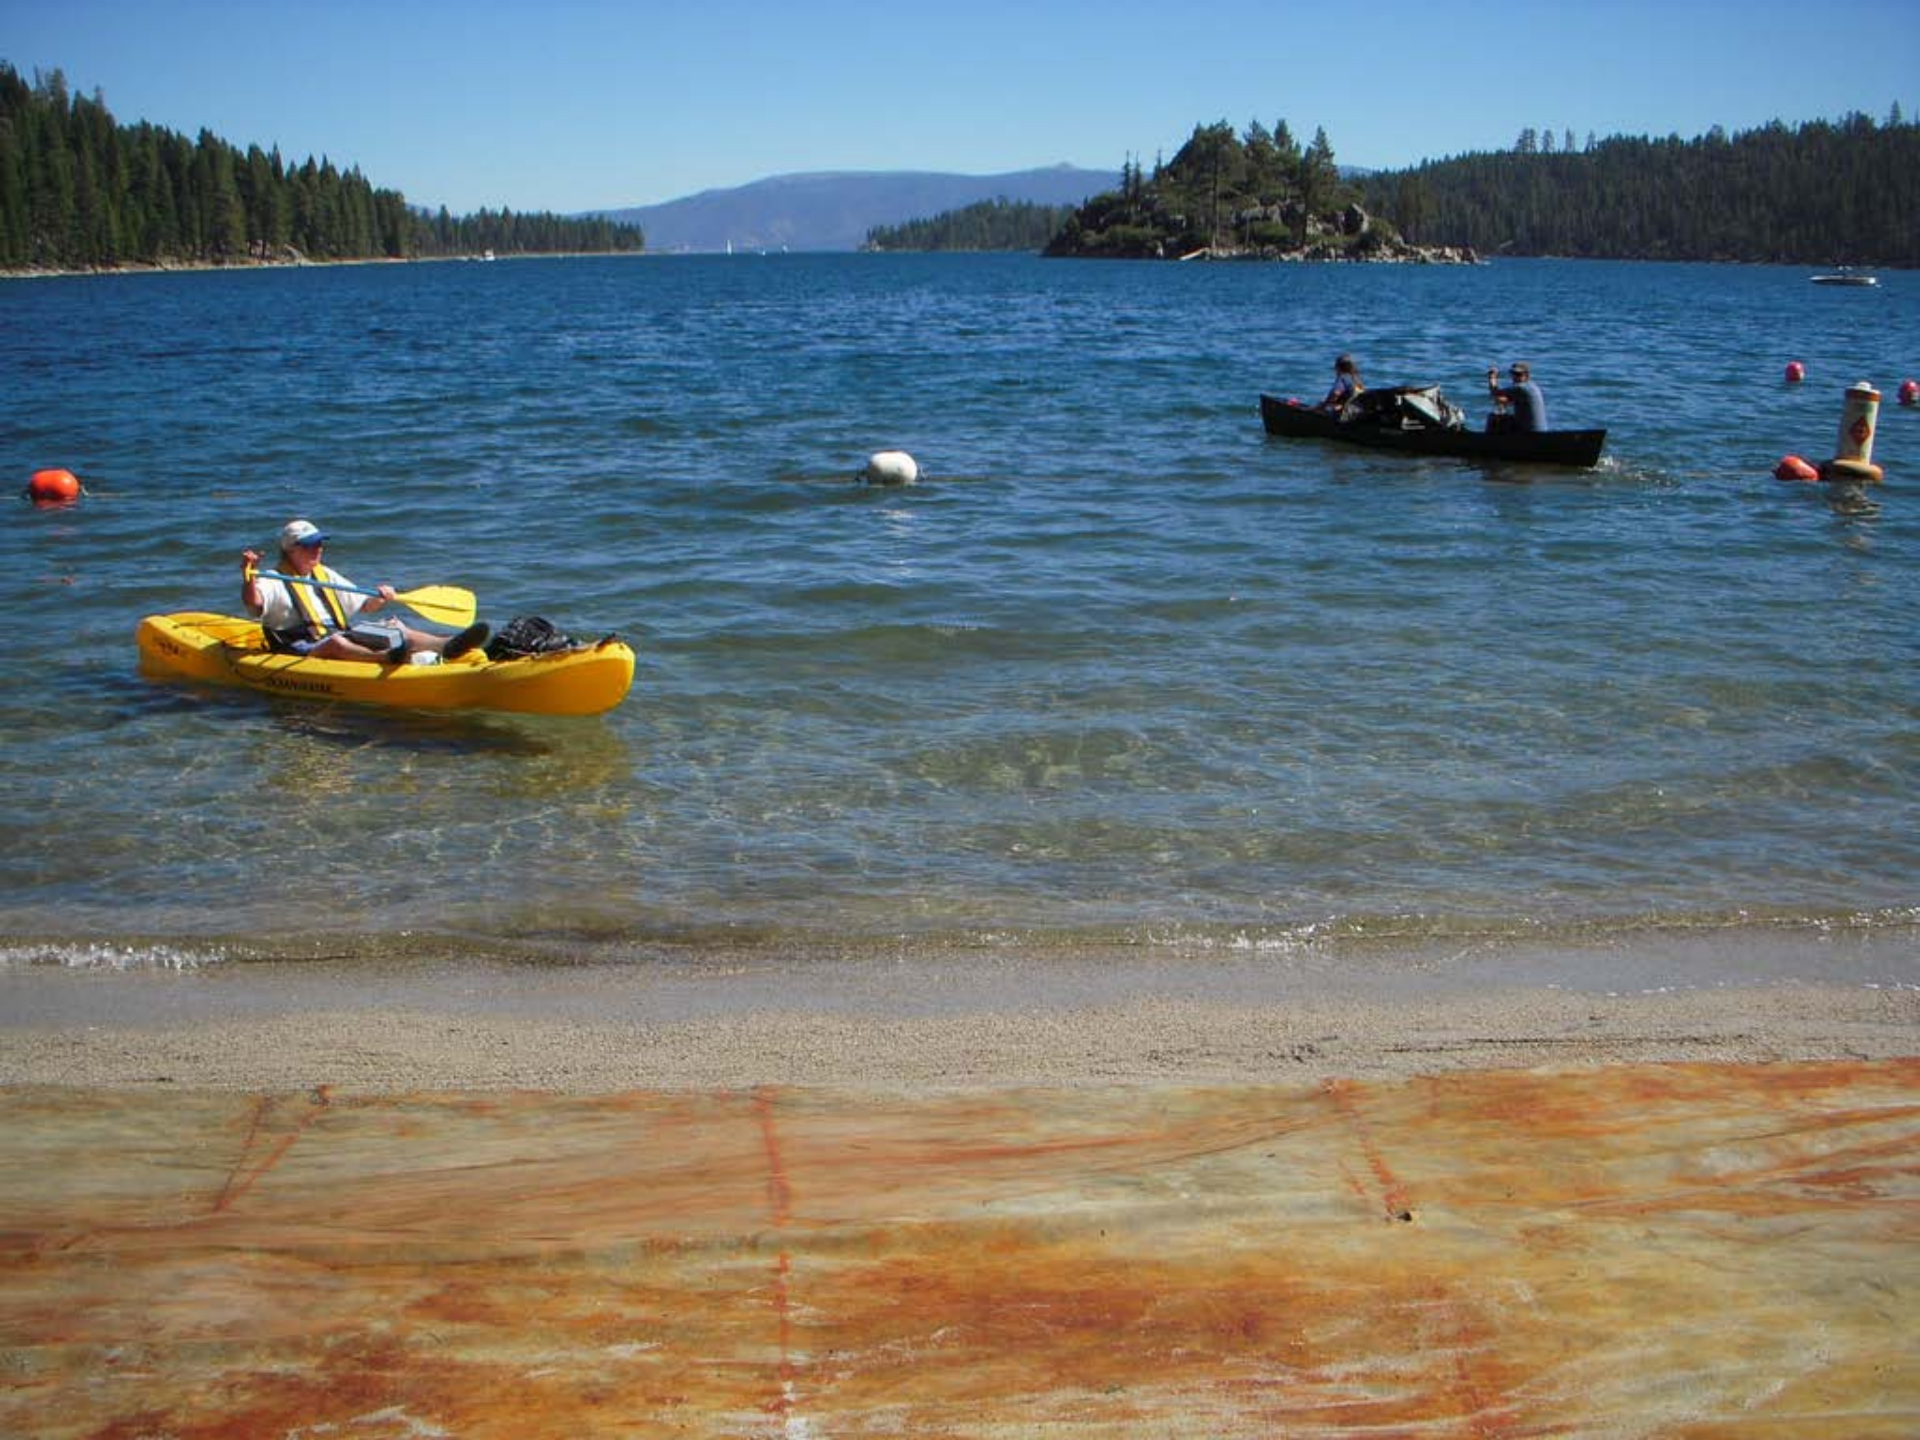
Barriers don't work in hard to reach places, but suction removal does

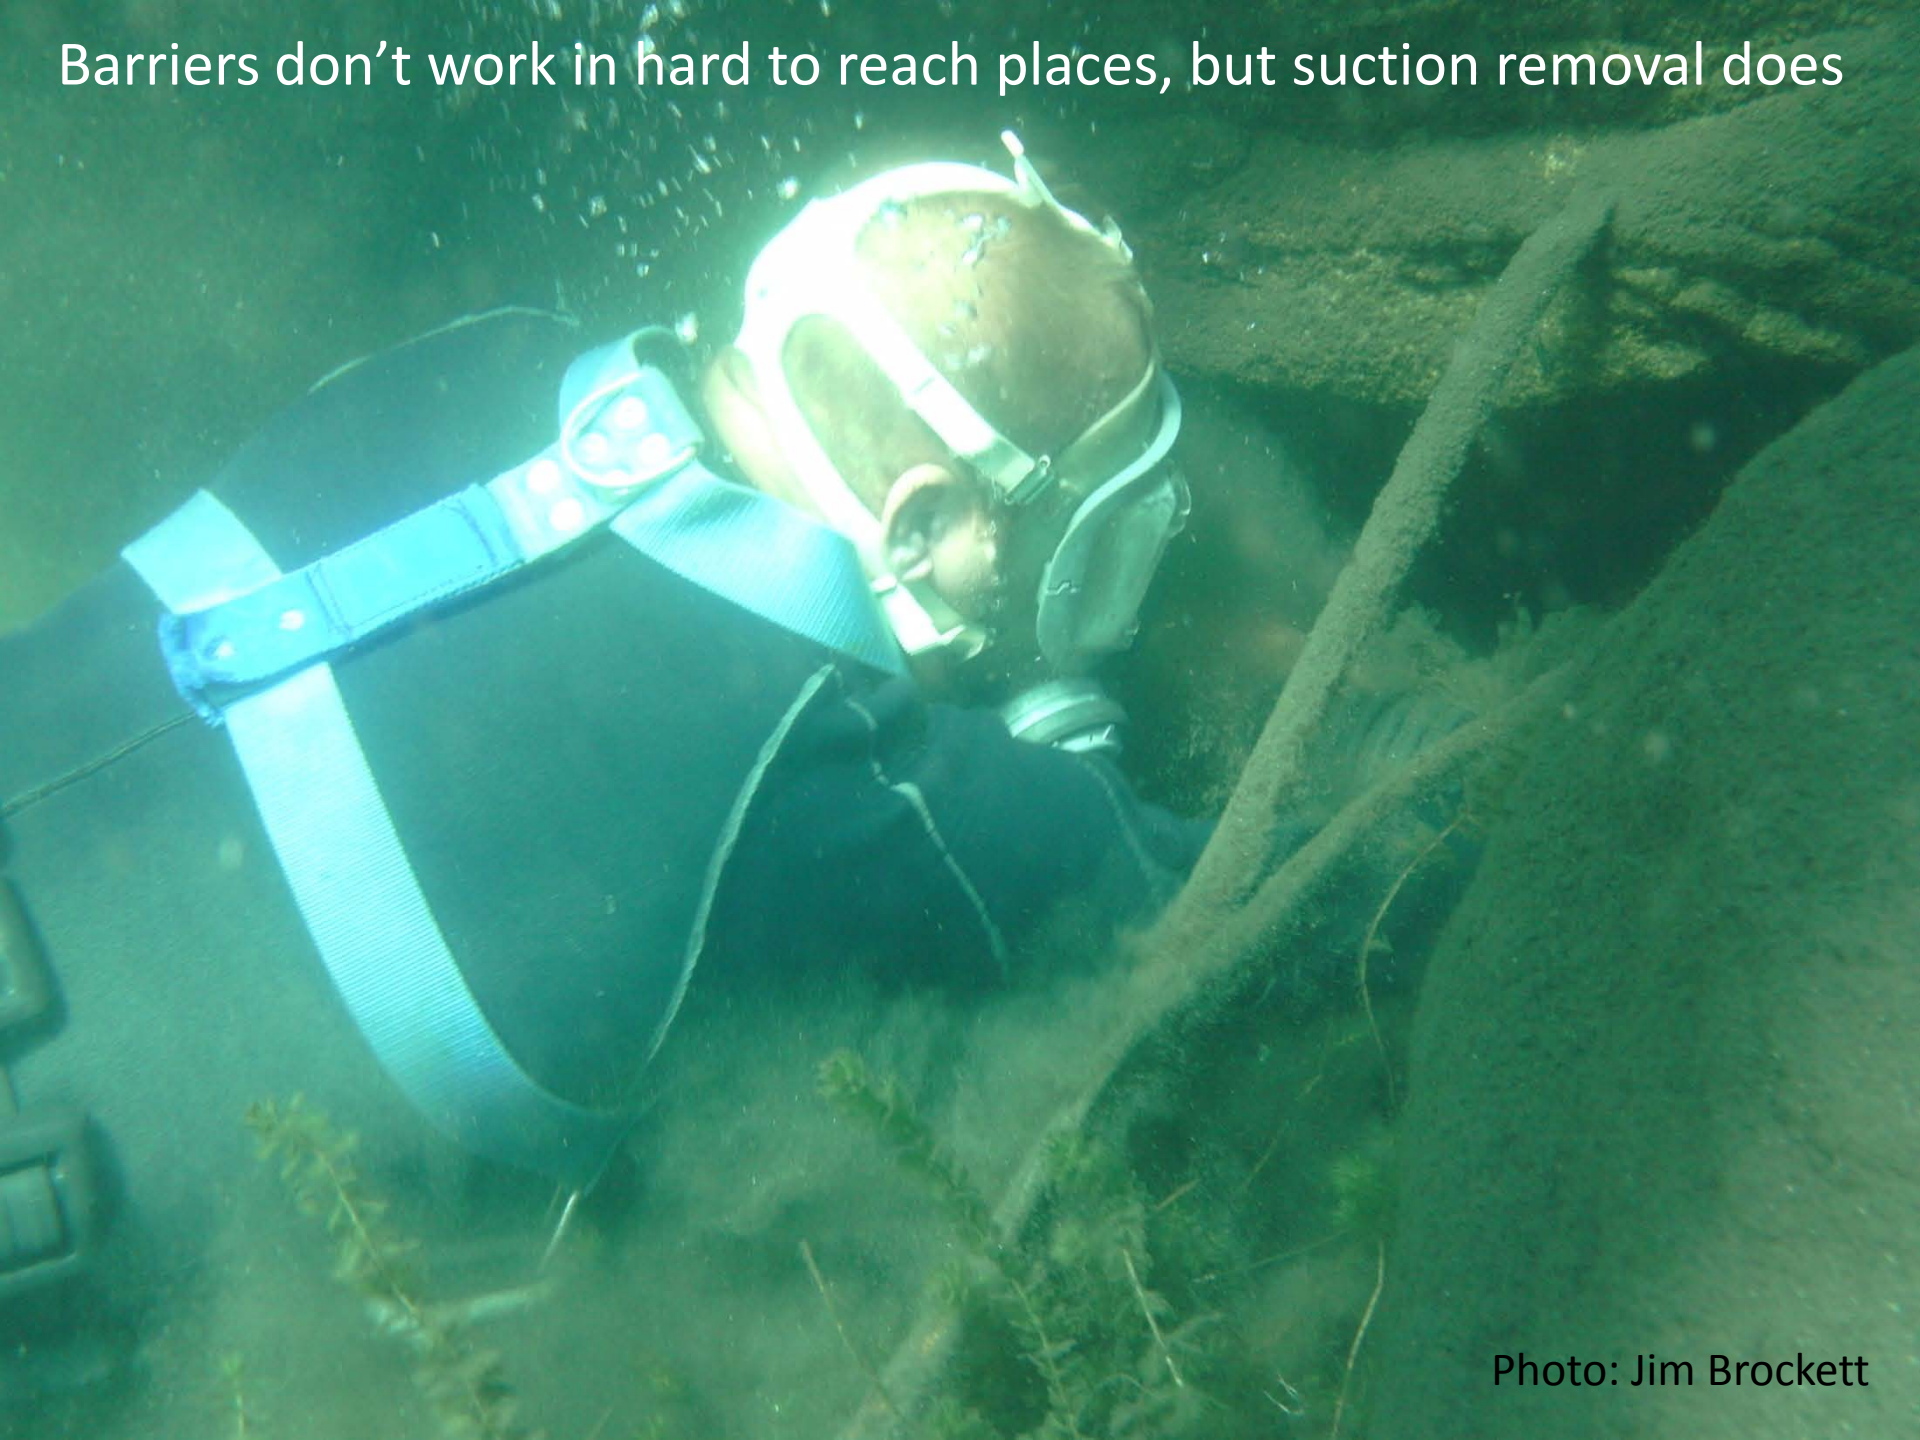
Suction Hose

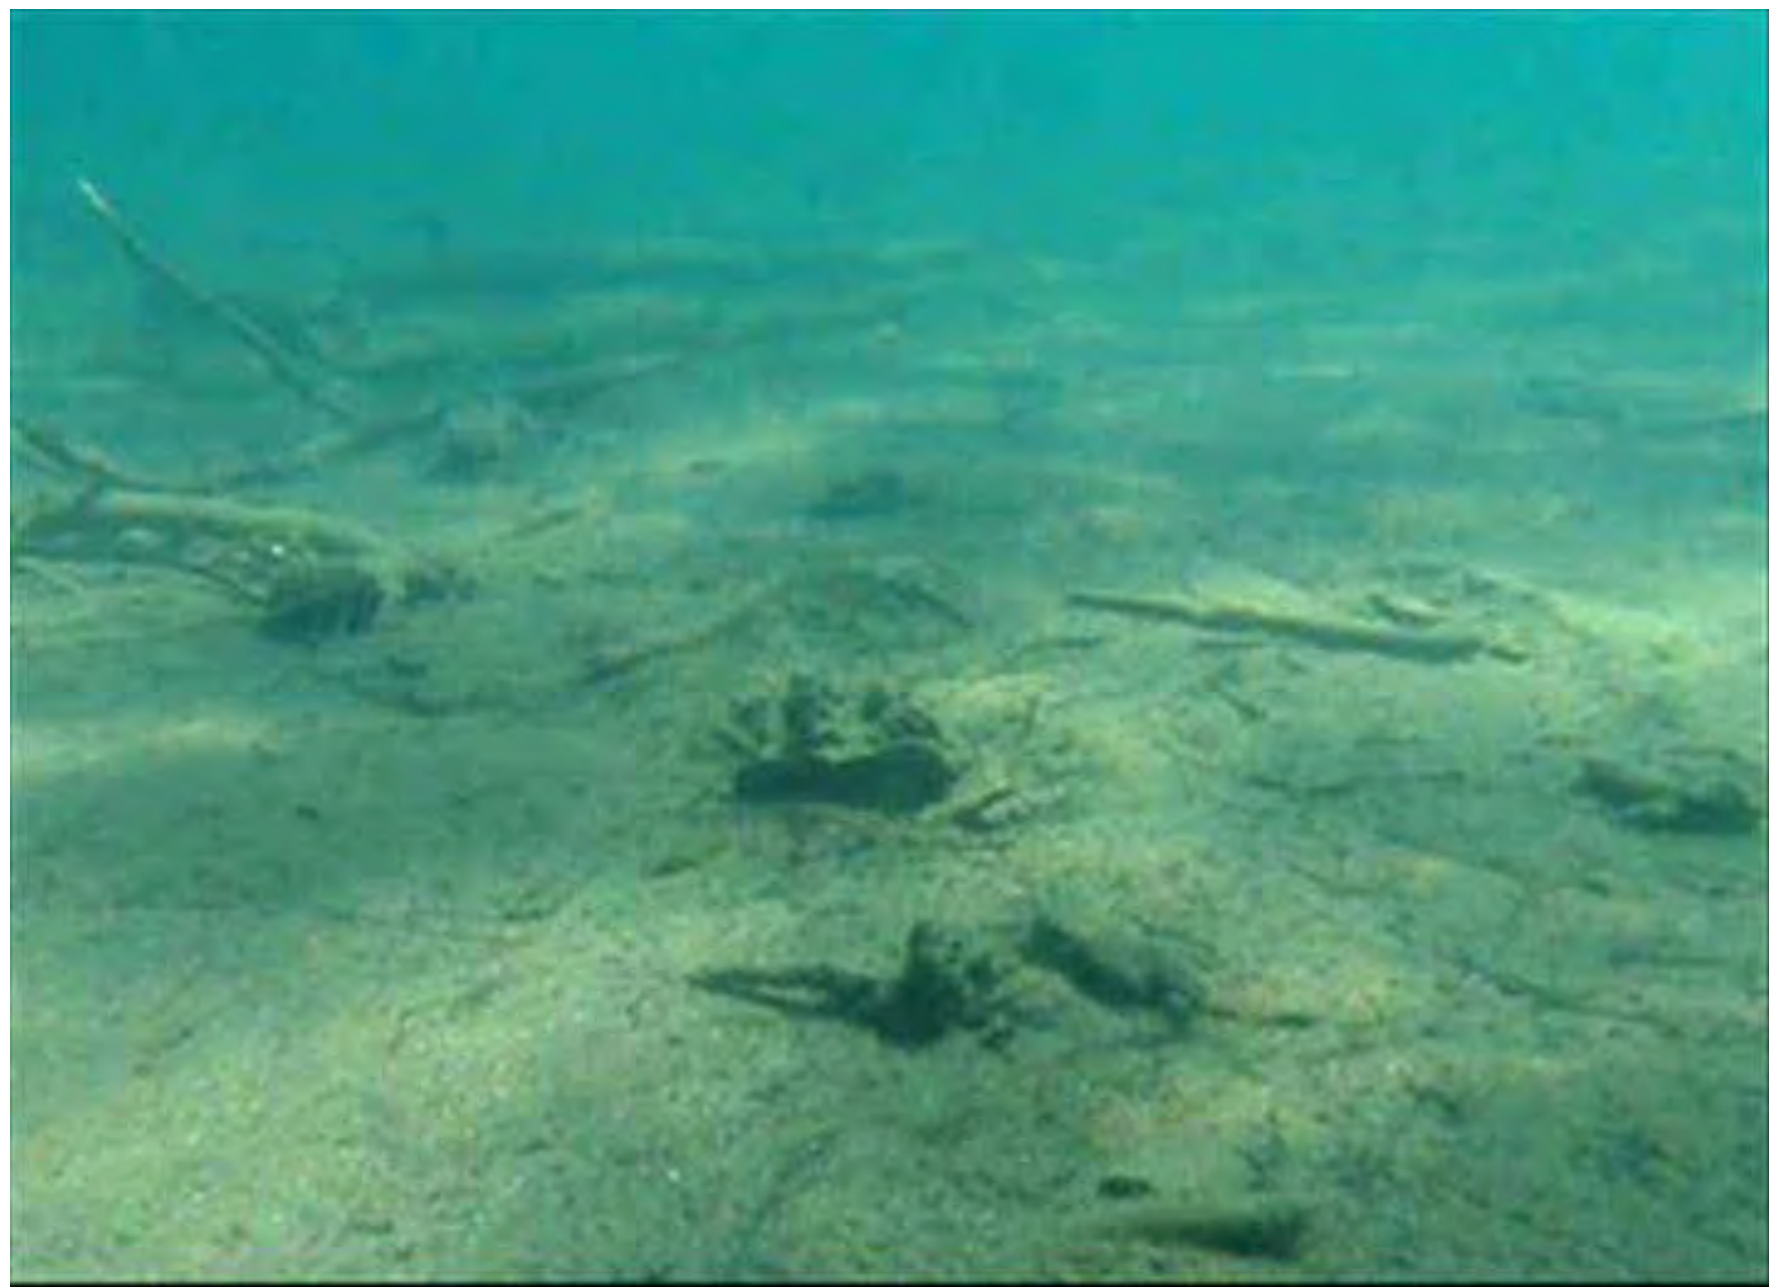
Sandy Bottom  
After Barrier Removal

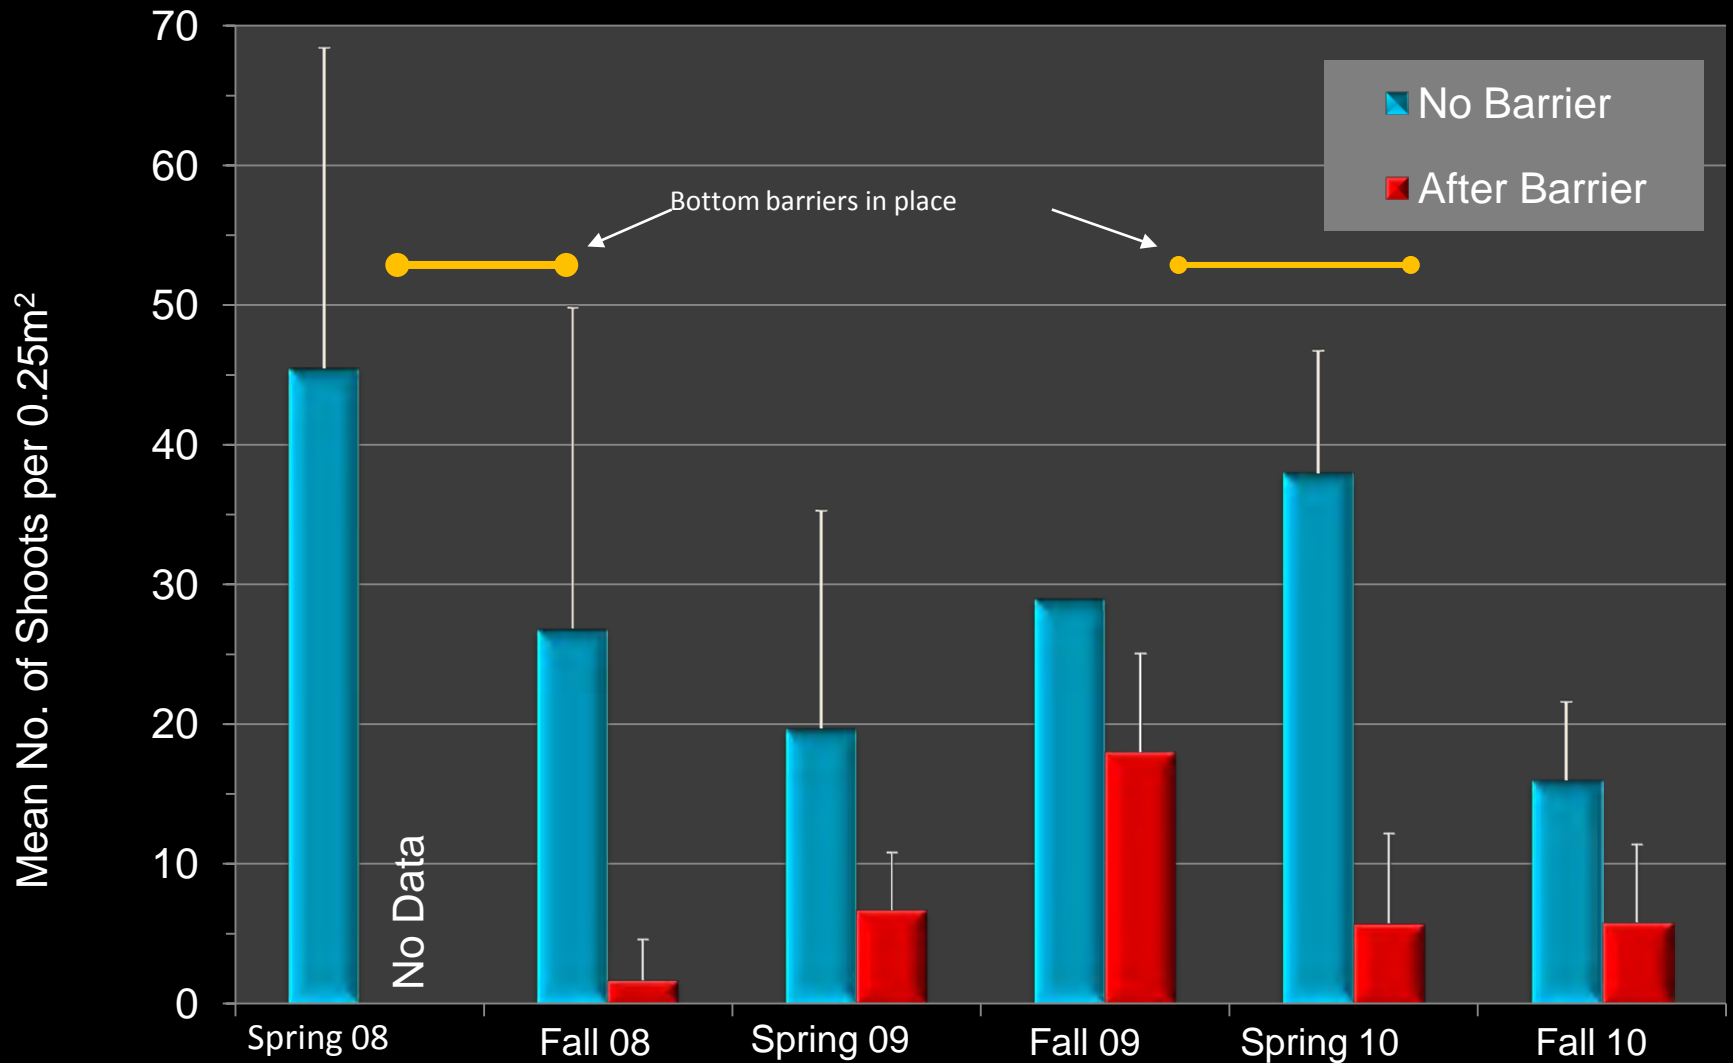
# EWM Densities at Parsons Rock Site
