EFFECTS OF ARUNDO DONAX ON SOUTHERN CALIFORNIA RIVER PROCESSES

PRELIMINARY ANALYSIS OF RIVER HYDRAULICS, SEDIMENT TRANSPORT, AND GEOMORPHOLOGY

FINAL DRAFT

northwest hydraulic consultants inc
3950 Industrial Blvd. #100C
West Sacramento, CA 95691

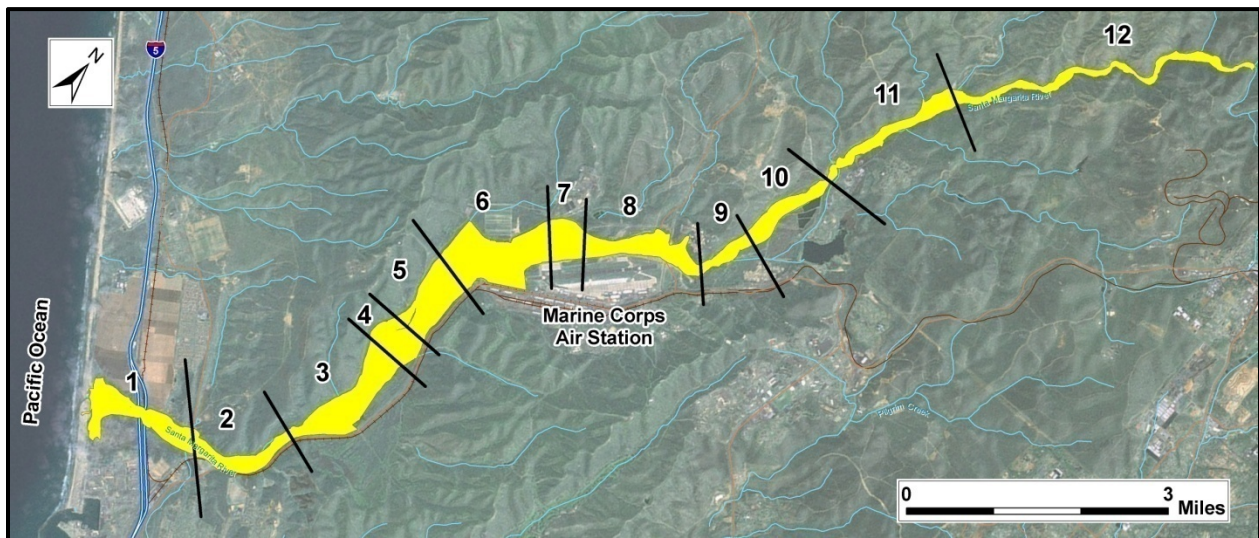
Figure 3.1: Santa Margarita River Study Reaches (yellow denotes extent of mapped floodplain).

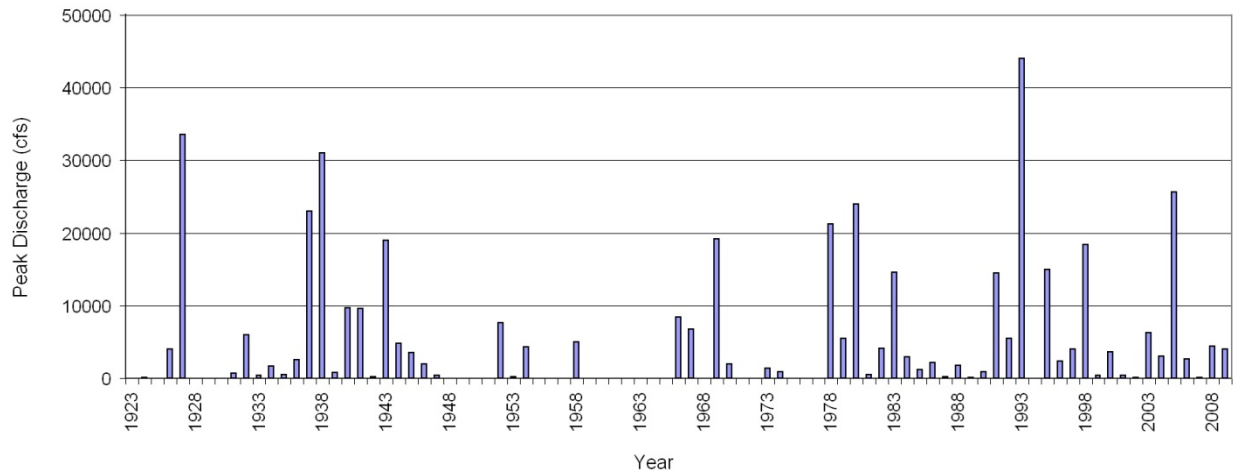
Figure 4.1: Annual peak discharges recorded at USGS stream gage 11046000 on Santa Margarita River near Ysidora. Years with zero values or no data are shown as blank.

1977 water years. Inspection of the gage records shows an annual hydrograph where runoff primarily occurs during winter months, and is event-driven with most of the water discharge (and also most of the sediment discharge) occurring during a few, intense storms (Warrick and Rubin 2007). Annual maxima vary dramatically from year to year; annual instantaneous peaks at the Ysidora gage have ranged from zero to 44,000 cfs (Figure 4.1).

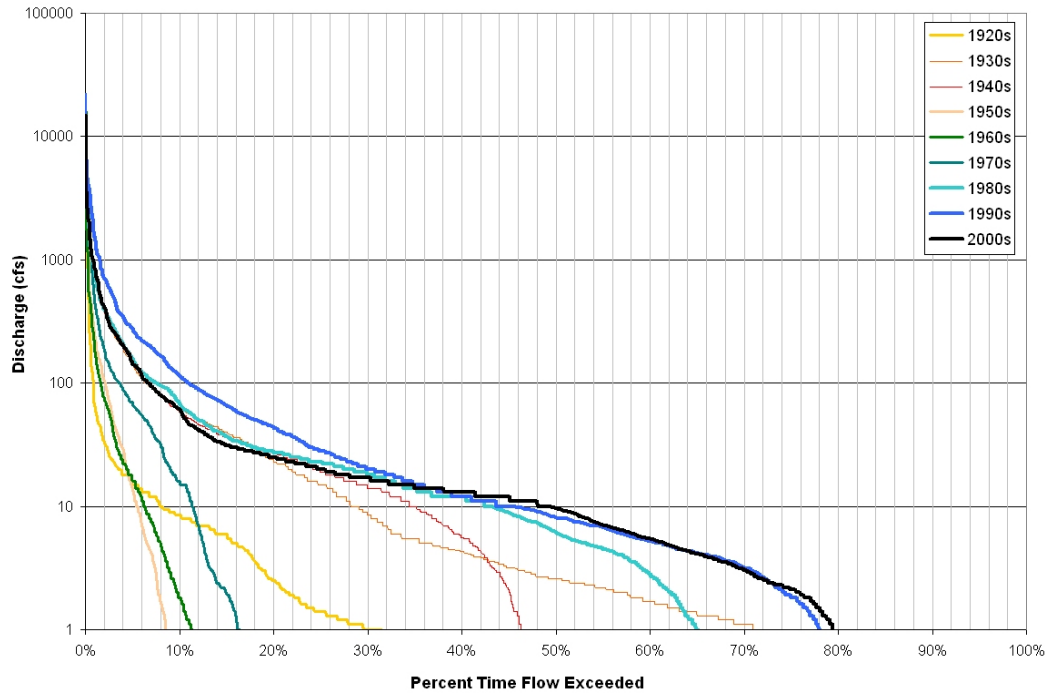
Figure 4.2: Flow duration curves plotted by decade at the Ysidora gage (11046000).

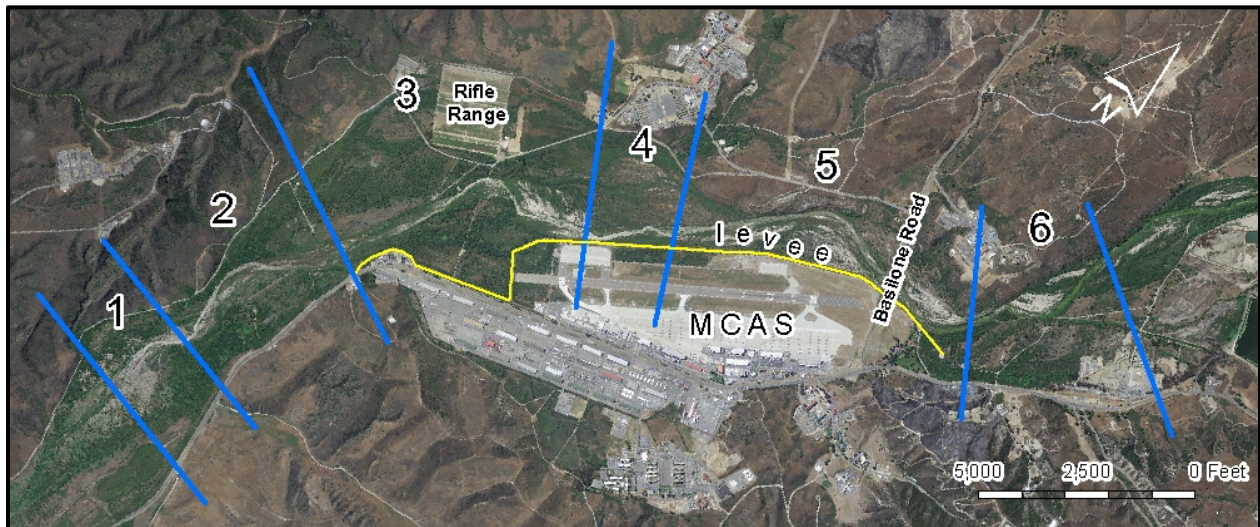
Figure 4.3: Sub-reaches (numbers 1 through 6) in the lower Santa Margarita River project reach.

The focus for this chapter is a 5.5 mile long project reach of the lower Santa Margarita River, which is adjacent to the MCAS and extends from De Luz Canyon to Ysidora Flats (Figure 4.3).

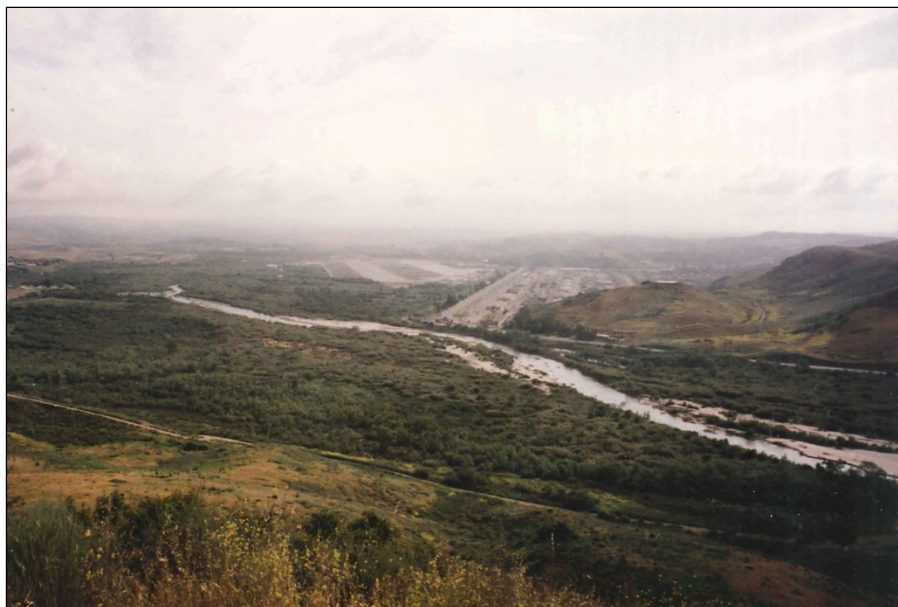
Figure 4.4: View of the Santa Margarita River in Sub-Reaches 2 & 3 (view is upstream) taken on May 16, 1995.

In the late 1990s, the main channel, as defined by channel banks, was typically 200 ft to 400 ft wide and bordered by moderate to abundant vegetation where the floodplain had not been developed. The main channel was generally about four to eight times wider than the low flow channel defined in Table 3.1. The floodplain surface was generally 4 to 6 feet higher than the low flow channel invert, as indicated by field inspection and channel surveys. Small, concentrated flow paths (distributary or chute channels) were common on the floodplain and on vegetated bar surfaces throughout the project reach (Figure 4.4).

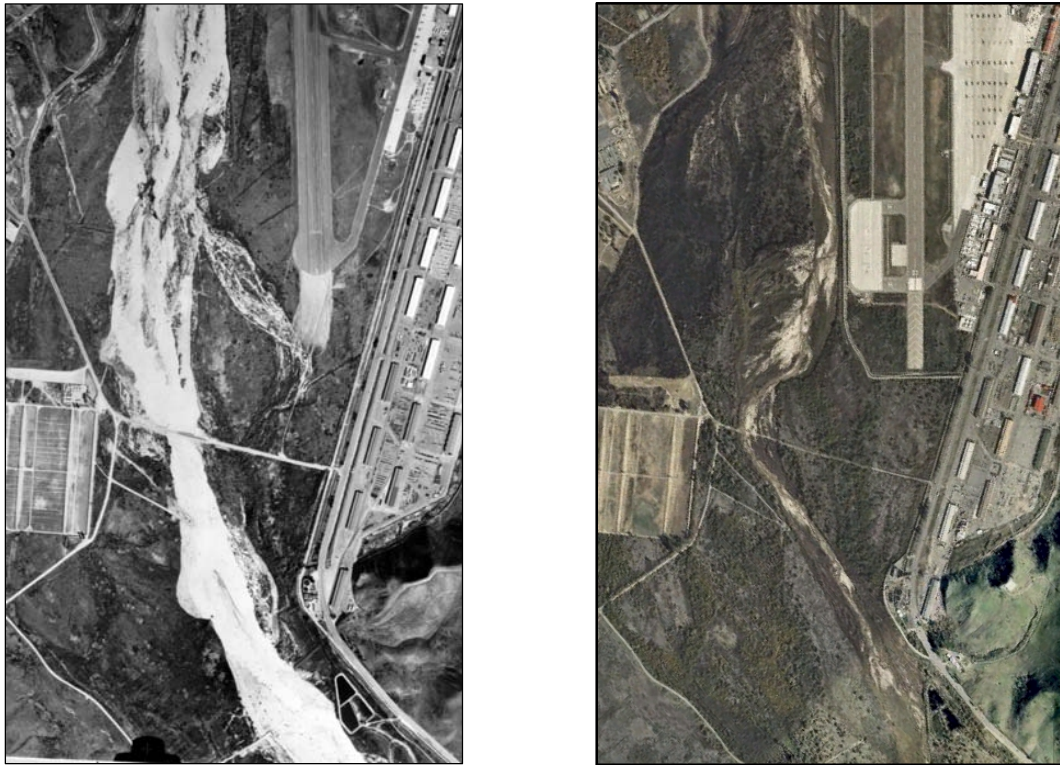
Figure 4.5: Comparison of 1970 (left) and 2008 (right) air photos of Sub-reach 3.

Figure 4.5 compares air photos of Sub-reach 3 from 1970 and 2008. The non-vegetated active channel bed is several times wider in 1970 than 2008, and floodplain vegetation also appears to be less dense in 1970 than 2008, despite the recent *Arundo* eradication. Channel and floodplain conditions in the 1970 air photo resulted from the 1969 flood, which followed a twenty-five year period with no significant floods. Stetson Engineers (2001) reported that large floods in 1927 and 1993 also scoured much of the valley bottom and dramatically enlarged the active channel in Deluz Canyon just upstream of the project reach.

Interestingly, the 2008 air photos were taken not long after the 2005 flood, whose peak was slightly greater than that in 1969. Despite this, the 2008 channel shows no evidence that it had recently enlarged to the width observed after the 1969 flood. This different behavior is assumed to result from changes in the riparian vegetation in the channel and on the floodplain, or changes in channel and floodplain geometry, that resulted in greater bank and floodplain resistance to erosion.

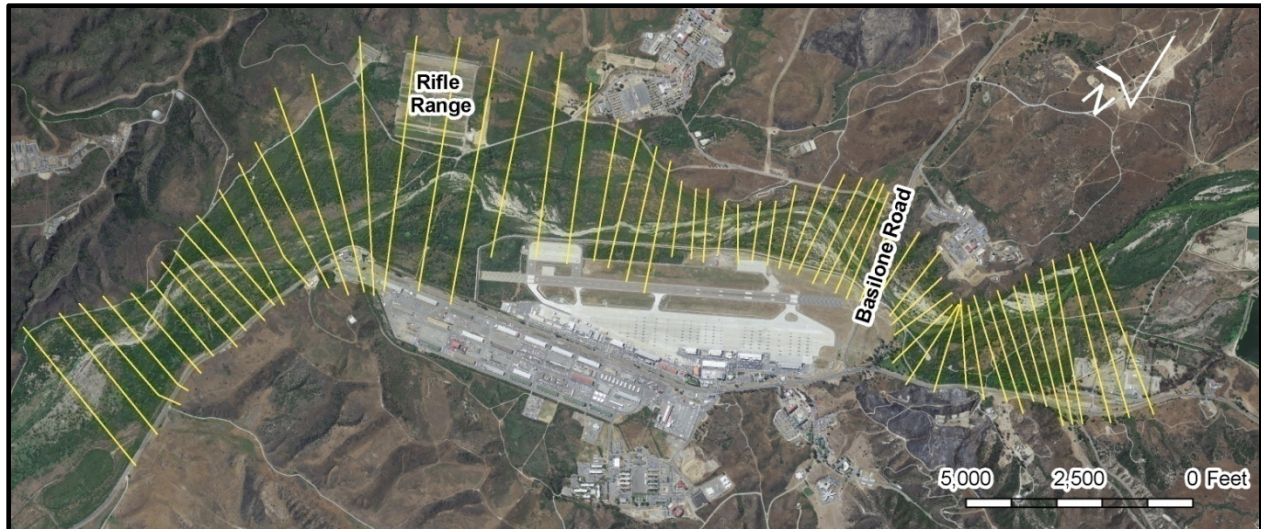
Figure 4.6: Location of HEC-RAS model cross-sections (in yellow) (NHC 2001).

In the late 1990s, NHC developed a calibrated, steady, one-dimensional HEC-RAS model (USACE 2010) of the Santa Margarita River project reach, as part of studies for a new levee (NHC 2001). The model was based on 62 cross-sections in the project reach, an average of one every 470 ft, developed either from July 1998 LiDAR, September 1996 air photos or June and July 1998 cross section surveys (Figure 4.6).

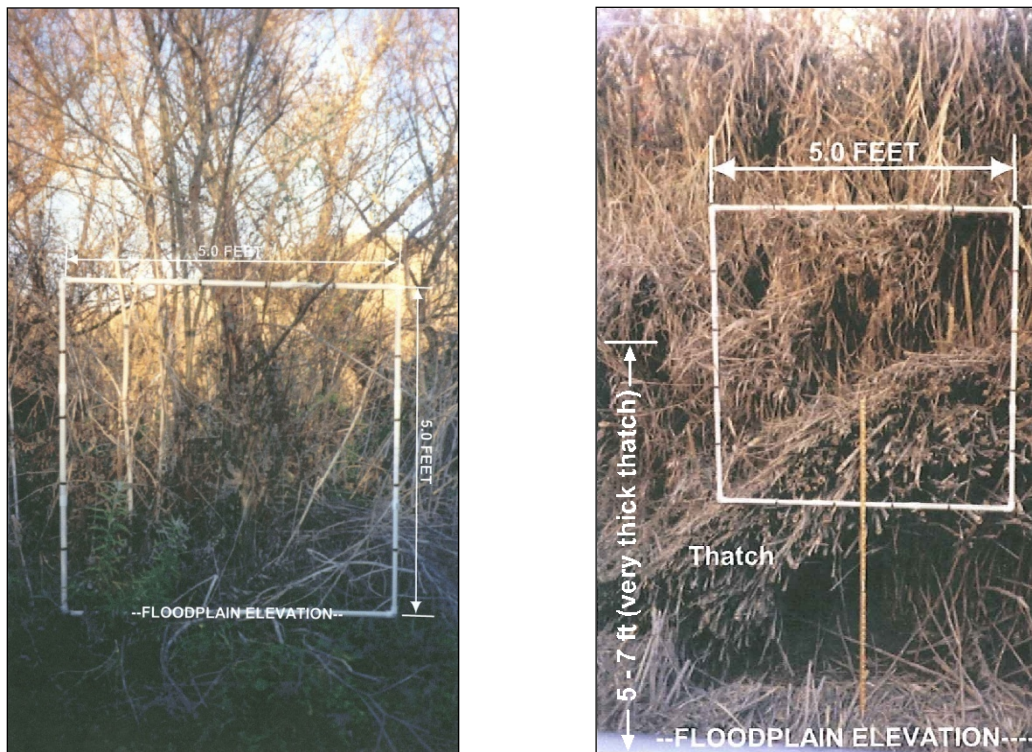
(a) Native Riparian Vegetation

(b) Mature Stand of Arundo

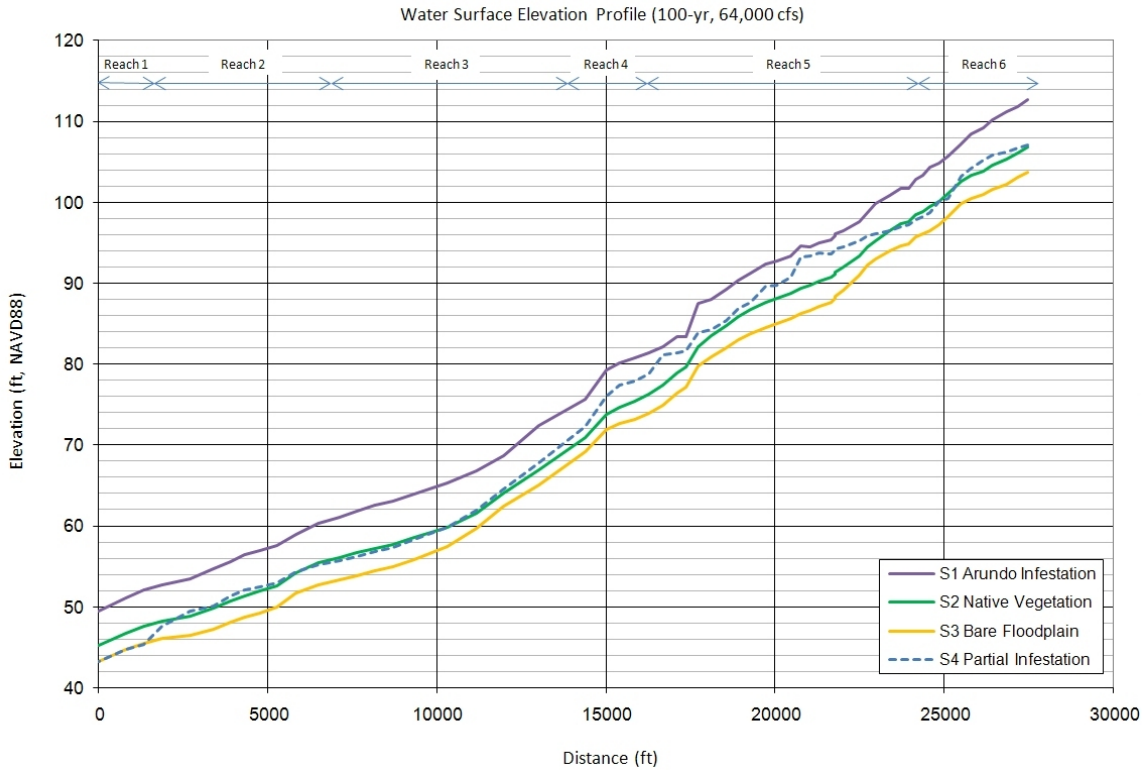
Figure 4.8: Project Reach Water surface profiles for Scenarios 1 to 4: 100-year peak flow.

Water surface profiles for the 5-year flood show a similar pattern to that for the 100-year flood, but have smaller differences in stage. The full Arundo coverage scenario (Scenario 1) raises water levels up to 3 ft above those for native vegetation, whereas bare soil or no floodplain vegetation (Scenario 3) lowers them about 1 ft. The 5-year water levels for the 1997 vegetation scenario (Scenario 4) are close to those for complete native vegetation coverage, but rise one to two feet in sub-reaches where the infestation is particularly concentrated.

Comparison of results from Scenarios 1 and 4 to those from Scenario 2 suggests that there is a threshold for floodplain coverage by mature Arundo, below which impacts on average depths and water surface profiles are relatively insignificant. A rough idea of the threshold can be obtained by comparing Arundo densities in Sub-reaches 4 and 5 to those further downstream (Table 4.4). On this basis, percent Arundo coverage somewhere over 30% generally results in significant adjustments to the water surface profile.

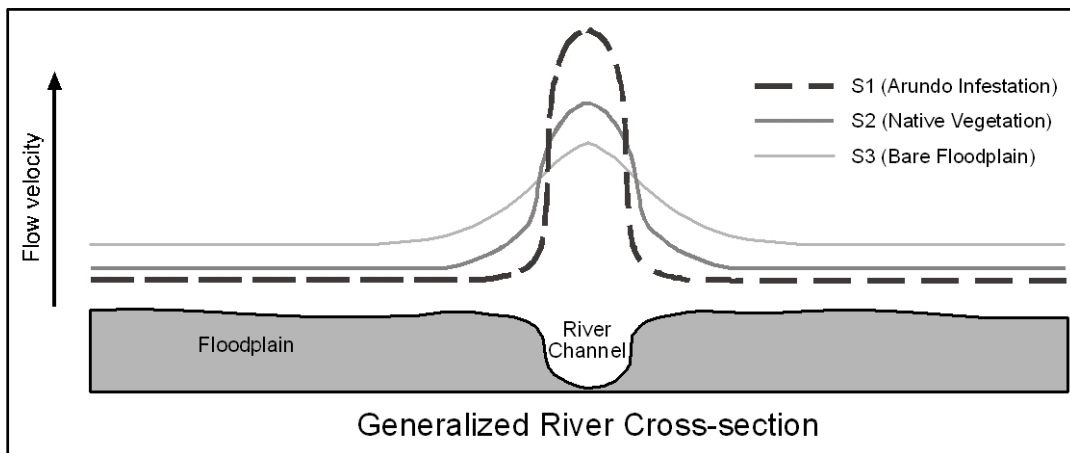
Figure 4.9: Generalized illustration of the effects of floodplain roughness (dense vegetation) on velocity across the section for Scenarios 1, 2, and 3.

Table 4.3 indicated that complete coverage by Arundo results in the deepest flows and greatest velocities in the main channel and the slowest velocities on the floodplain. This illustrates a key characteristic of dense vegetation, such as Arundo, in the hydraulic model: flows are concentrated in the main channel by dense stands along the stream banks, resulting in deeper and faster flow through the main channel for a given discharge.

In contrast, removal of floodplain vegetation results in the lowest average velocities in the main channel. Main channel velocities with floodplain vegetation removed would be lower still if channel widening due to the lower bank strength was incorporated in the RAS model. These observations are summarized in Figure 4.9.
