5.0 IMPACTS OF *ARUNDO*: Hydrology, Geomorphology and Flooding

5.1 Hydraulics, Sediment Transport, Geomorphology

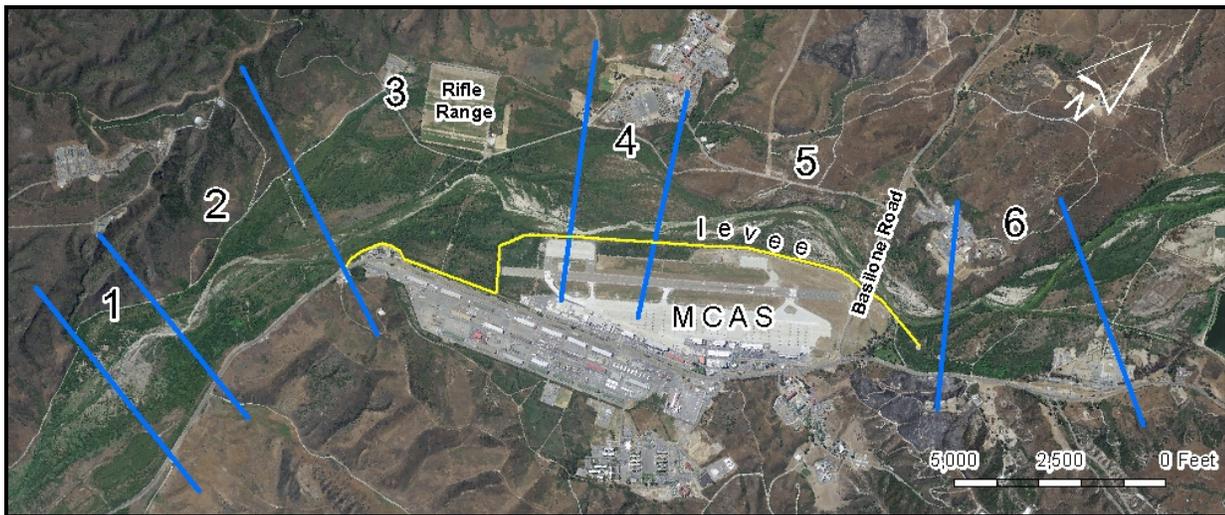
Figure 5-1.6. Sub-reaches (numbers 1 through 6) in the lower Santa Margarita River project reach.

The focus for this chapter is a 5.5 mile long project reach of the lower Santa Margarita River, which is adjacent to the MCAS and extends from De Luz Canyon to Ysidora Flats (Figure 5-1.6).

This project reach is where NHC examined hydraulics and sediment transport capacity with mature stands of *Arundo* on the river bank and floodplain (NHC 1997a; 1997b; 2001) and covers about the same river mileage as Reaches 4 through 9 in Table 5-1.1 and Figure 5-1.1. The river floodplain is confined to varying degrees throughout the project reach, particularly upstream of the O’Neill Lake diversion and in the vicinity of Basilone Road Bridge (Table 5-1.4; Figure 5-1.6).

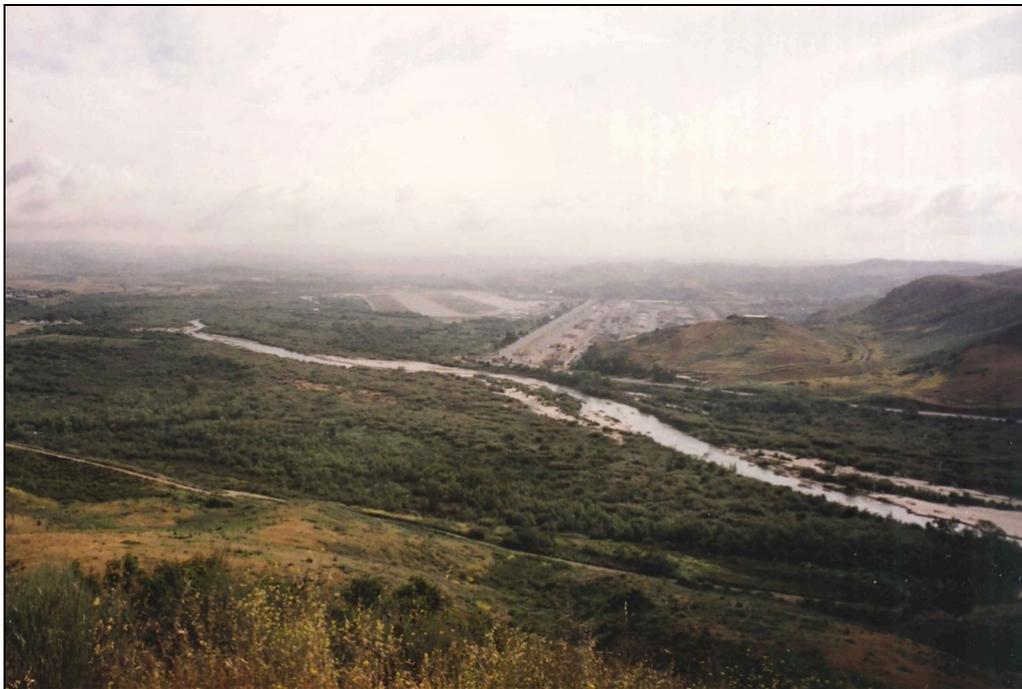
Figure 5-1.7. View of the Santa Margarita River in Sub-Reaches 2 & 3 (view is upstream) taken on May 16, 1995.

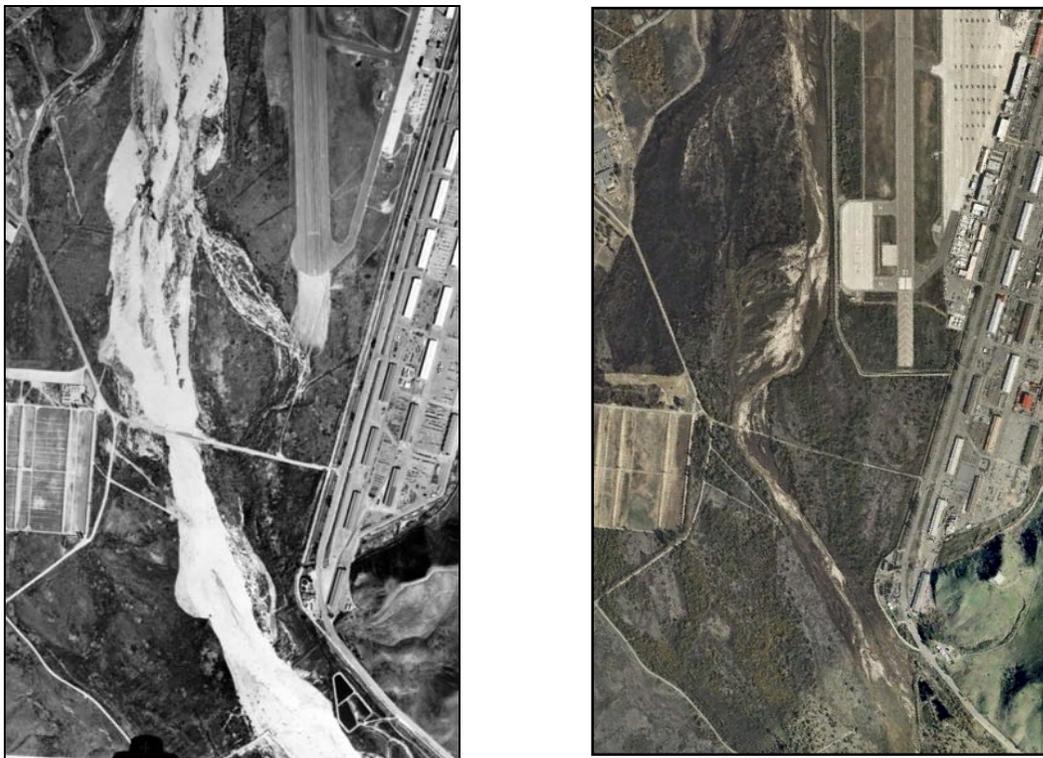
Figure 5-1.8. Comparison of 1970 (left) and 2008 (right) air photos of Sub-reach 3.

Within this general alignment, the main or active channel has shifted several hundred feet at some locations and exhibited a general decrease in width since 1938, interrupted by dramatic increases in channel width following large floods, such as in 1969 (NHC 1997a; see also Figure 5-1.8). Large floods also restored multiple flow channels and braid bars in the project reach. Vegetation encroached on recently deposited bar and overbank sediments and a single channel re-established over time.

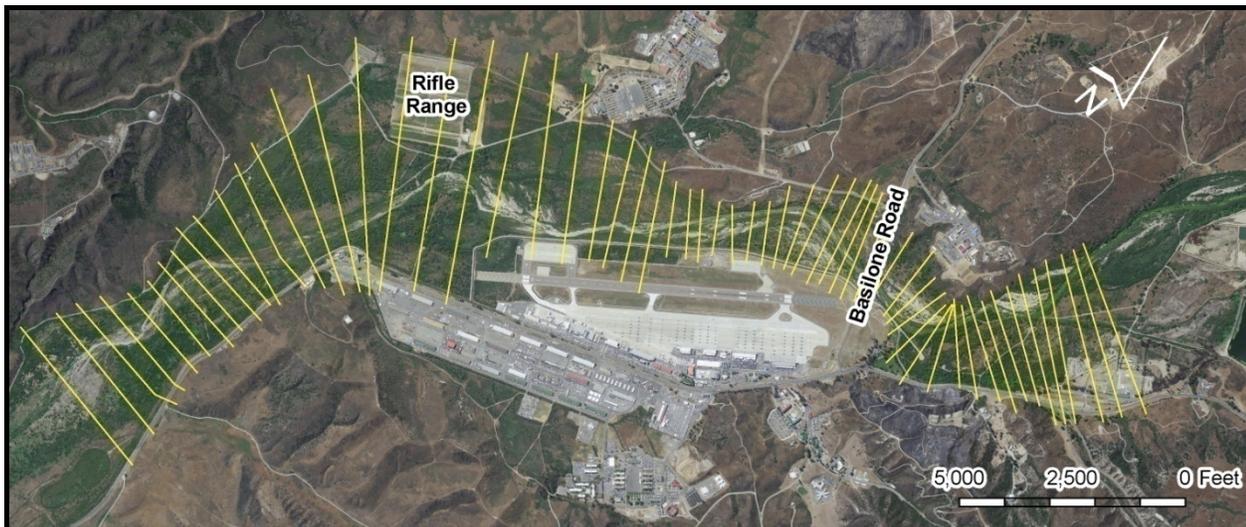
Figure 5-1.9. Location of HEC-RAS model cross-sections (in yellow) (NHC 2001).

In the late 1990s, NHC developed a calibrated, steady, one-dimensional HEC-RAS model (USACE 2010) of the Santa Margarita River project reach, as part of studies for a new levee (NHC 2001). The model was based on 62 cross-sections in the project reach, an average of one every 470 ft, developed either from July 1998 LiDAR, September 1996 air photos or June and July 1998 cross section surveys (Figure 5-1.9).

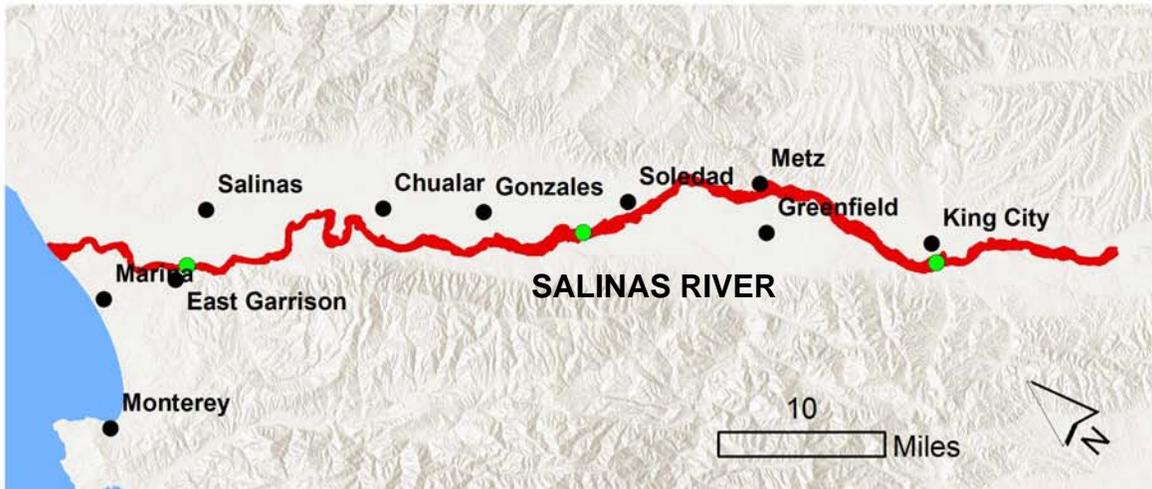
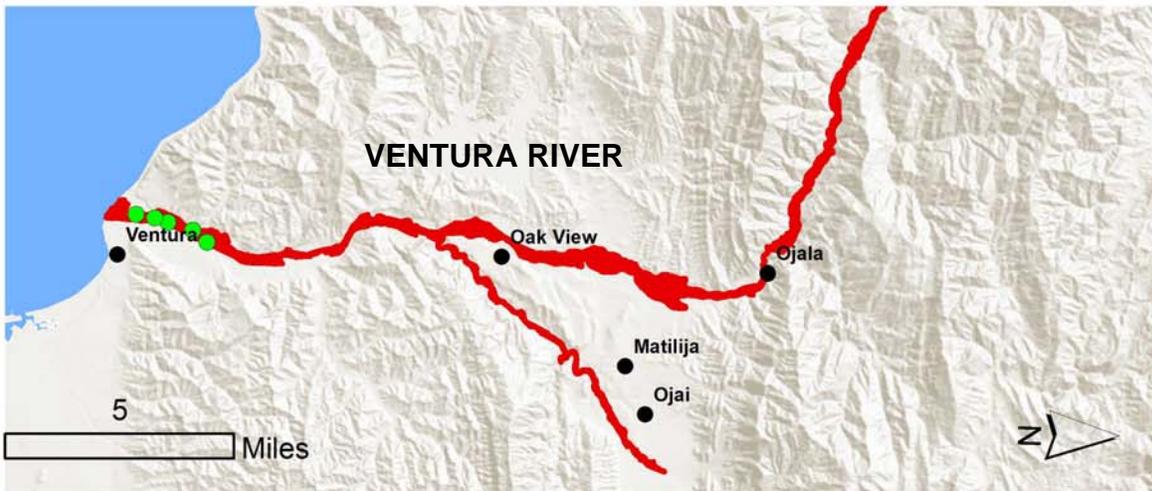
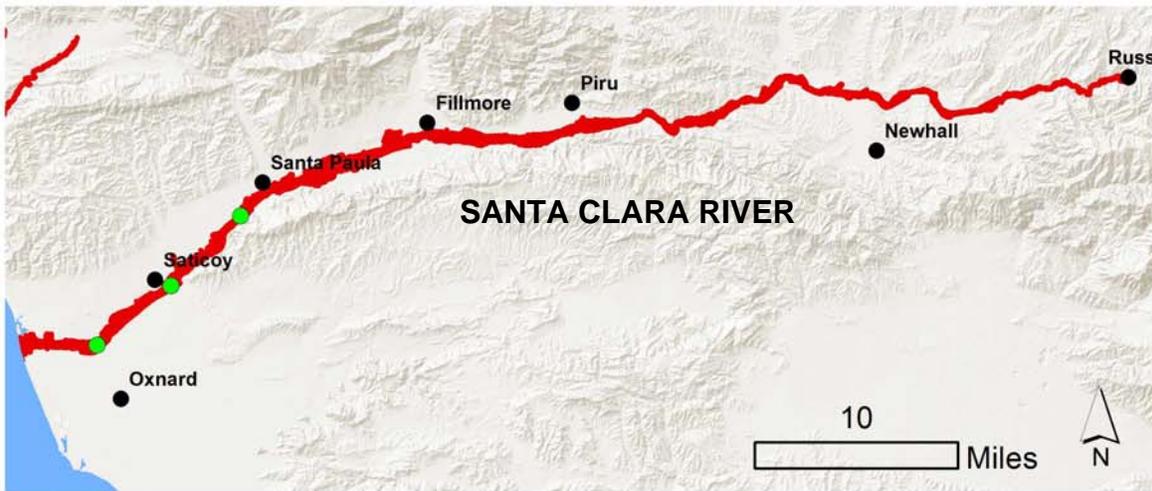
Figure 5-2.1. Location of the Area of Interest and cross-sections (northern watersheds).

The area of interest (AOI) covers the six most *Arundo* invaded watersheds within the study area. This represents 77% of the gross *Arundo* acreage calculated for the entire study area (Figures 5-2.1 & 5-2.2). Since these are the most invaded areas, it is important to examine the distribution of *Arundo* within geomorphic forms found in the riparian zone.

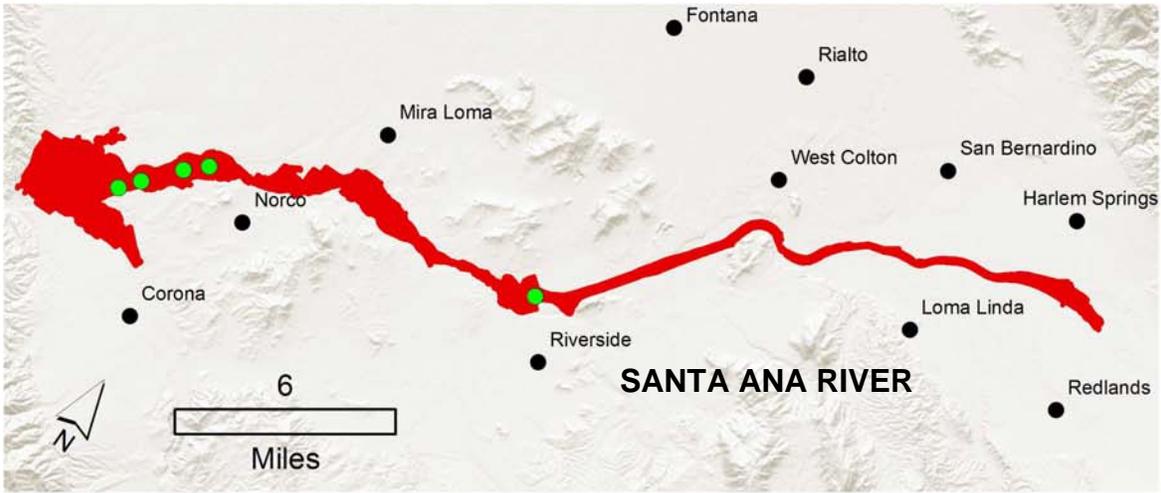
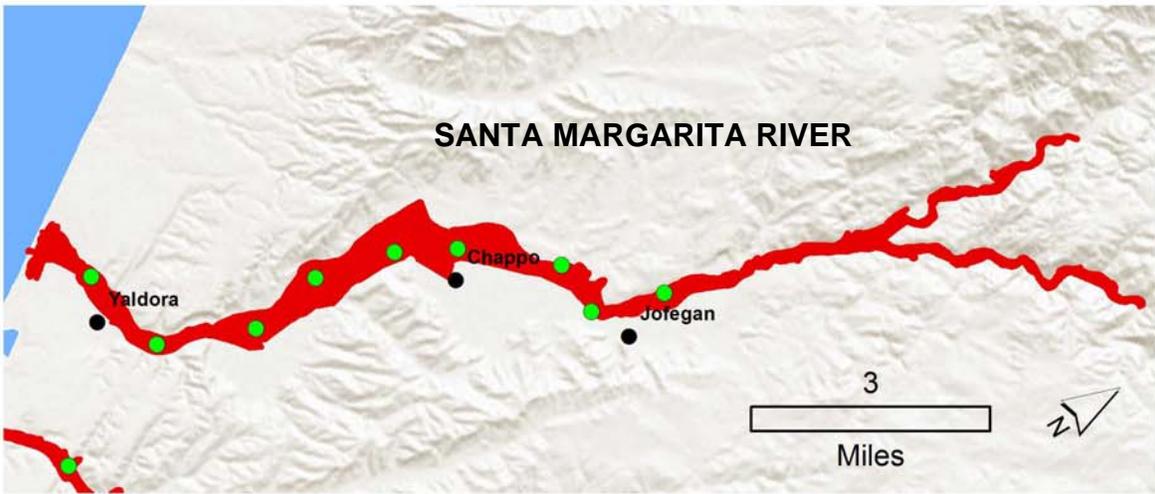
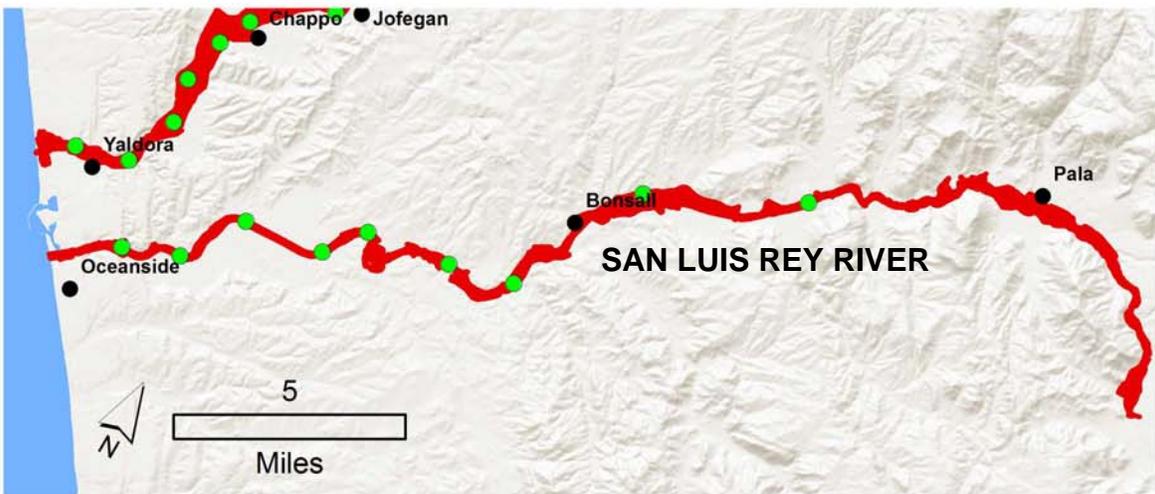
Figure 5-2.2. Location of the Area of Interest and cross-sections (southern watersheds).

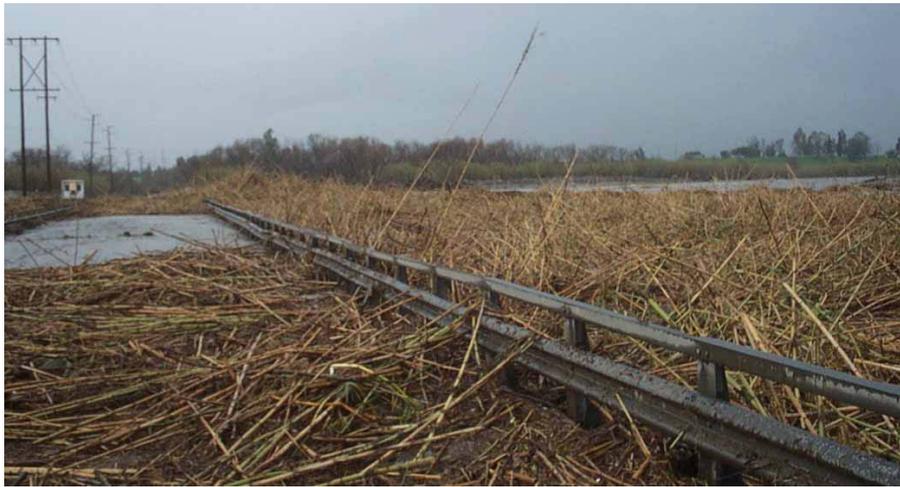
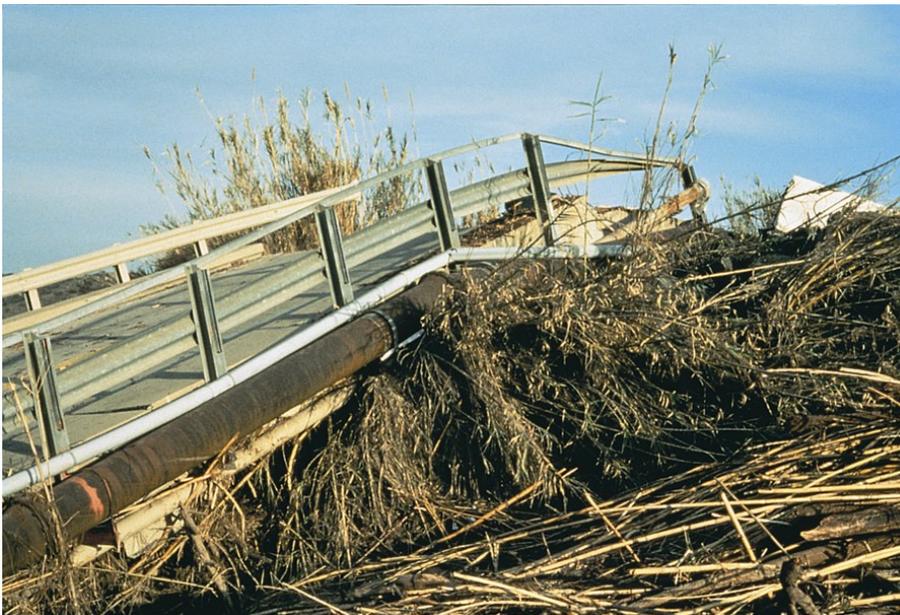
Figure 5-2.29. Floods stacked *Arundo* biomass against the River Road Bridge on the Santa Ana River, resulting in the bridge being pushed off its foundation in 2004. Photo by Richard Zembal.

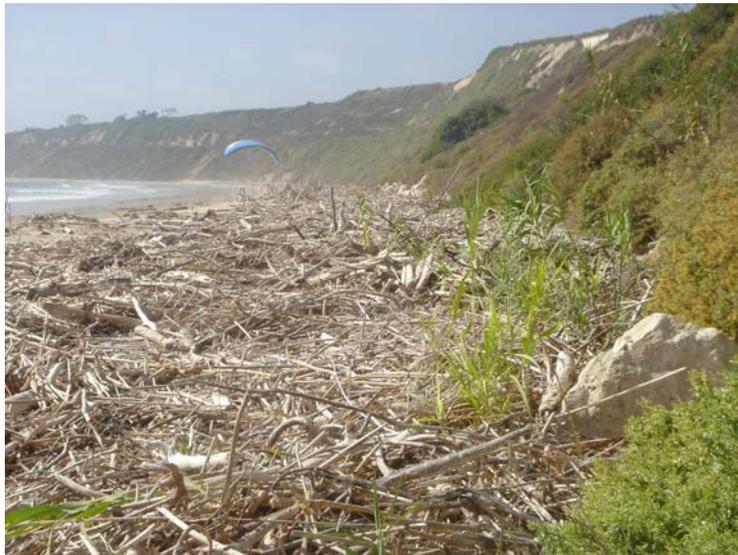
Figure 5-2.30. In Santa Barbara County, *Arundo* washes down the Santa Clara River and accumulates on Rincon Beach, blocking access for beachgoers and increasing the cost of beach maintenance. Photo by David Chang.

Arundo biomass on beaches following flow events is a recurring impact (Figure 5-2.30 & 5-2.31). In many areas, particularly from Santa Monica to San Diego, biomass is cleared by Municipal, County and State workers using tractors, loaders and sweepers. Estimating the magnitude and cost of these efforts is complicated due to their periodic nature, in addition to a large range in the amount of material. *Arundo* biomass is not the only material discharged by river flow events. There are also other non-native plants, native plants and refuse. It is not unusual for more than 80% of the material to be *Arundo* biomass near heavily invaded watersheds (San Luis Rey, Santa Margarita, Santa Clara, Ventura). Two of these systems will have lower *Arundo* biomass yields in the future as most *Arundo* has been removed (San Luis Rey, Santa Margarita). Santa Ana has lower *Arundo* discharge than other systems because most *Arundo* is present above the Prado Dam. Small and mid-sized watersheds may discharge large amounts of *Arundo* material, particularly watersheds in the Los Angeles basin (Douce 1993).

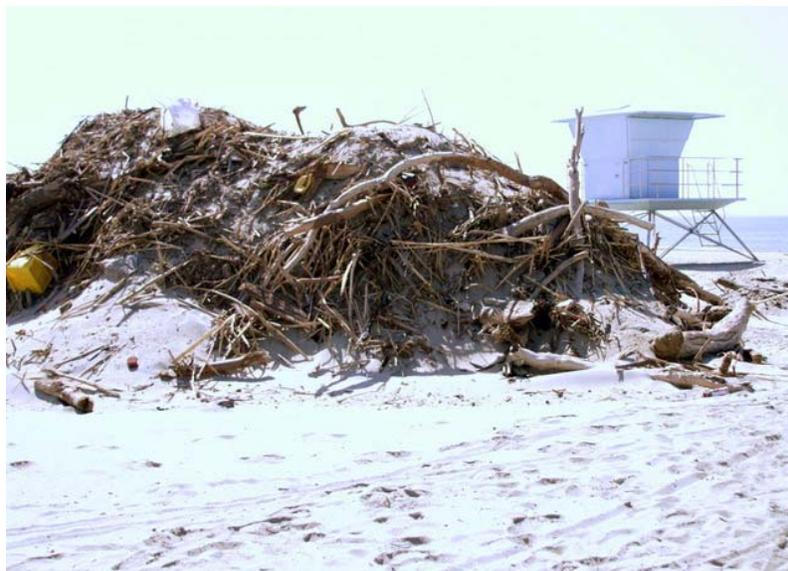
Figure 5-2.31. *Arundo* and other biomass washed onto the beach in Long Beach after a large flow event on the Los Angeles/San Gabriel River. Photo by Drew Ready.
