*Arundo donax*  
**Distribution and Impact Report**

**March 2011**

**Agreement No. 06-374-559-0  
State Water Resources Control Board**

***Prepared by:* California Invasive Plant Council**

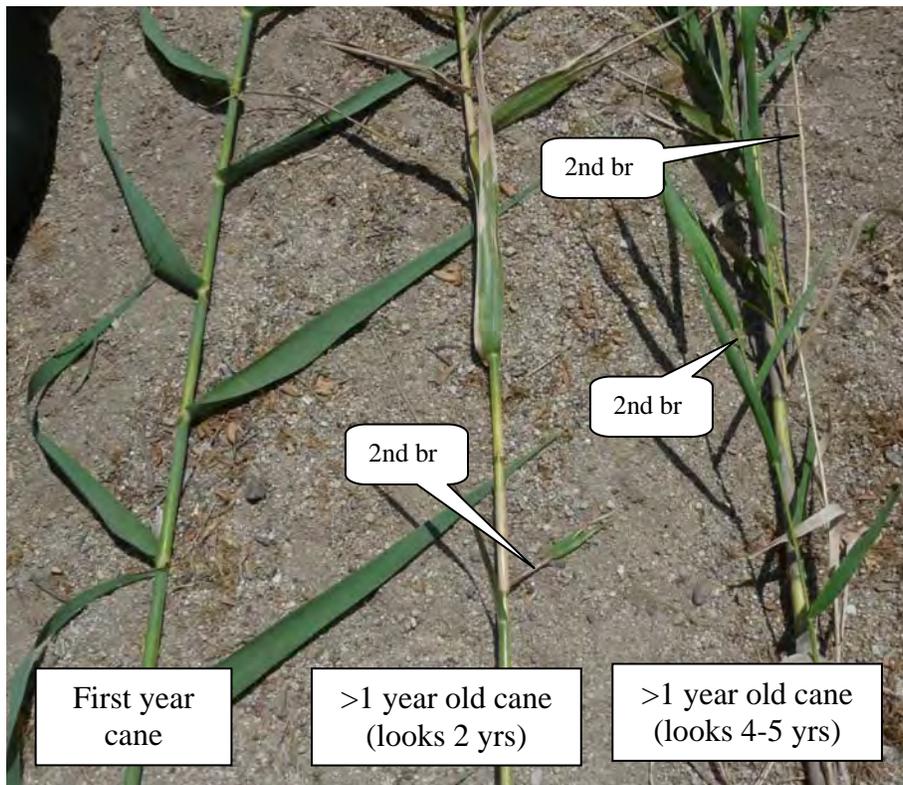
**Figure 2-3.** First year and >1yr year old *Arundo* canes, showing leaf and branching structure. First year canes have only cauline leaves. Older canes have an increasing number of secondary branches with leaves on them, and leaves on the old leader are often damaged and dying.

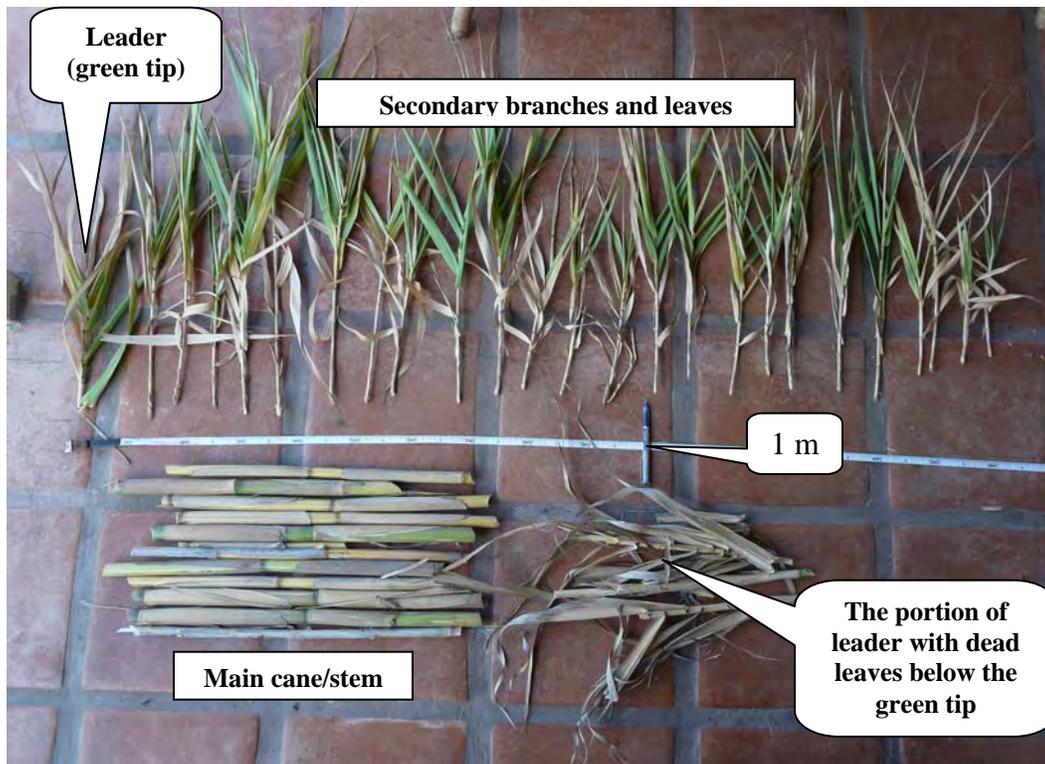
**Figure 2-4.** A single older cane with all secondary branches (25), leader, and main stem. This was cane SD#1b from the San Diego River with a height of 8.1m.

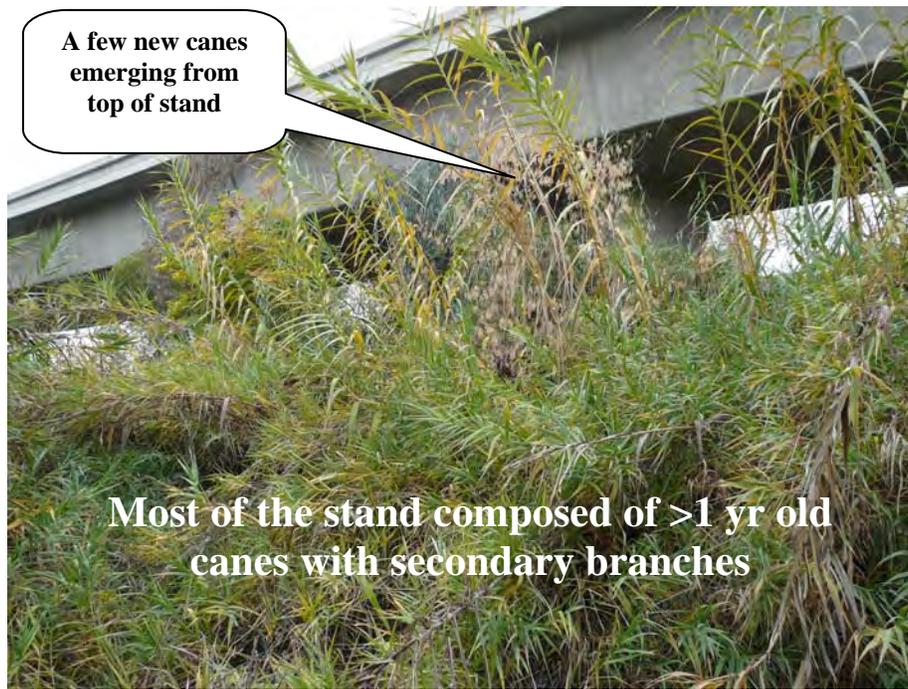
**Figure 2-5.** New first year canes often protrude from the *Arundo* canopy. Older canes with extensive secondary branching cannot support the weight of the branches and leaves, and usually flop over and do not stand upright, especially in the upper portions of the stand's canopy.

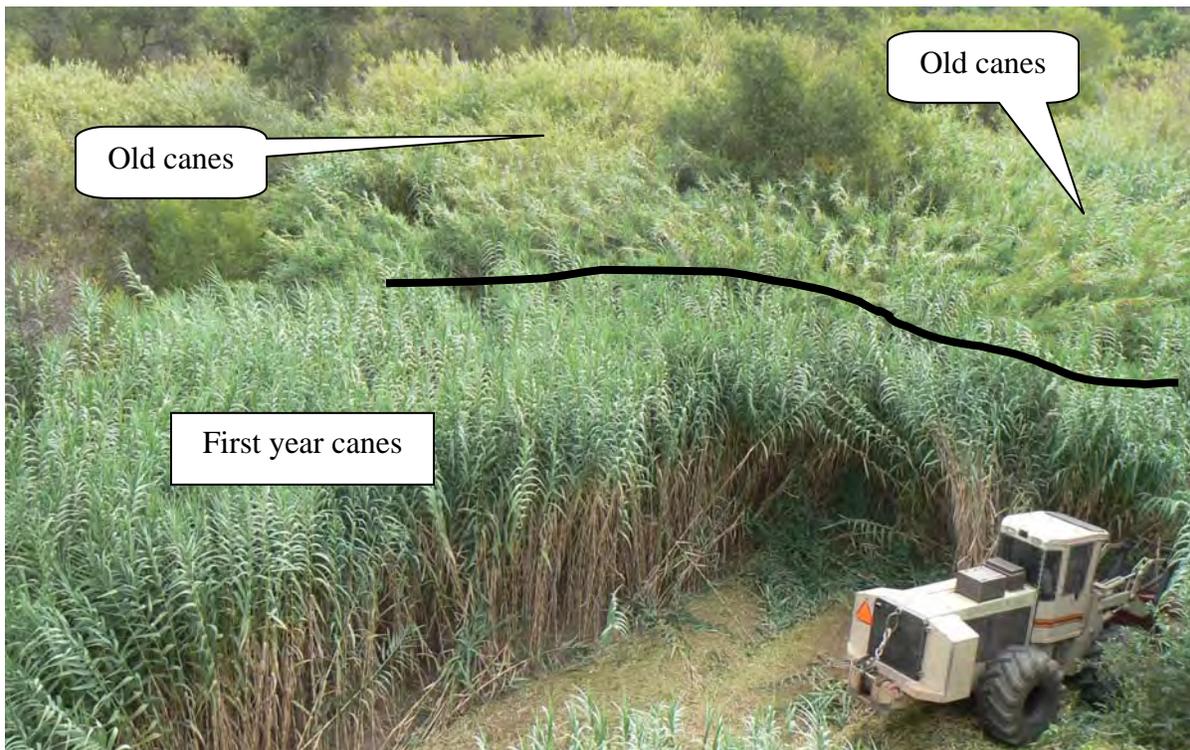
**Figure 2-6.** First year *Arundo* canes at full height (6+ m). The tractor is 10' high. This area had been cut as a fuel break the year before and is being cut again. Energy stored in rhizomes underground allow this rapid regrowth after cutting or fire events. Note simple unbranched vertical structure, very high cane density, and deep green color of the new, resprouted canes. Older canes in the background are less vertical and are a more yellowish color.

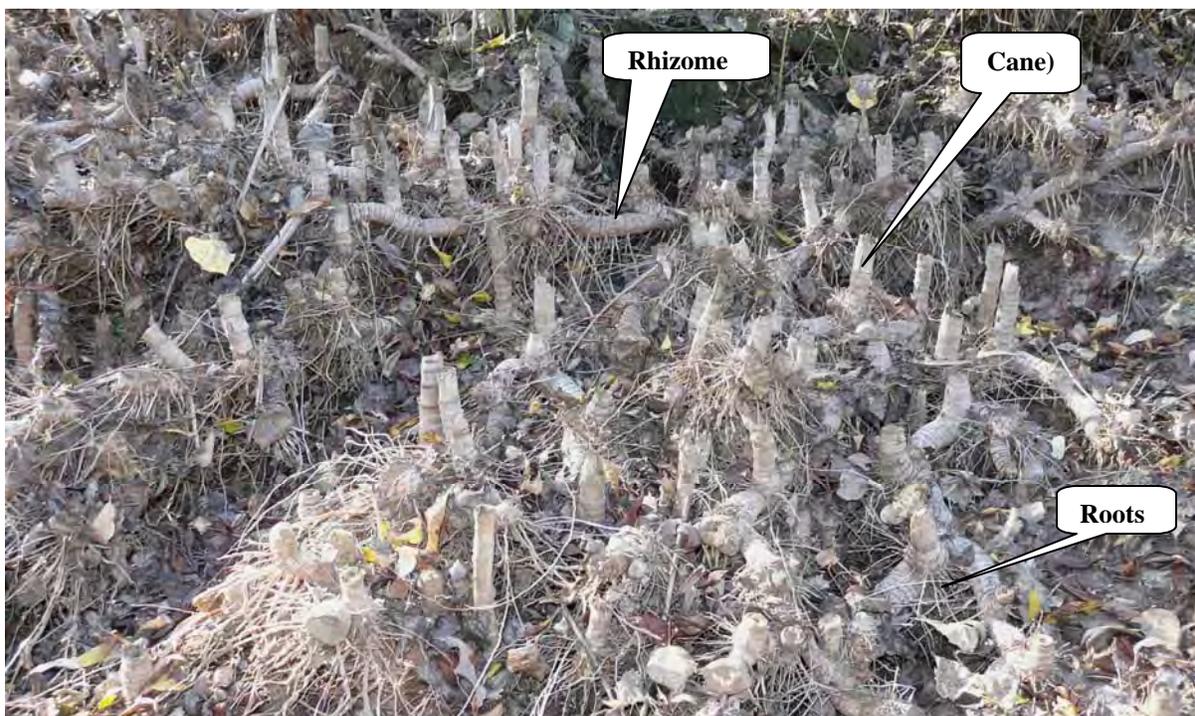
**Figure 2-7.** Dense rhizome and root network of an *Arundo* clump that was scoured during a flow event, removing the upper soil matrix and canes.

The underground structure of *Arundo* is composed of fleshy rhizomes from which arise roots that penetrate deeper into the soil (Figures 2-2 & 2-7 to 11). Rhizomes are generally shallowly buried, spreading out horizontally from the plant and forming a dense underground mat. Rhizomes are generally found 5-15 cm below the soil surface, with a maximum depth of 50 cm, while roots can be more than 100 cm deep (Sharma et al. 1998, this study).

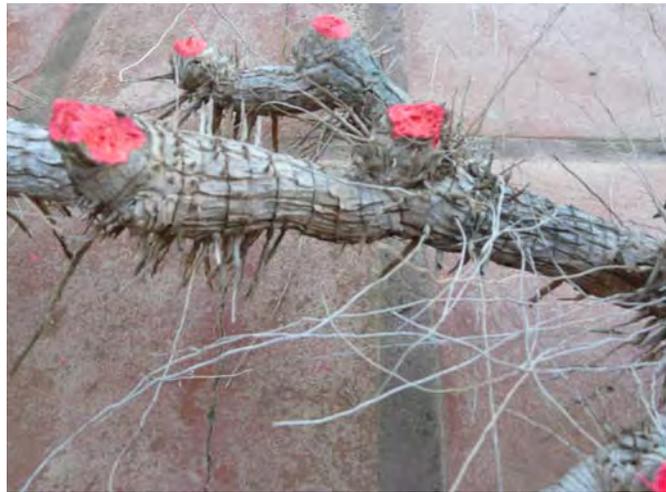
**Figure 2-10.** Close-up of slightly desiccated *Arundo* rhizome. The cane emergence points at the nodes are painted red, and long thin roots are visible.

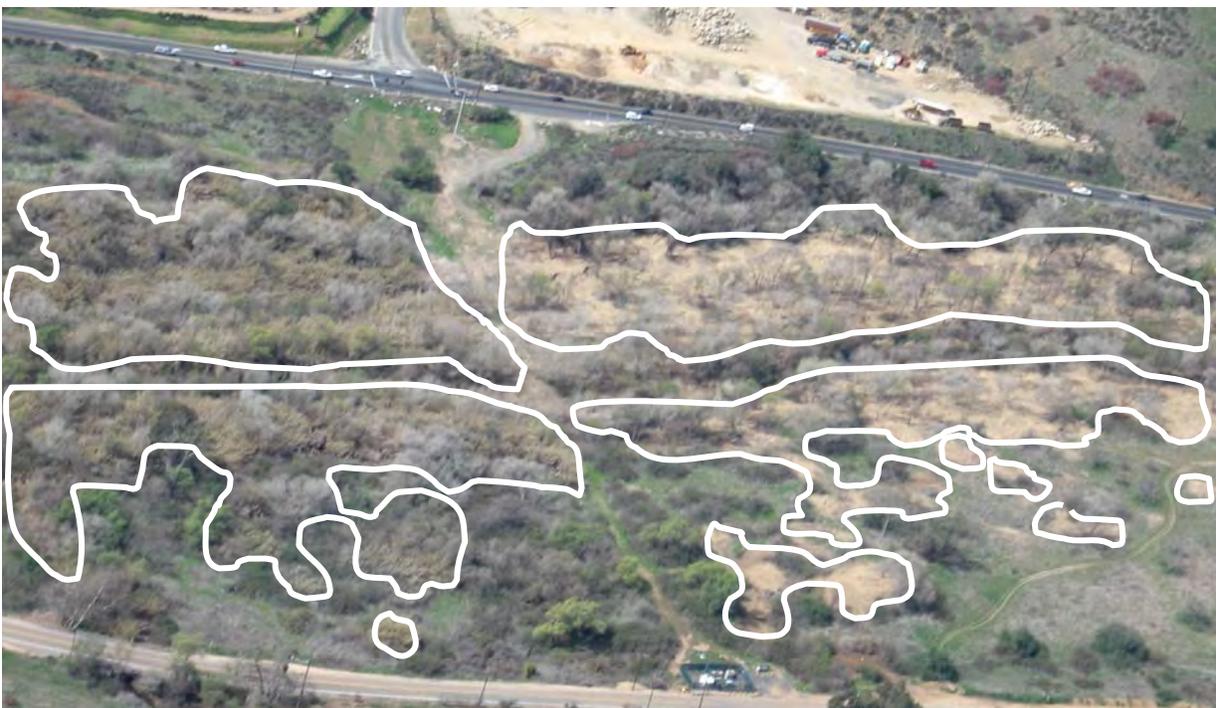
**Figure 2-14.** Oblique aerial photo showing patchiness of *Arundo* stands, particularly farther from the low-flow channel.

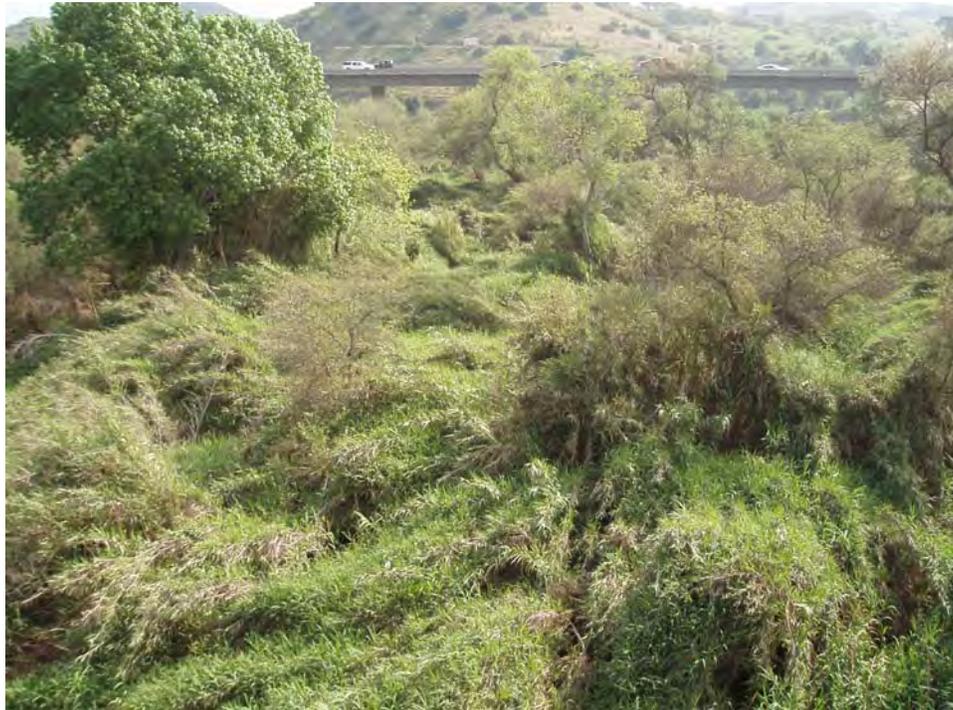
**Figure 2-15.** View from bridge over San Luis Rey River showing the top of a mature *Arundo* stand. This stand is >10 years old, > 9 m height, and 100% cover. Note the high amount of leaf surface area and non-vertical (nearly horizontal) position of the upper portion of the canes with secondary branches.

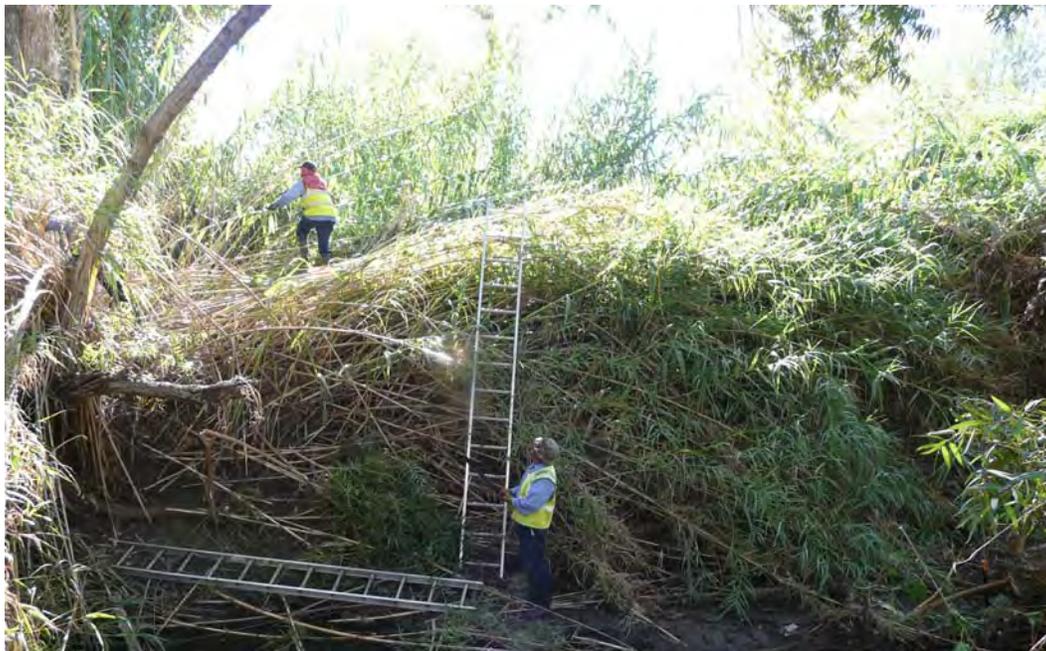
**Figure 2-16.** *Arundo* stand being prepared for foliar herbicide treatment. The crew is pushing the stand away from the native trees. *Arundo* canes are supporting the worker on the left. Canes are 8-9 m long and density is typical of a mature stand (about 40 canes/m<sup>2</sup>). San Diego River, Giessow 2010.

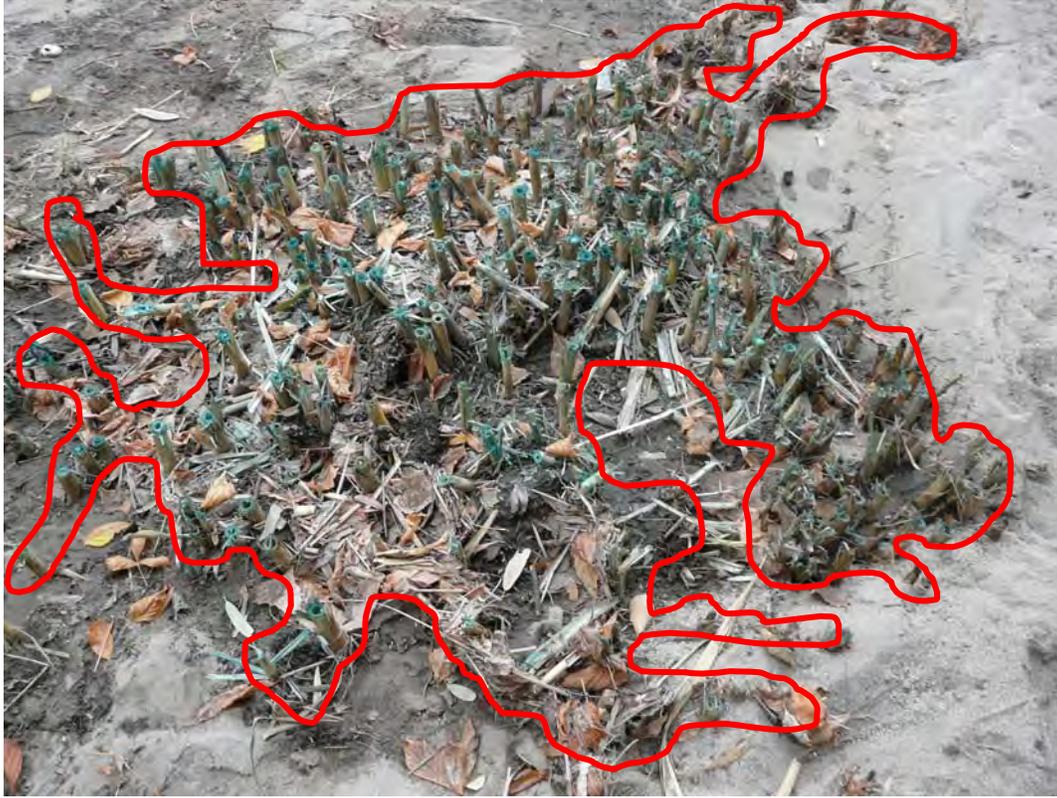
**Figure 2-17.** A cut *Arundo* clump showing uneven cane density.

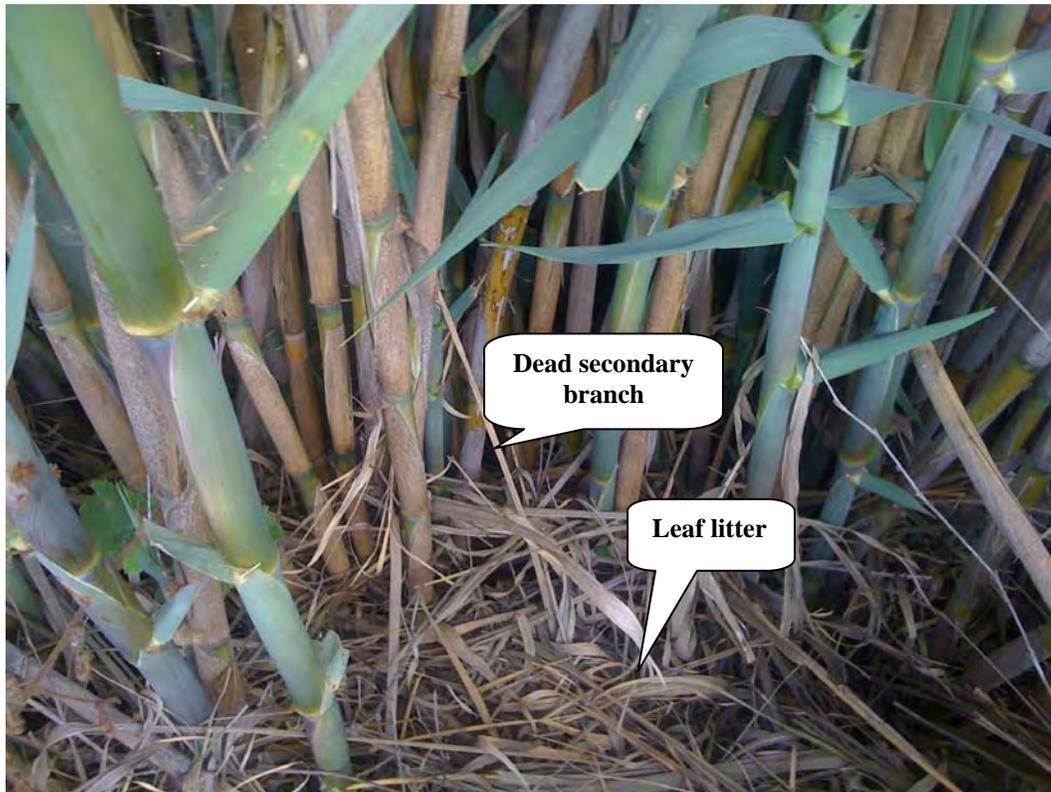
**Figure 2-18.** Cane density and dead leaf litter within a dense *Arundo* stand.

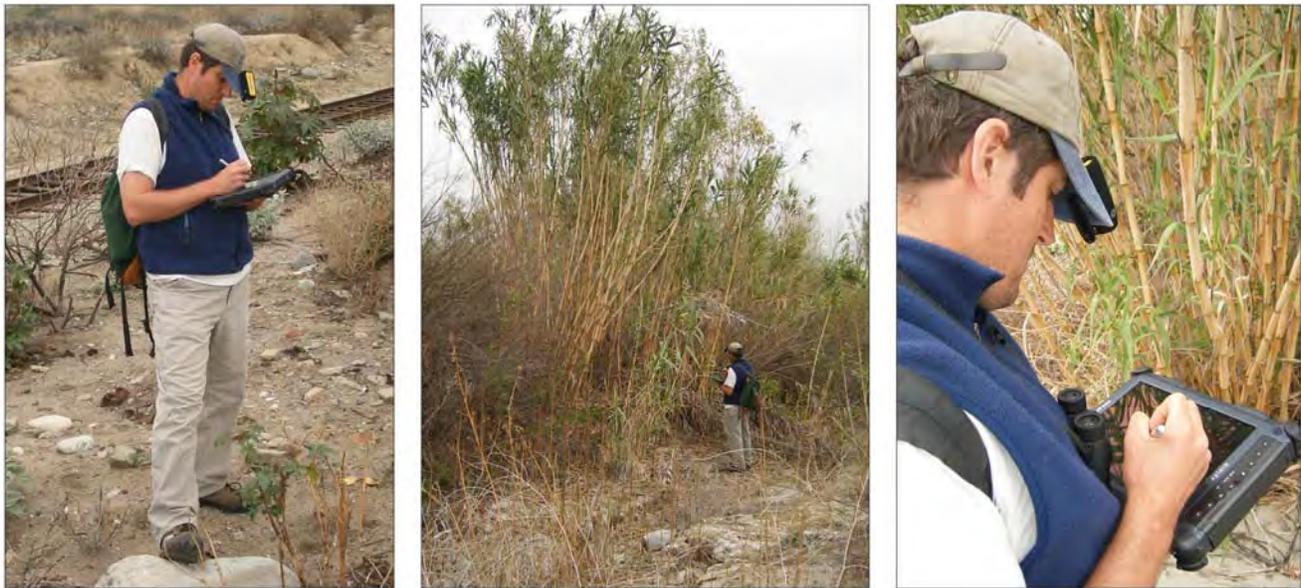
**Figure 3-3.** Field surveys with ruggedized tablet PCs and integrated GPS.

After the initial survey of a watershed was completed, the data was “checked out” of the GIS database and transferred to a ruggedized tablet PC. The field tablets used for this project (Xplore’s iX104c3) were outfitted with GPS receivers (mounted or bluetooth) with an accuracy of 2-5 m (with real-time corrections) (Figure 3-3). The most current vertical aerial photography from the GIS database was also transferred onto the tablet as a base layer for the field mapping software. ESRI’s ArcPad 8.0 was chosen as the mapping application because of its seamless integration between the field computers and central database back in the office. Toolbars in ArcPad were customized to optimize the time spent collecting data in the field.

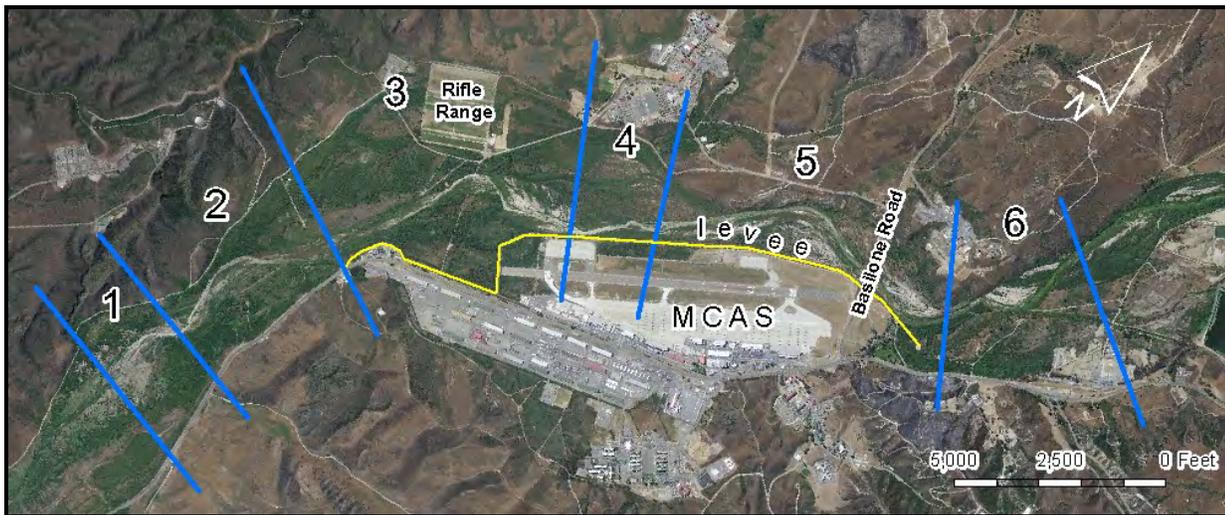
**Figure 5-1.6.** Sub-reaches (numbers 1 through 6) in the lower Santa Margarita River project reach.

This project reach is where NHC examined hydraulics and sediment transport capacity with mature stands of *Arundo* on the river bank and floodplain (NHC 1997a; 1997b; 2001) and covers about the same river mileage as Reaches 4 through 9 in Table 5-1.1 and Figure 5-1.1. The river floodplain is confined to varying degrees throughout the project reach, particularly upstream of the O’Neill Lake diversion and in the vicinity of Basitone Road Bridge (Table 5-1.4; Figure 5-1.6).

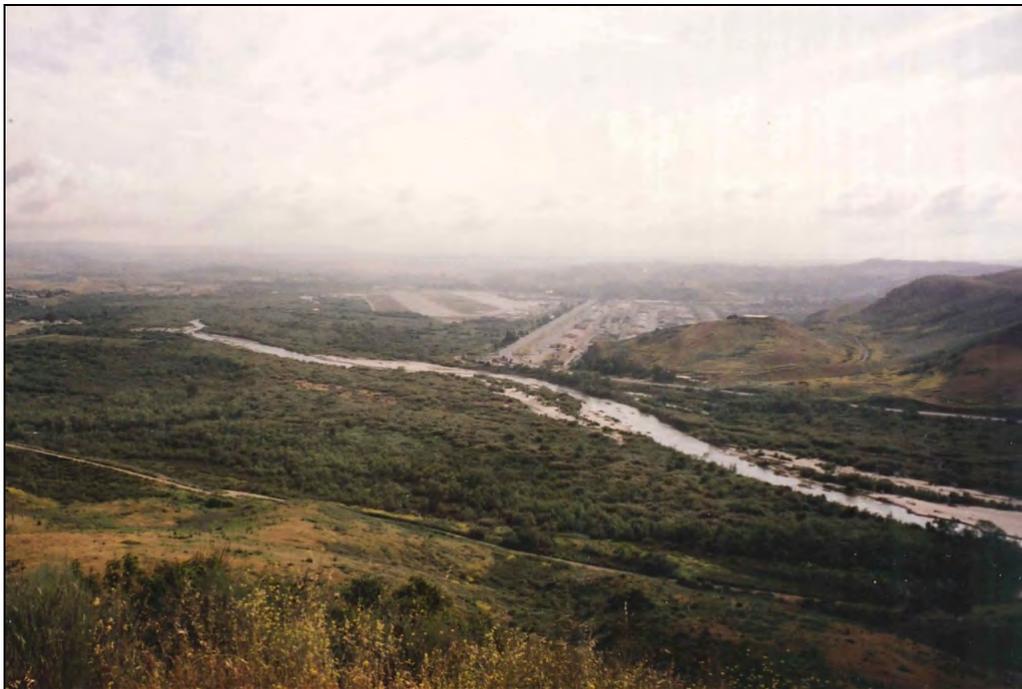
**Figure 5-1.7.** View of the Santa Margarita River in Sub-Reaches 2 & 3 (view is upstream) taken on May 16, 1995.

In the late 1990s, the main channel, as defined by channel banks, was typically 200 ft to 400 ft wide and bordered by moderate to abundant vegetation where the floodplain had not been developed. The main channel was generally four to eight times wider than the low flow channel defined in Table 5-1.1. The floodplain surface was generally 4 to 6 feet higher than the low flow channel invert, as indicated by field inspection and channel surveys. Small, concentrated flow paths (distributary or chute channels) were common on the floodplain and on vegetated bar surfaces throughout the project reach (Figure 5-1.7).

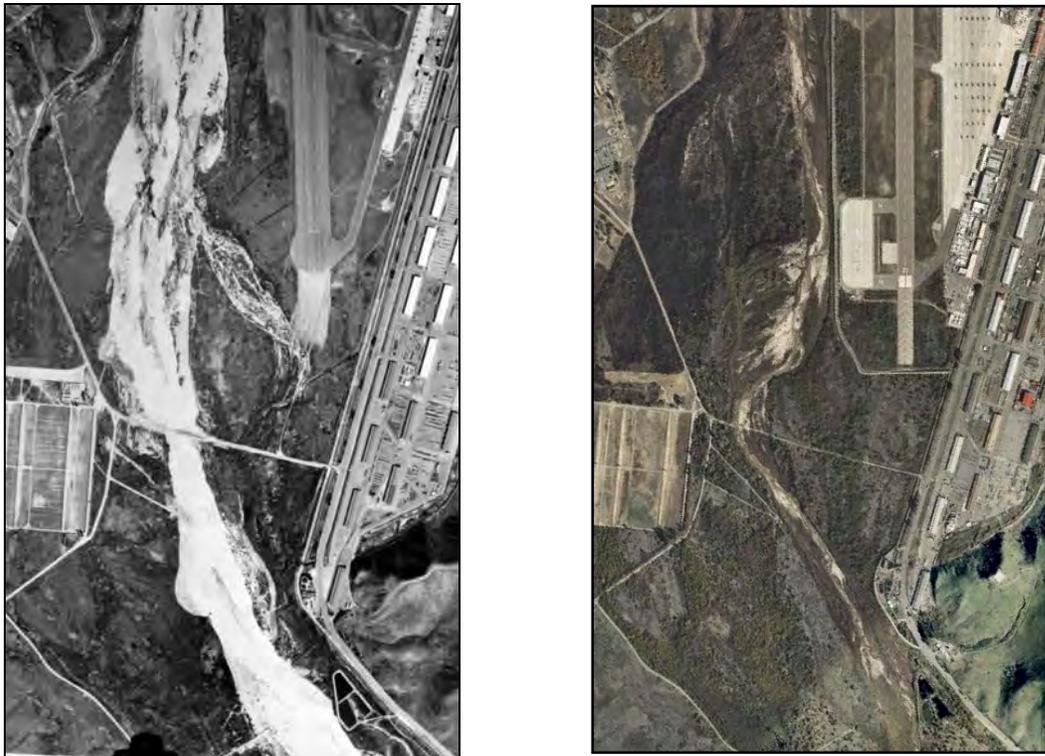
**Figure 5-1.8.** Comparison of 1970 (left) and 2008 (right) air photos of Sub-reach 3.

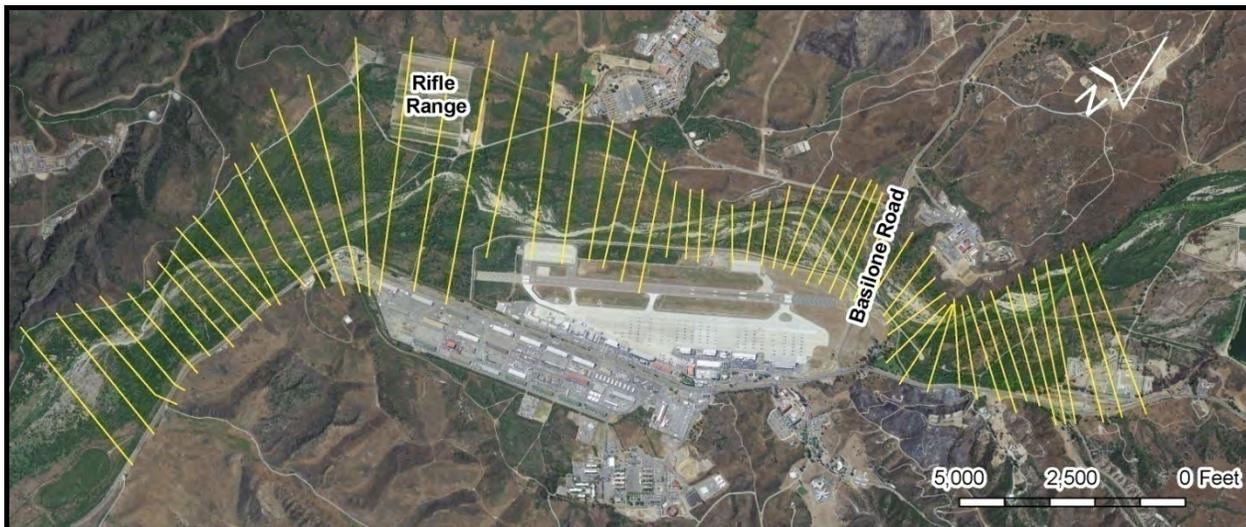
**Figure 5-1.9.** Location of HEC-RAS model cross-sections (in yellow) (NHC 2001).

In the late 1990s, NHC developed a calibrated, steady, one-dimensional HEC-RAS model (USACE 2010) of the Santa Margarita River project reach, as part of studies for a new levee (NHC 2001). The model was based on 62 cross-sections in the project reach, an average of one every 470 ft, developed either from July 1998 LiDAR, September 1996 air photos or June and July 1998 cross section surveys (Figure 5-1.9).

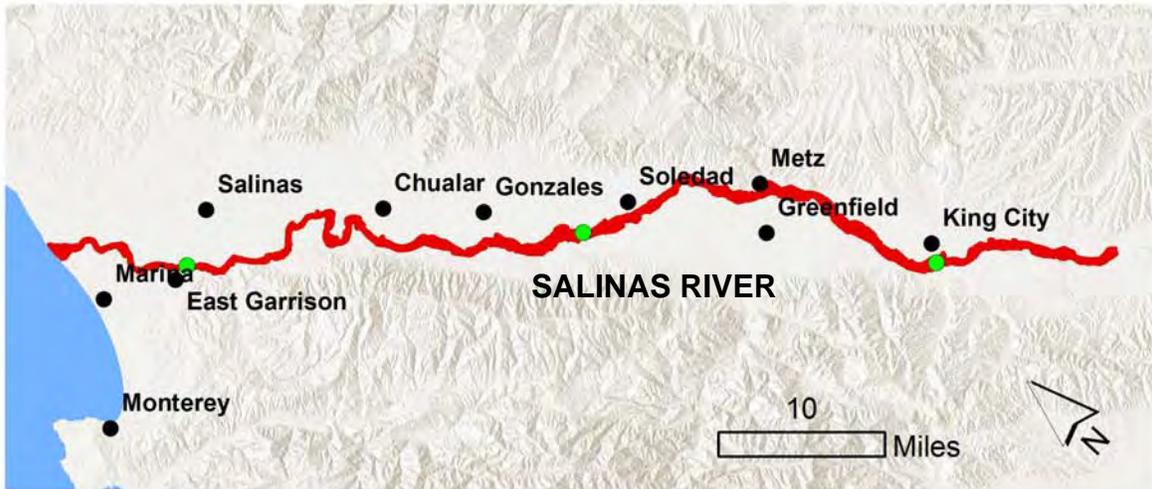
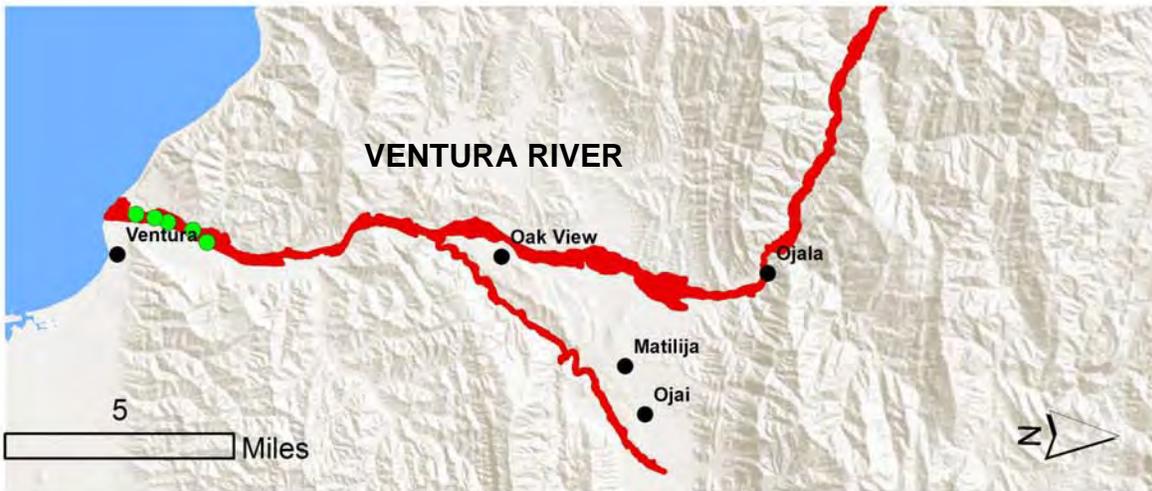
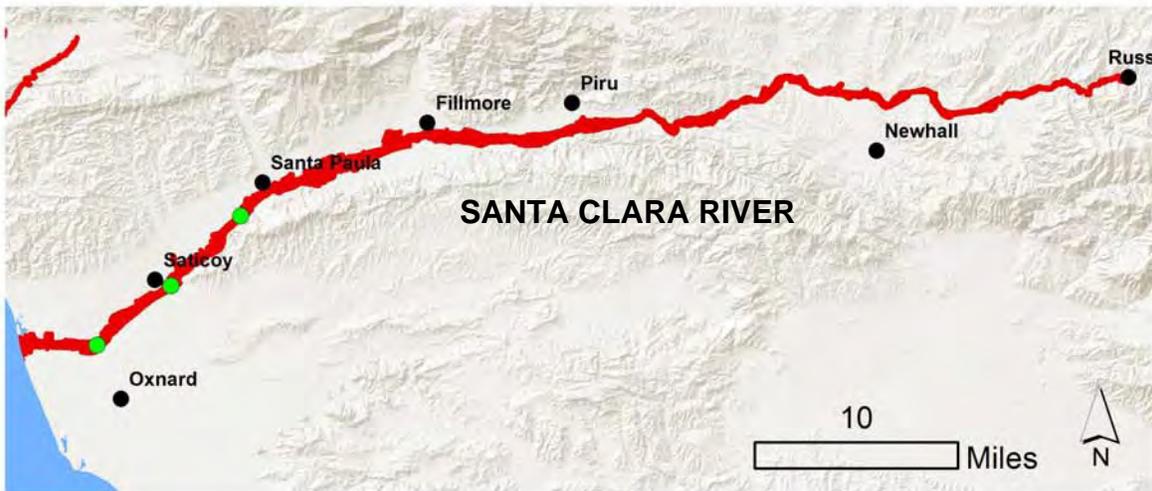
**Figure 5-2.1.** Location of the Area of Interest and cross-sections (northern watersheds).

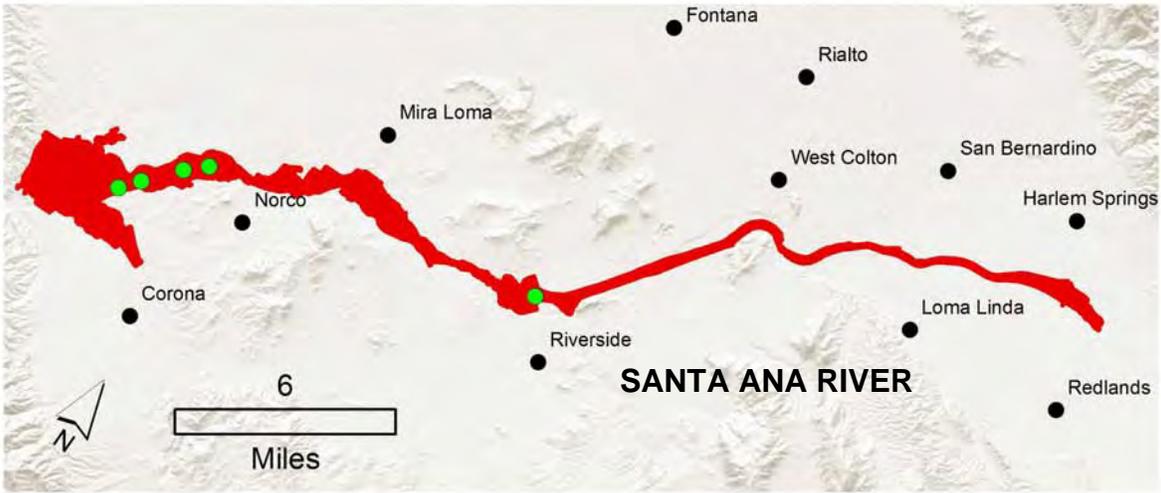
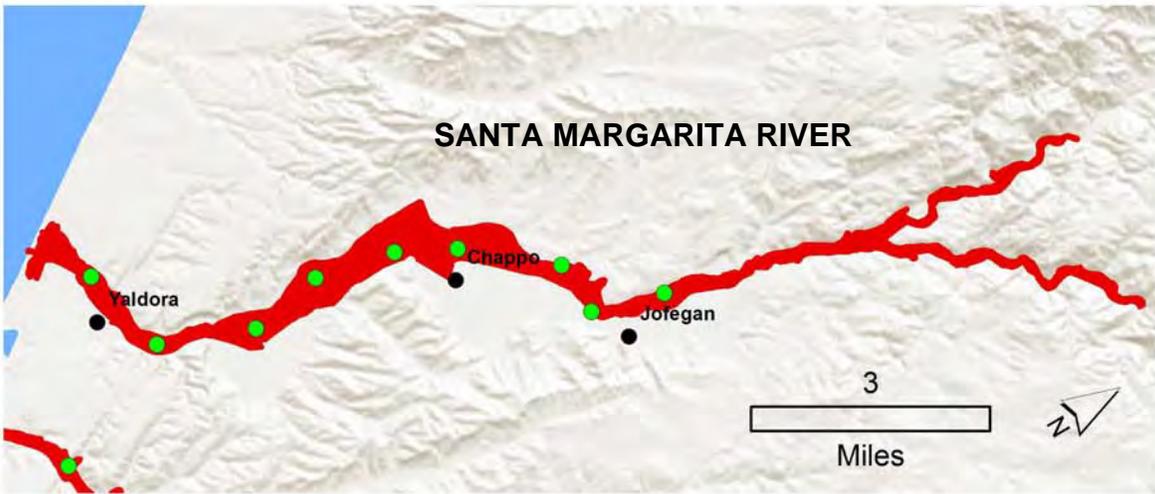
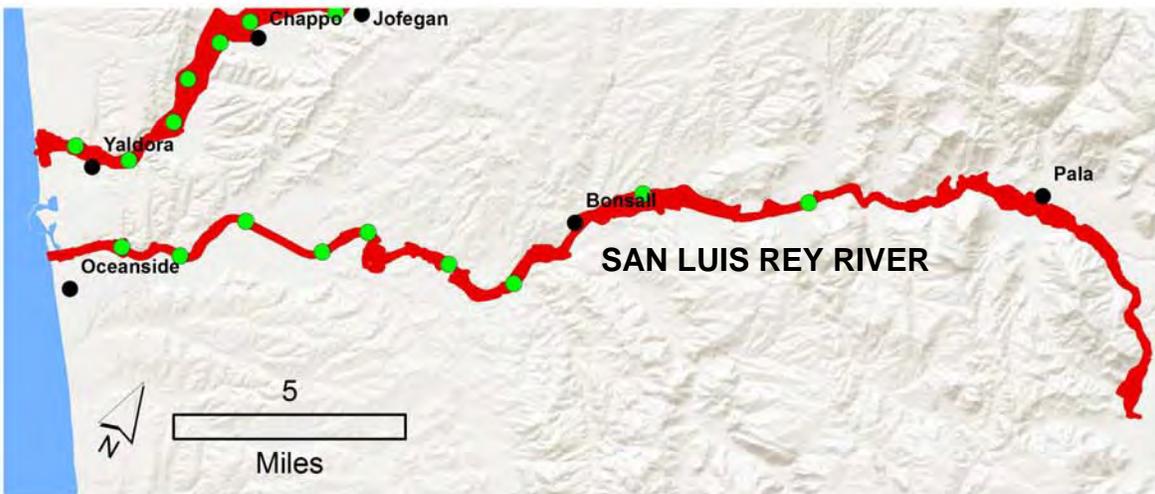
**Figure 5-2.2.** Location of the Area of Interest and cross-sections (southern watersheds).

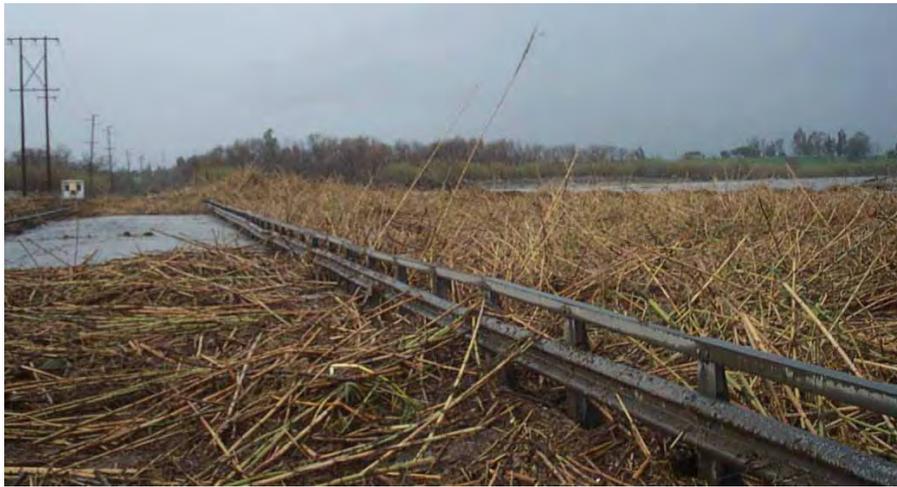
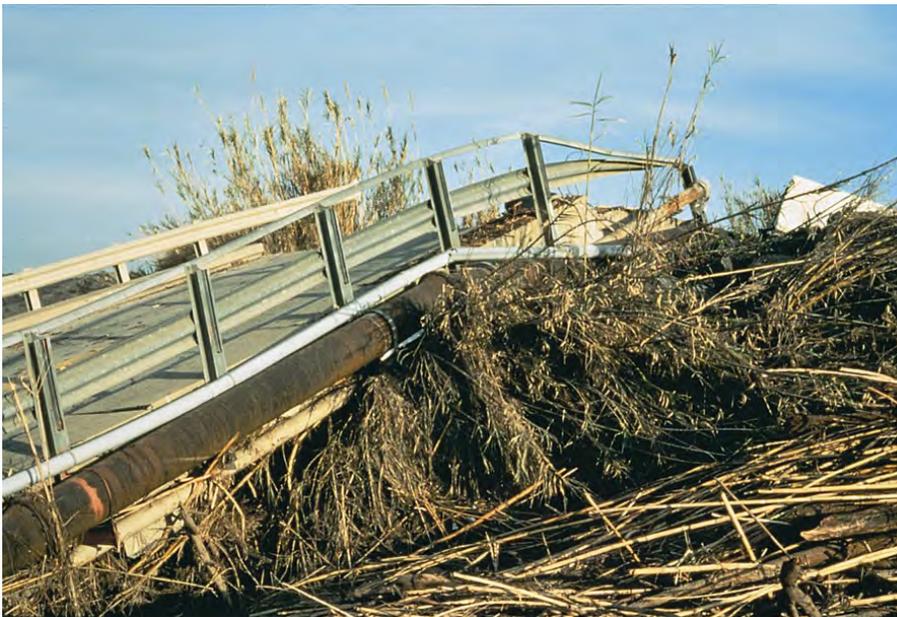
**Figure 5-2.29.** Floods stacked *Arundo* biomass against the River Road Bridge on the Santa Ana River, resulting in the bridge being pushed off its foundation in 2004. Photo by Richard Zembal.

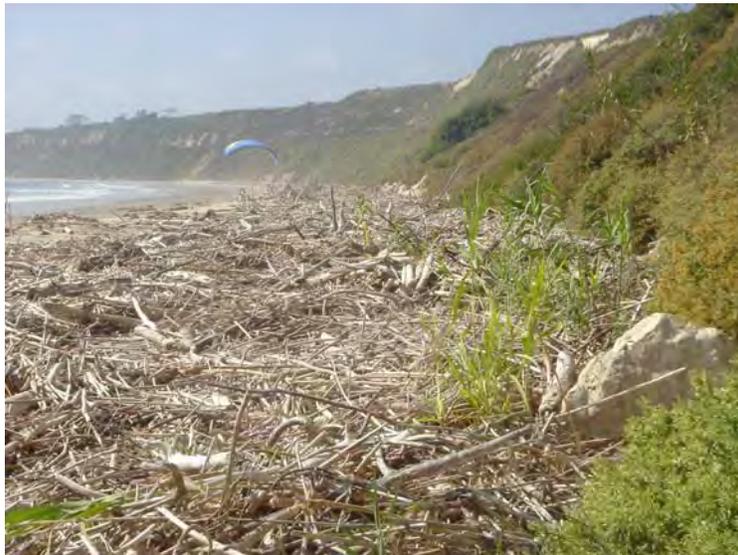
**Figure 5-2.30.** In Santa Barbara County, *Arundo* washes down the Santa Clara River and accumulates on Rincon Beach, blocking access for beachgoers and increasing the cost of beach maintenance. Photo by David Chang.

*Arundo* biomass on beaches following flow events is a recurring impact (Figure 5-2.30 & 5-2.31). In many areas, particularly from Santa Monica to San Diego, biomass is cleared by Municipal, County and State workers using tractors, loaders and sweepers. Estimating the magnitude and cost of these efforts is complicated due to their periodic nature, in addition to a large range in the amount of material. *Arundo* biomass is not the only material discharged by river flow events. There are also other non-native plants, native plants and refuse. It is not unusual for more than 80% of the material to be *Arundo* biomass near heavily invaded watersheds (San Luis Rey, Santa Margarita, Santa Clara, Ventura). Two of these systems will have lower *Arundo* biomass yields in the future as most *Arundo* has been removed (San Luis Rey, Santa Margarita). Santa Ana has lower *Arundo* discharge than other systems because most *Arundo* is present above the Prado Dam. Small and mid-sized watersheds may discharge large amounts of *Arundo* material, particularly watersheds in the Los Angeles basin (Douce 1993).

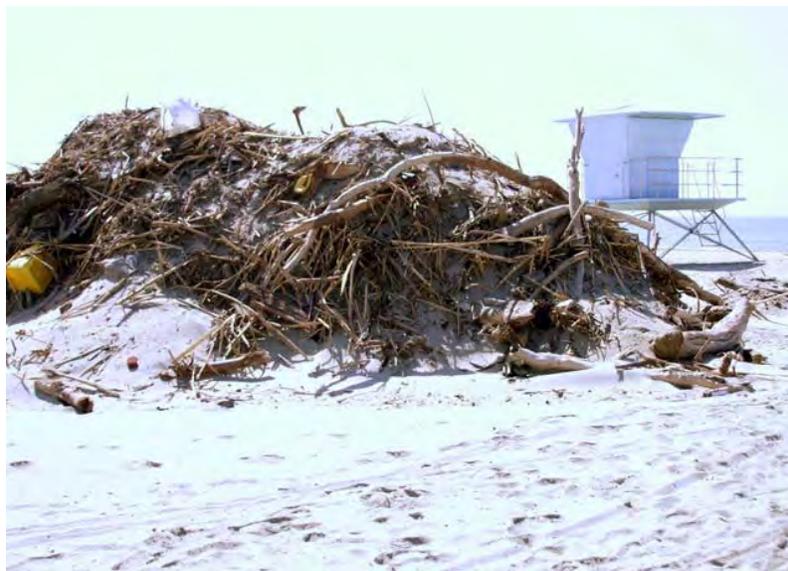
**Figure 5-2.31.** *Arundo* and other biomass washed onto the beach in Long Beach after a large flow event on the Los Angeles/San Gabriel River. Photo by Drew Ready.

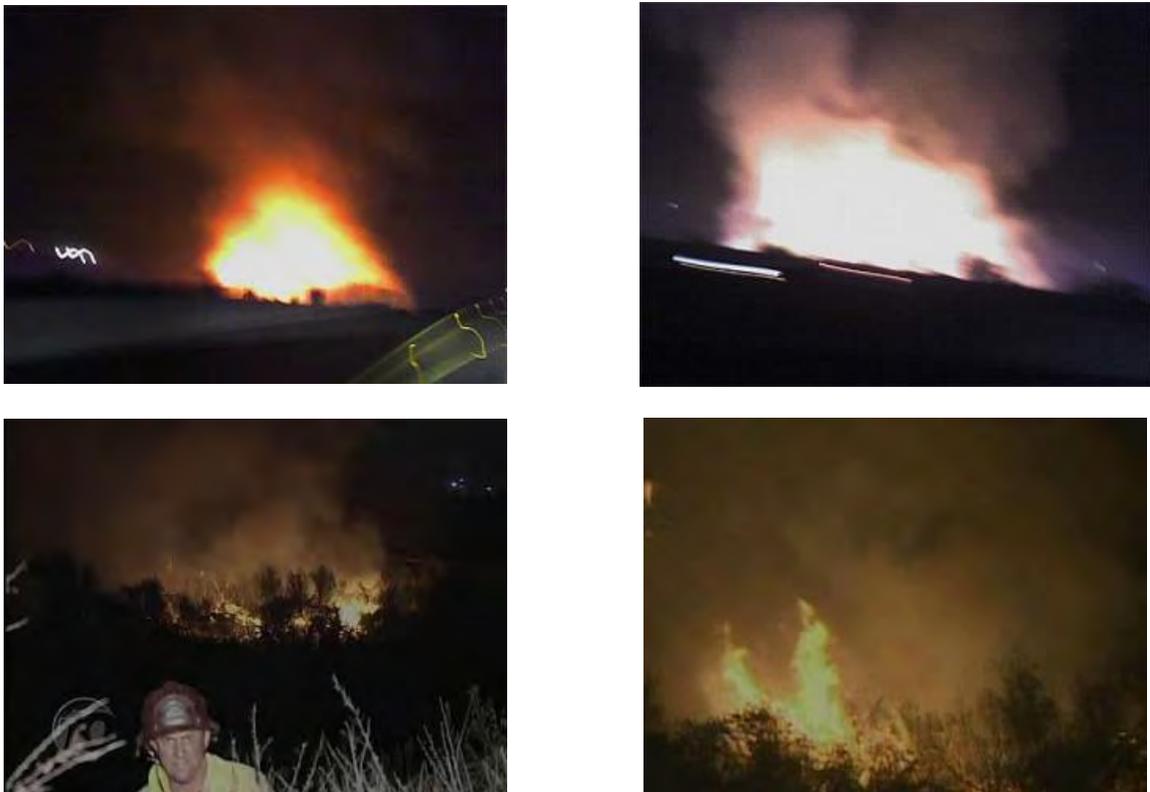
**Figure 6-2.** This fire started in *Arundo* at night during a light rain in October 2006. Photos from San Diego News outlets (Fires SLR#1-3).

Movement and intensity of the fire are also related to weather, but conditions do not need to be favorable for a fire to occur in *Arundo*. *Arundo* can burn any time of the year under varying conditions. *Arundo* stands contain enough dead dry fuel that they can be ignited and carry a fire even under poor fire conditions, such as low wind speed, cool weather, and even when humidity is high or during light rains. This was demonstrated by the fire event on October 2006, which started at night during a light rain and low temperatures (Figure 6-2). Fires have also been observed during light rains and cool temperatures on the San Luis Rey River. Successive heavy rains will reduce *Arundo* stand flammability, but for many areas in the study region heavy rainfall only occurs for 6-10 weeks of the year. High fire threat weather conditions (low humidity and high winds) are not required to start or carry *Arundo* fires. The greatest risk of fire is still in the late summer/fall when stand moisture is low and Santa Ana conditions can exacerbate fire events.

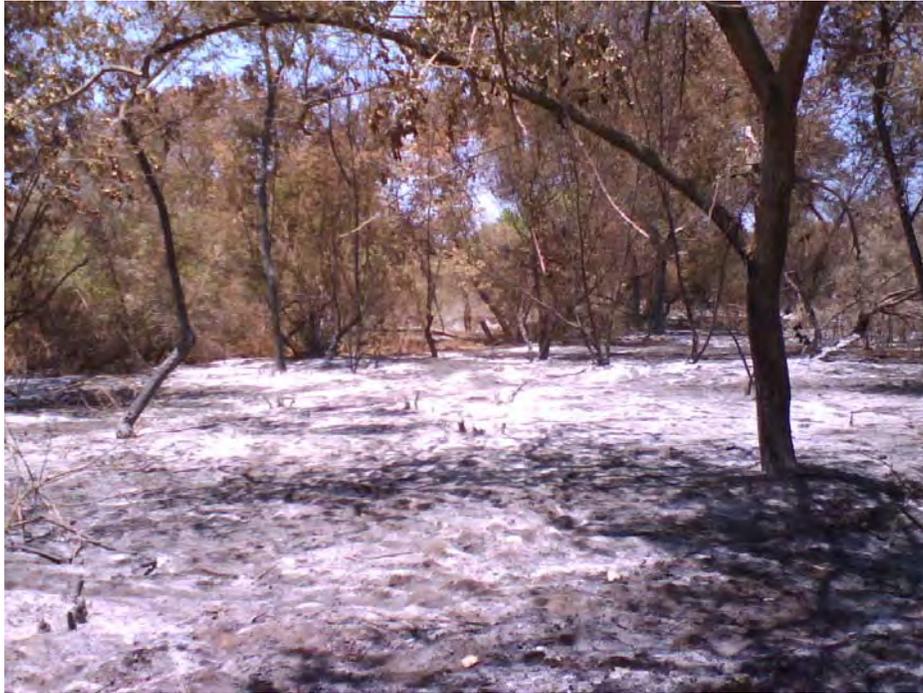
**Figure 6-3.** Burned *Arundo* stands on the San Luis Rey River (Fire SLR #6).

The large amount of biomass per unit area along with a favorable structure for burning generates fires that burn intensively. This is illustrated by fire behavior and an examination of post-fire site conditions. Low intensity fires leave unburned material. Ash levels and color can also be used to gauge fire intensity. *Arundo* fires usually leave little unburned biomass and ash is usually white (Figures 6-3 & 4, also section 6.4 photos).

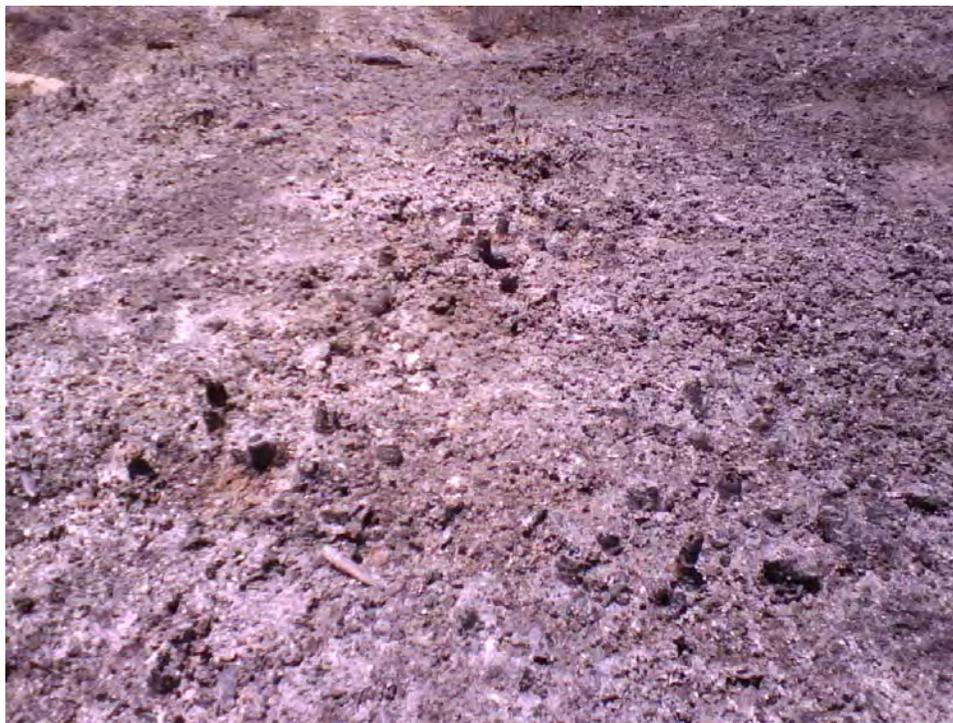
**Figure 6-4.** Burned *Arundo* stands on the San Luis Rey River (Fire SLR #6).

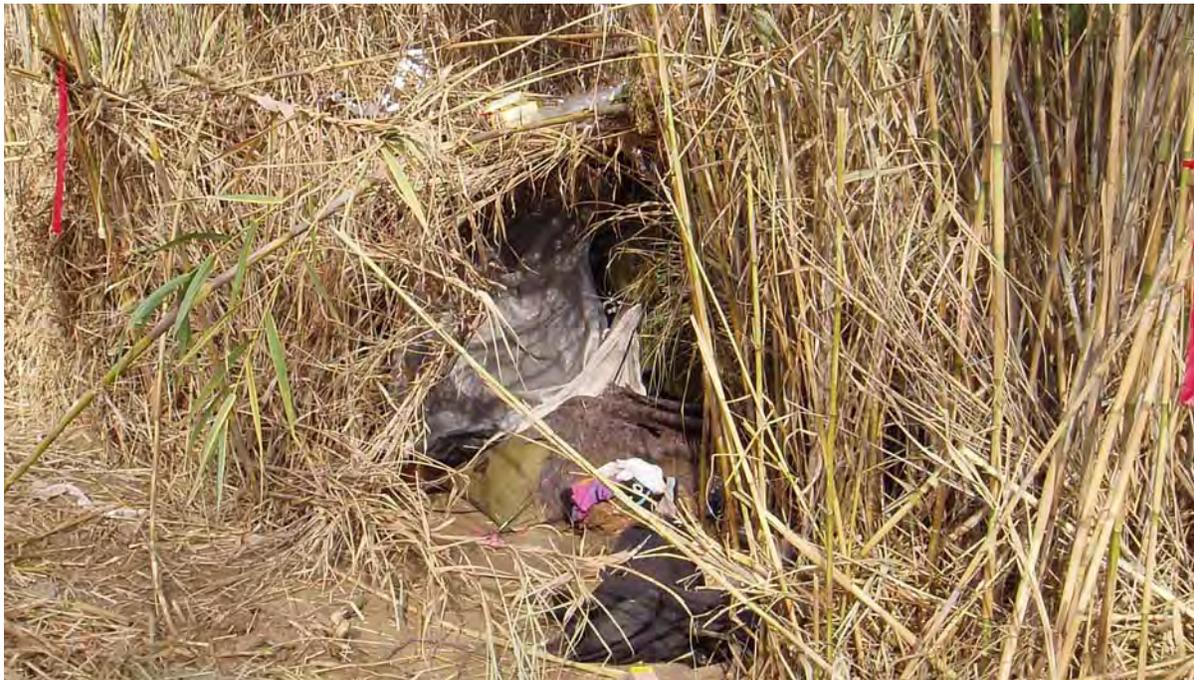
**Figure 6-5.** Camp on San Luis Rey River with *Arundo* folded over to make an enclosure.

This report documents that *Arundo* directly increases the probability of fire ignition due to *Arundo* stands supporting human activities that lead to fires. *Arundo* stands offer concealment and shelter, which results in encampments and use by transients (Figure 6-5). Activities by transients within *Arundo* stands directly start fires. The following examples are from the San Luis Rey watershed, which has had documented camps and fires within *Arundo* stands for the past 10 years. Camps often have open fires for cooking and heat (Figures 6-6 & 7). Some camps even have portable heaters and ovens (Figure 6-8). Humans frequently smoke and use substances that must be ignited or heated for use, or may process these materials in camps (Figure 6-9). Humans have also intentionally set fires to *Arundo* stands (NLF 2006/7). Fireworks and firearm discharge may also lead to fires. Concealment, availability of water, and remoteness in some areas has also led to the cultivating of cannabis on several watersheds (documented on the San Luis Rey and Santa Ana). These operations have resulted in at least one fire event from an area where the workers had an open campfire (Figure 6-10). Transient activities and encampments are the primary ignition source for fires that start in *Arundo* stands. Direct evidence of the ignition source is usually present at the fire site.
