*Arundo donax*  
**Distribution and Impact Report**

**March 2011**

**Agreement No. 06-374-559-0  
State Water Resources Control Board**

***Prepared by:* California Invasive Plant Council**

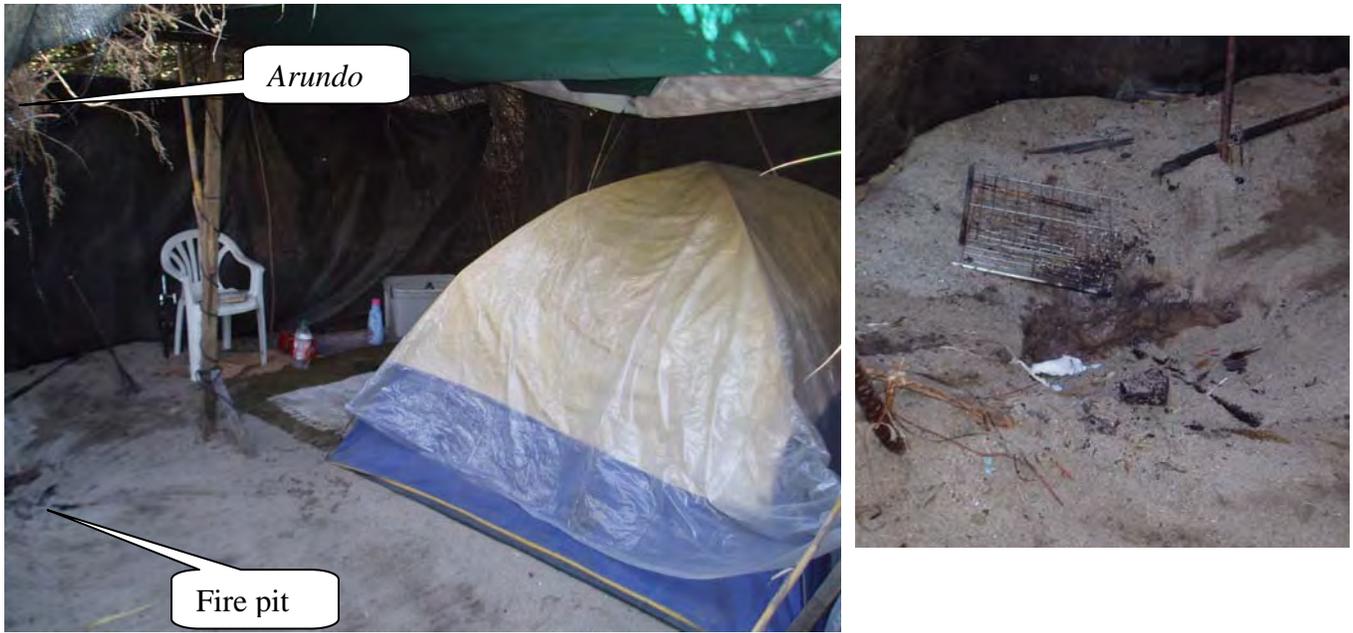
**Figure 6-6.** Camp on San Luis Rey River in *Arundo* stands showing tent, tarp and fire ring. *Arundo* surrounds the camp.

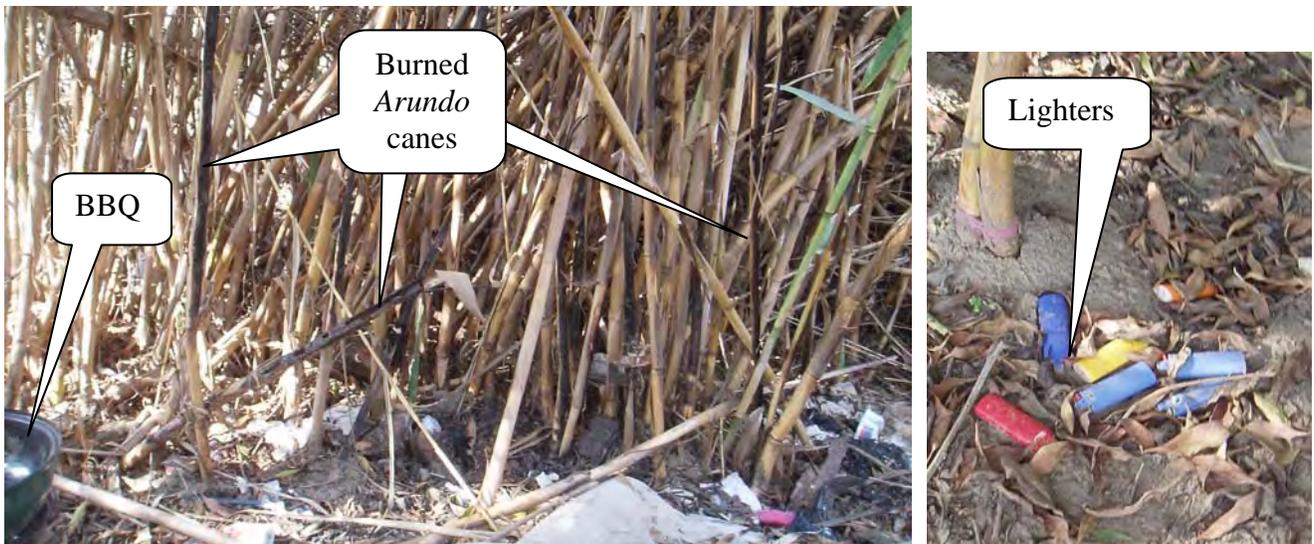
**Figure 6-7.** Camp on San Luis Rey River within *Arundo*, showing multiple lighters, cooking area and burned *Arundo* canes.

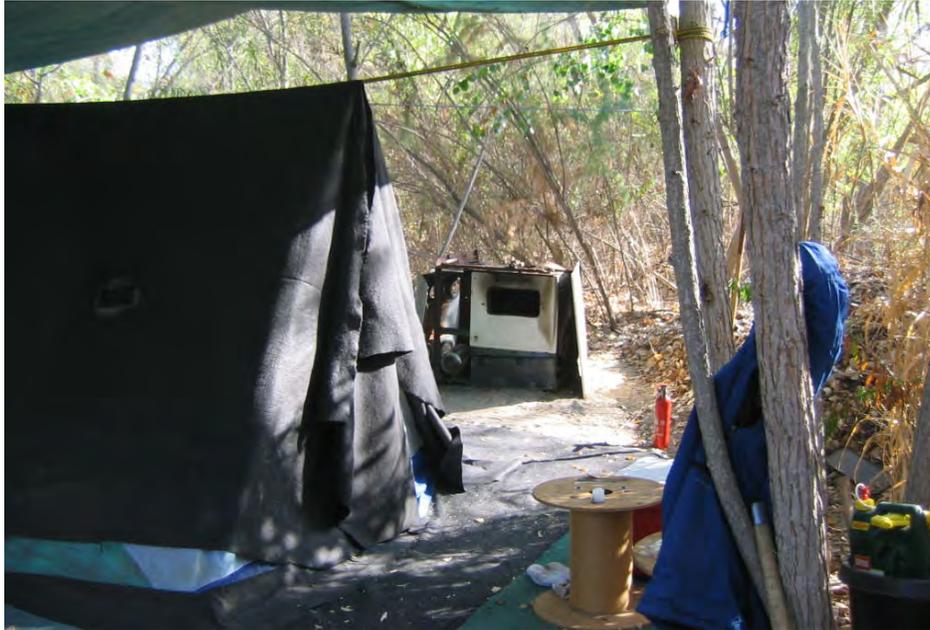
**Figure 6-8.** Camp on San Luis Rey River in *Arundo* showing tent and cooking area with a portable oven connected to propane.

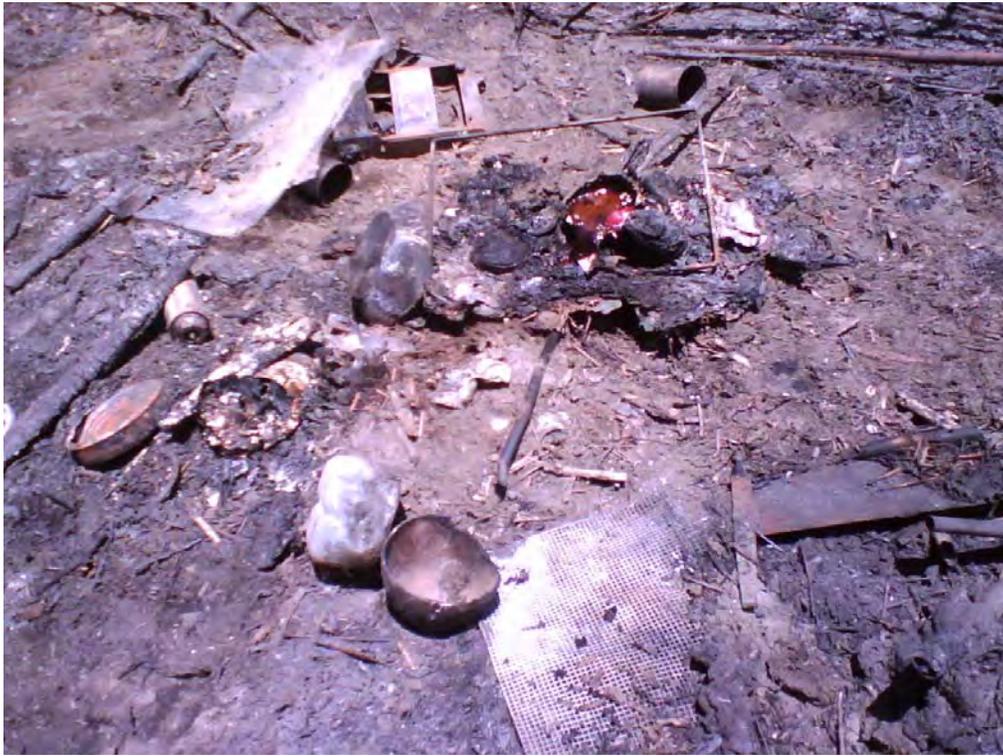
**Figure 6-10.** Open fire associated with workers of a cannabis plantation. This was the ignition source of a wildfire that started within *Arundo* on the San Luis Rey River (Fire SLR #6).

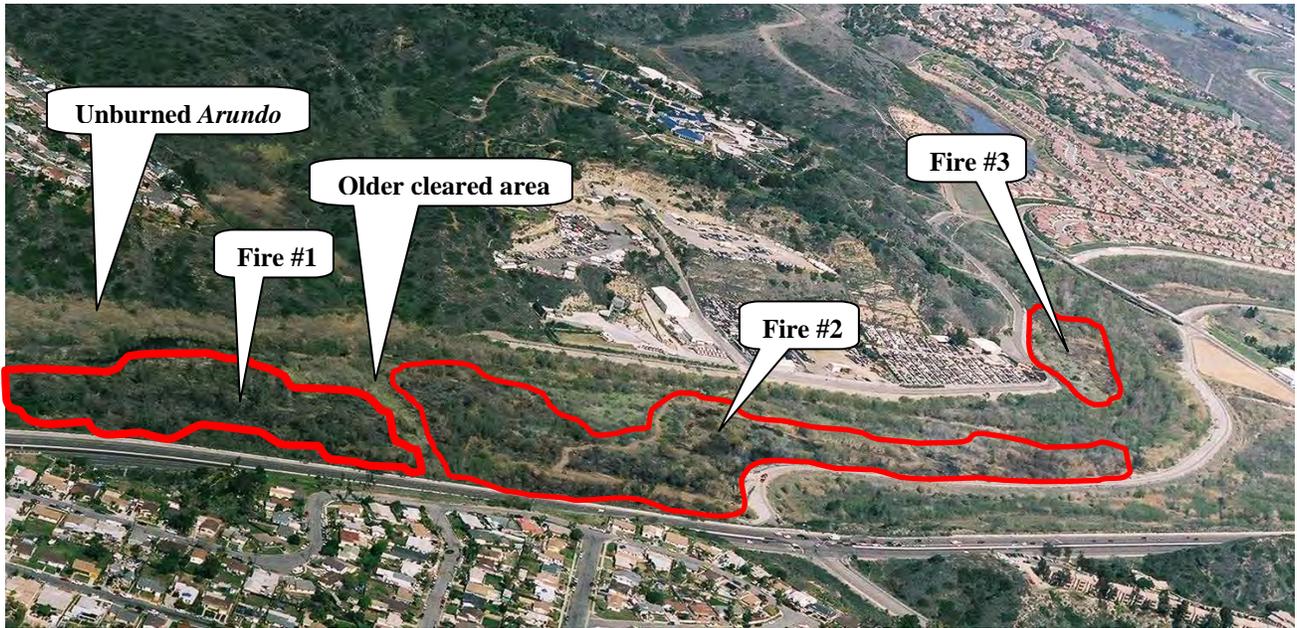
**Figure 6-13.** Footprint of fires # SLR 1-3 on the San Luis Rey River.

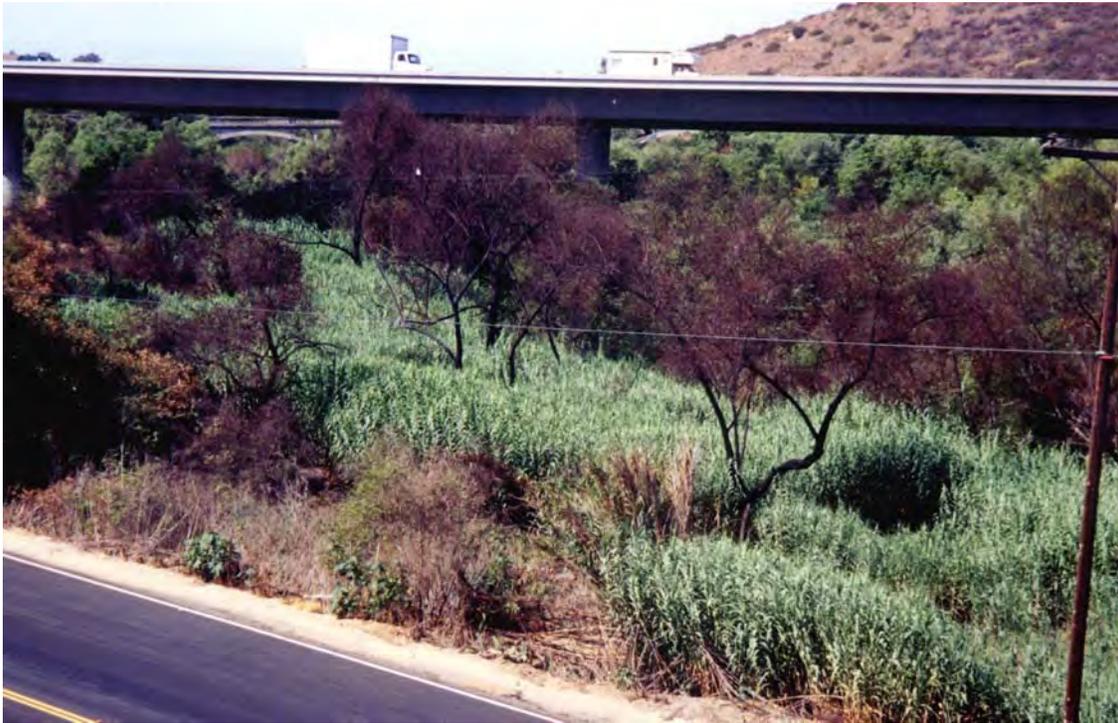
**Figure 6-15.** *Arundo* resprouting after a fire on the San Luis Rey River. Native trees are either dead, or still dormant (Fire SLR #5).

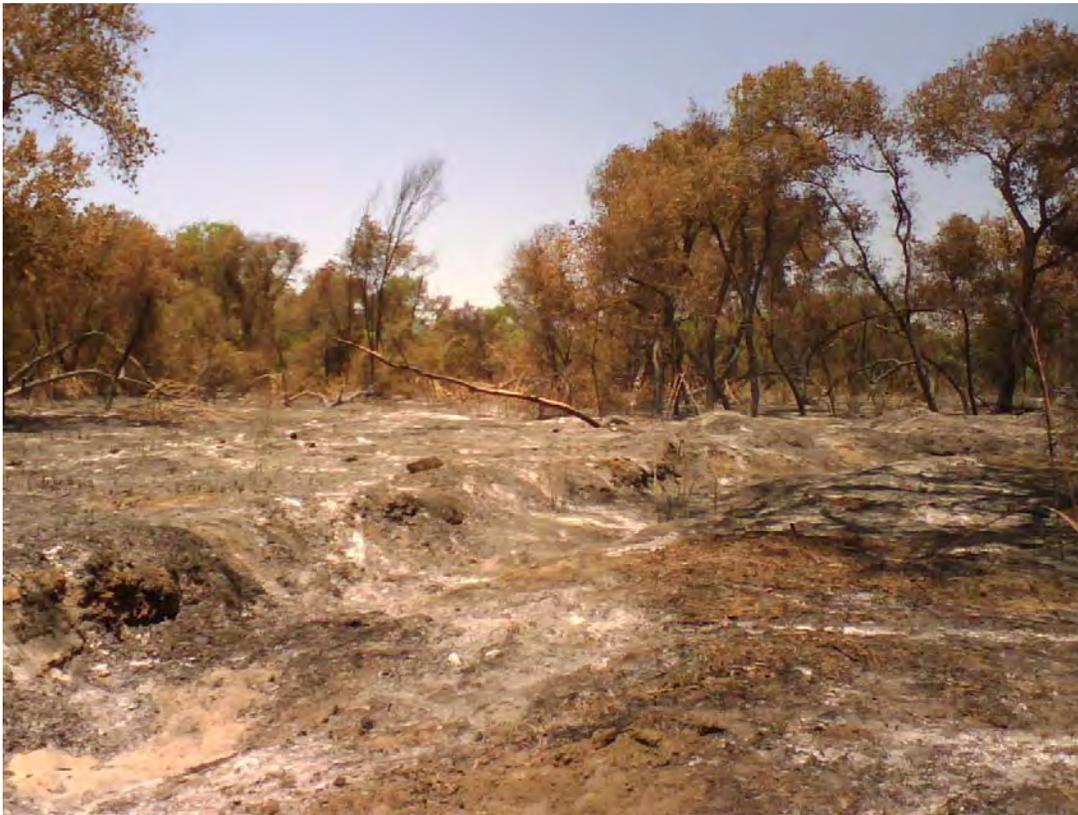
**Figure 6-16.** Immediately after a fire that burned an *Arundo* stand on the San Luis Rey River, leaving only ash and very little unburned material (Fire SLR #6).

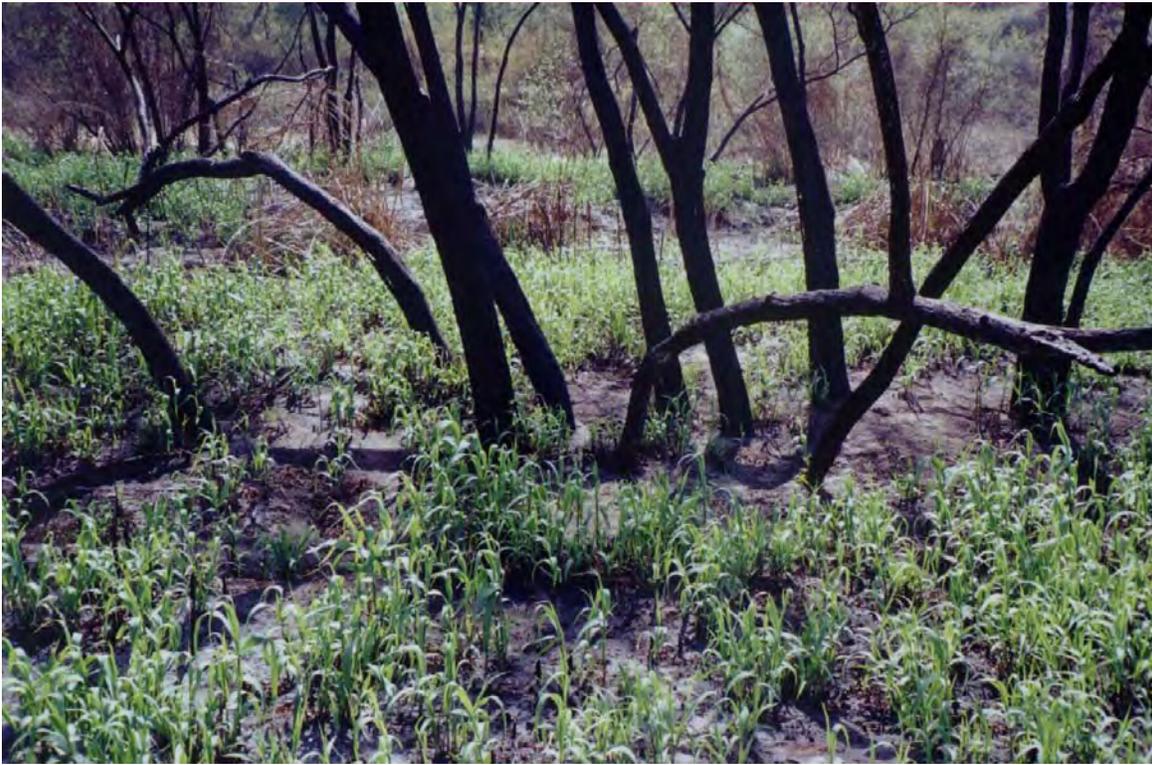
**Figure 6-17.** Shortly after a fire through *Arundo*-infested riparian habitat on the San Luis Rey River. This demonstrates the quick and dense resprouting of *Arundo* before any native vegetation (Fire SLR #7).

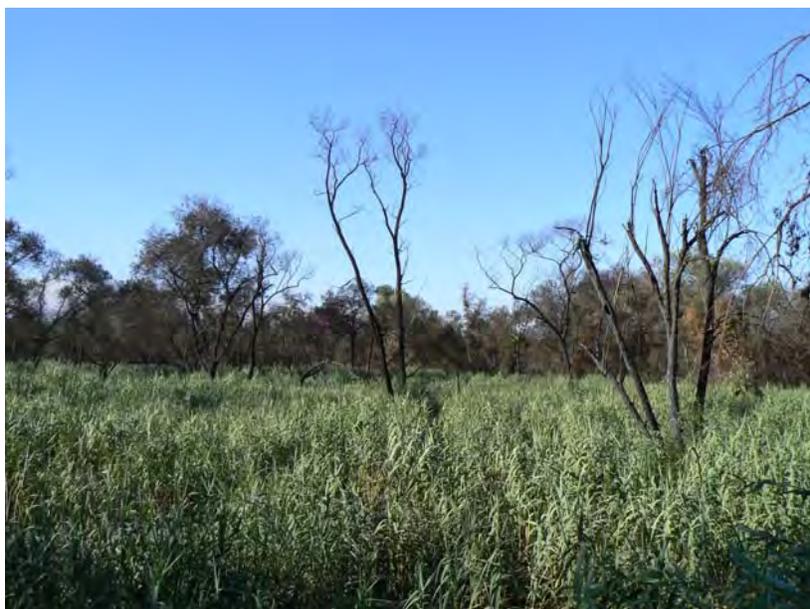
**Figure 6-20.** *Arundo* one year after a fire, already 2-3 feet high, at the site of fire SLR #6.
