A Watershed Approach to *Arundo donax* Removal and Riparian Restoration

Project Setting: Russian River Watershed

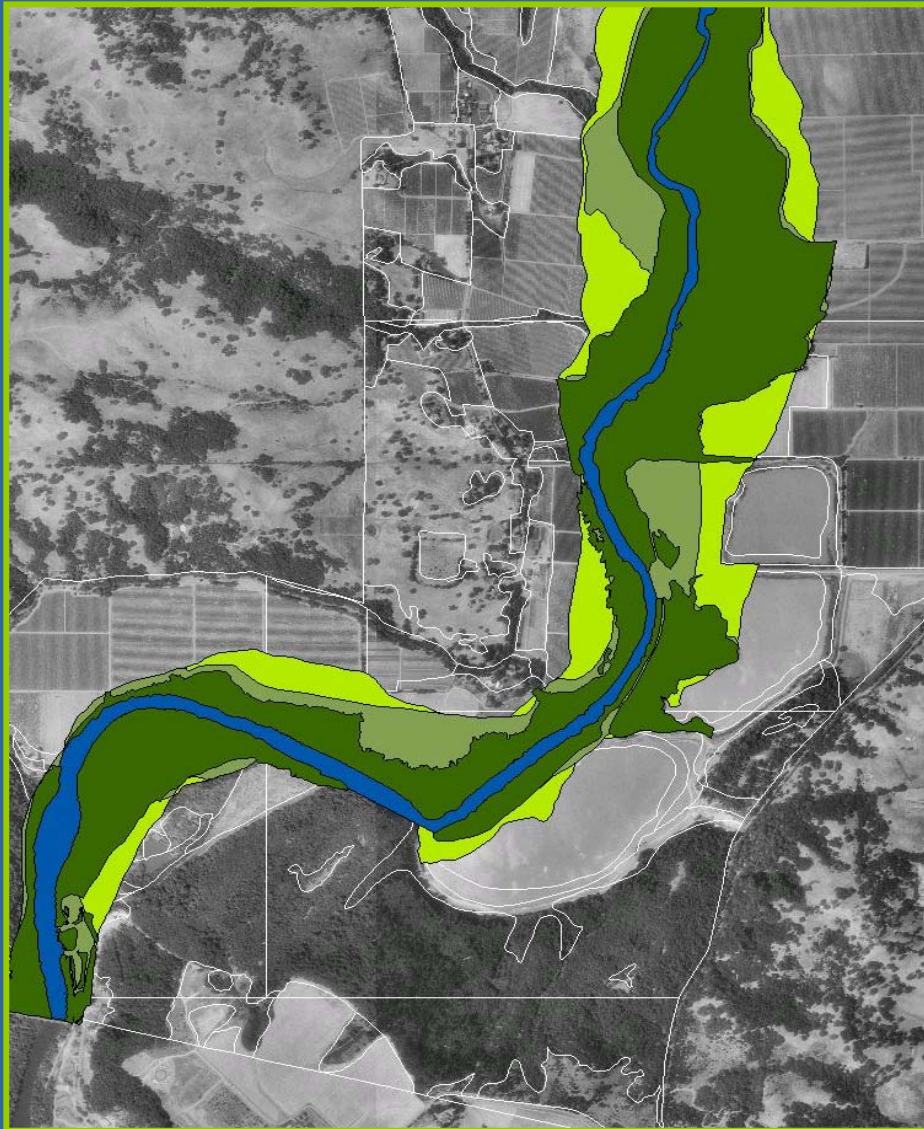
Riparian Vegetation Loss - Russian River

(50% since 1942 – earliest aerial photos)

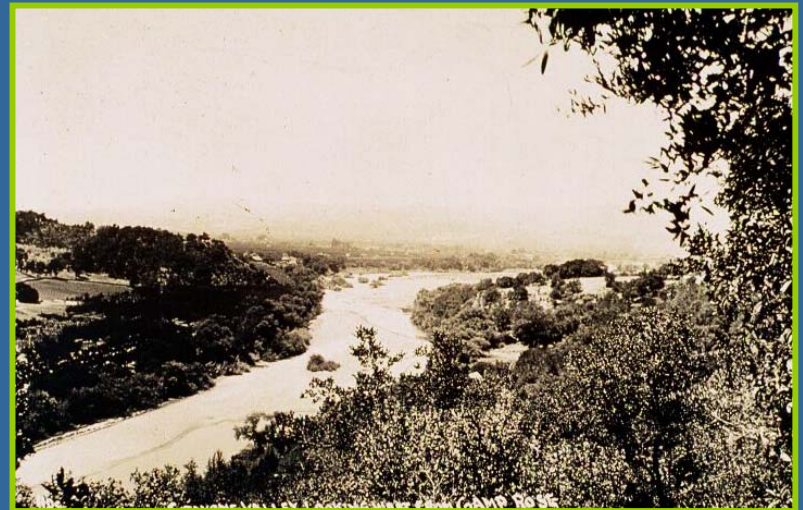
- 1942 Riparian Habitat
- 1990 Riparian Habitat
- 2000 Riparian Habitat

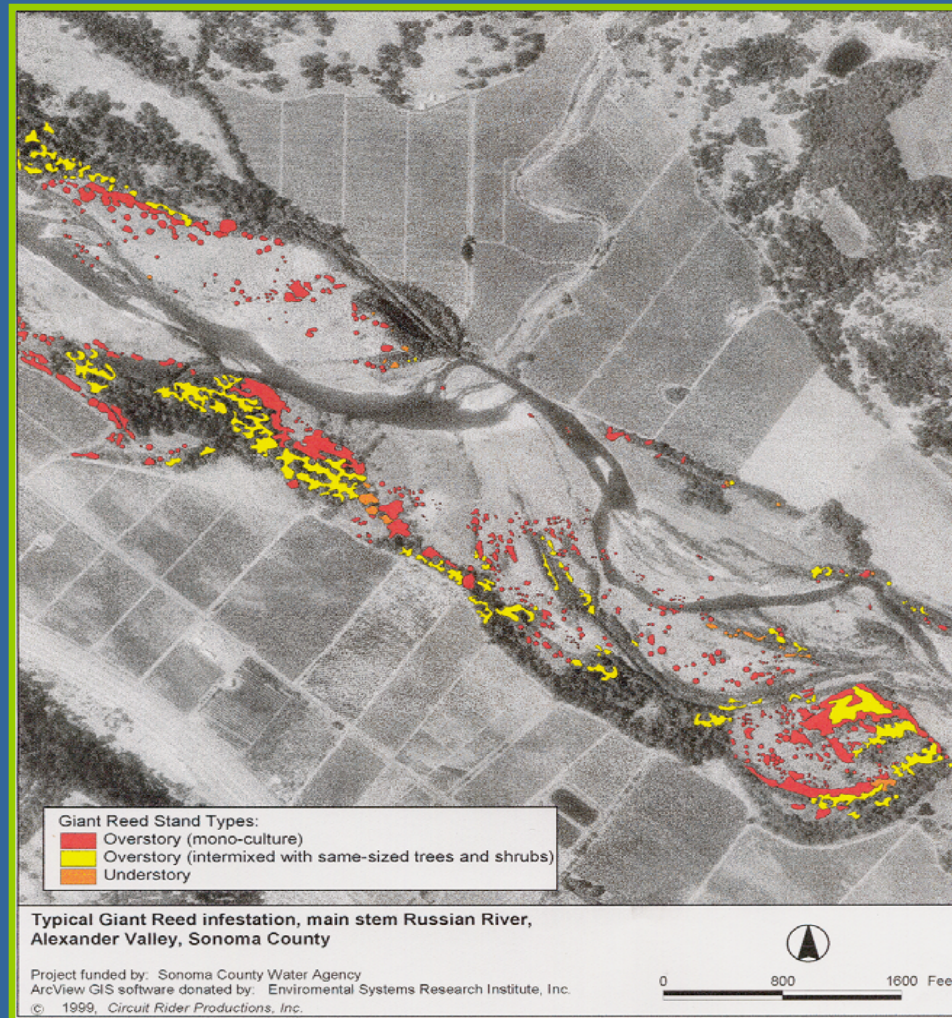
Giant Reed (*Arundo donax*) in the Russian River Watershed: infestation extent & type

- 250 acres main stem, mostly Sonoma County (60 % in Alexander Valley)
- 44 infested tributaries
- 700 tributary point locations
- Predominantly monoculture or intermixed

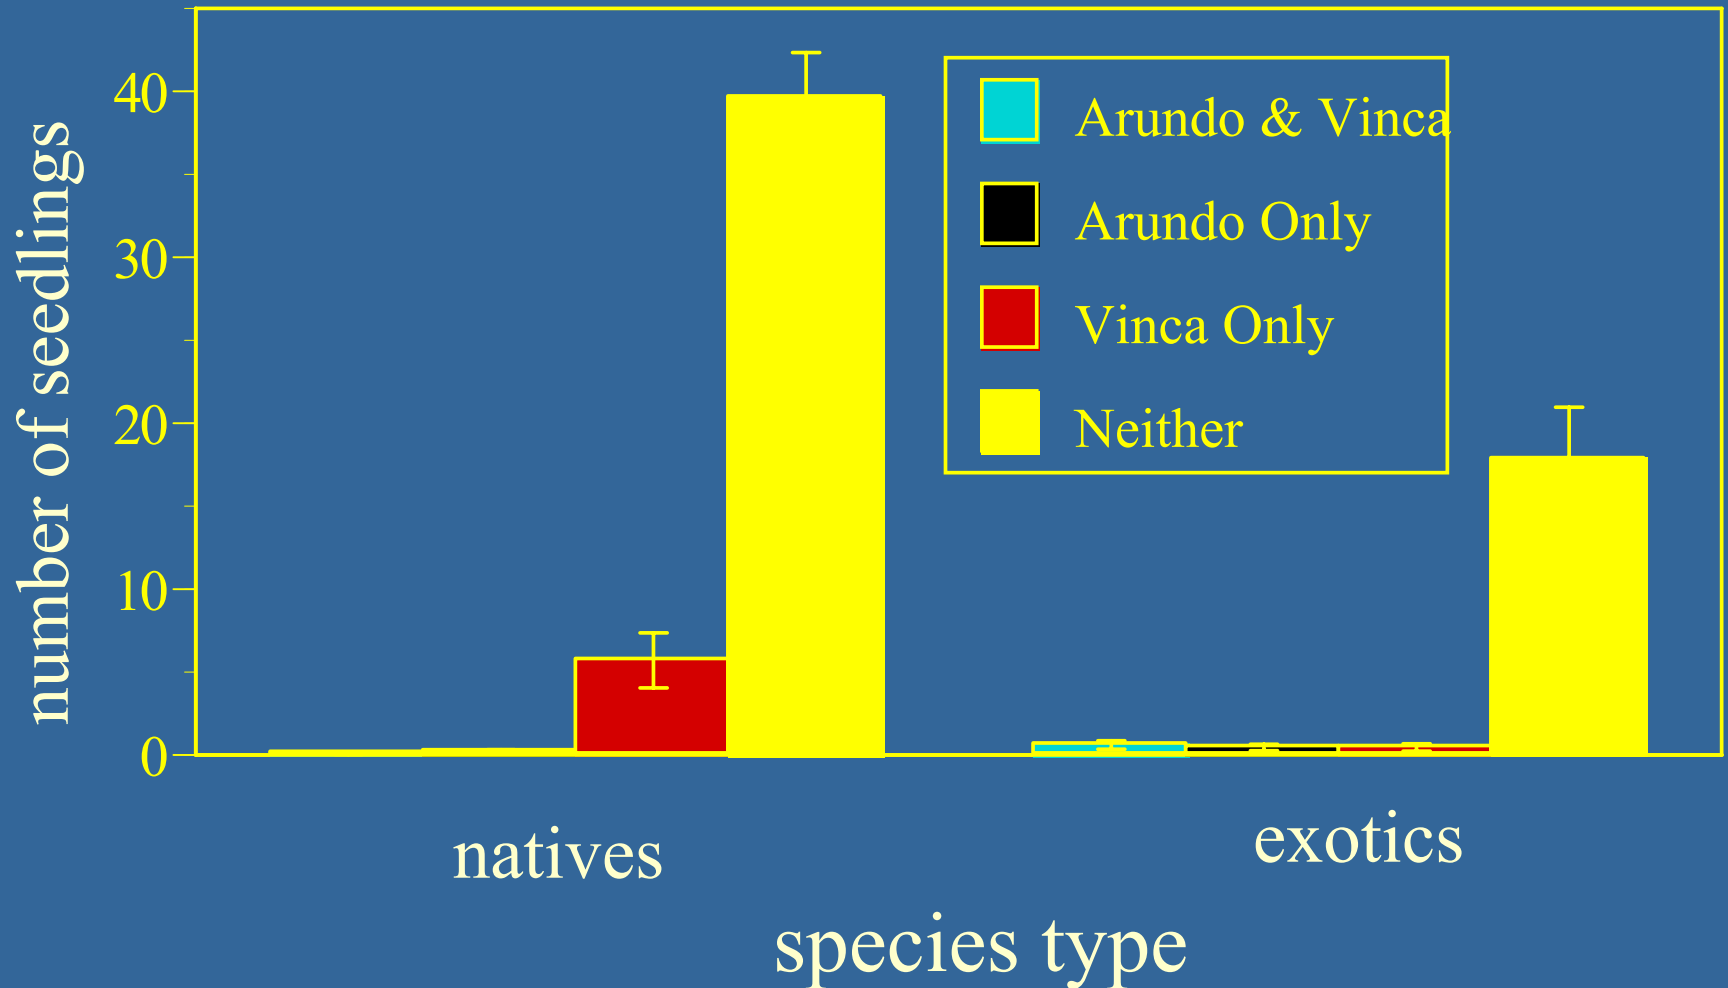
Number of Seedlings in *Arundo* and *Vinca* Invaded Habitats

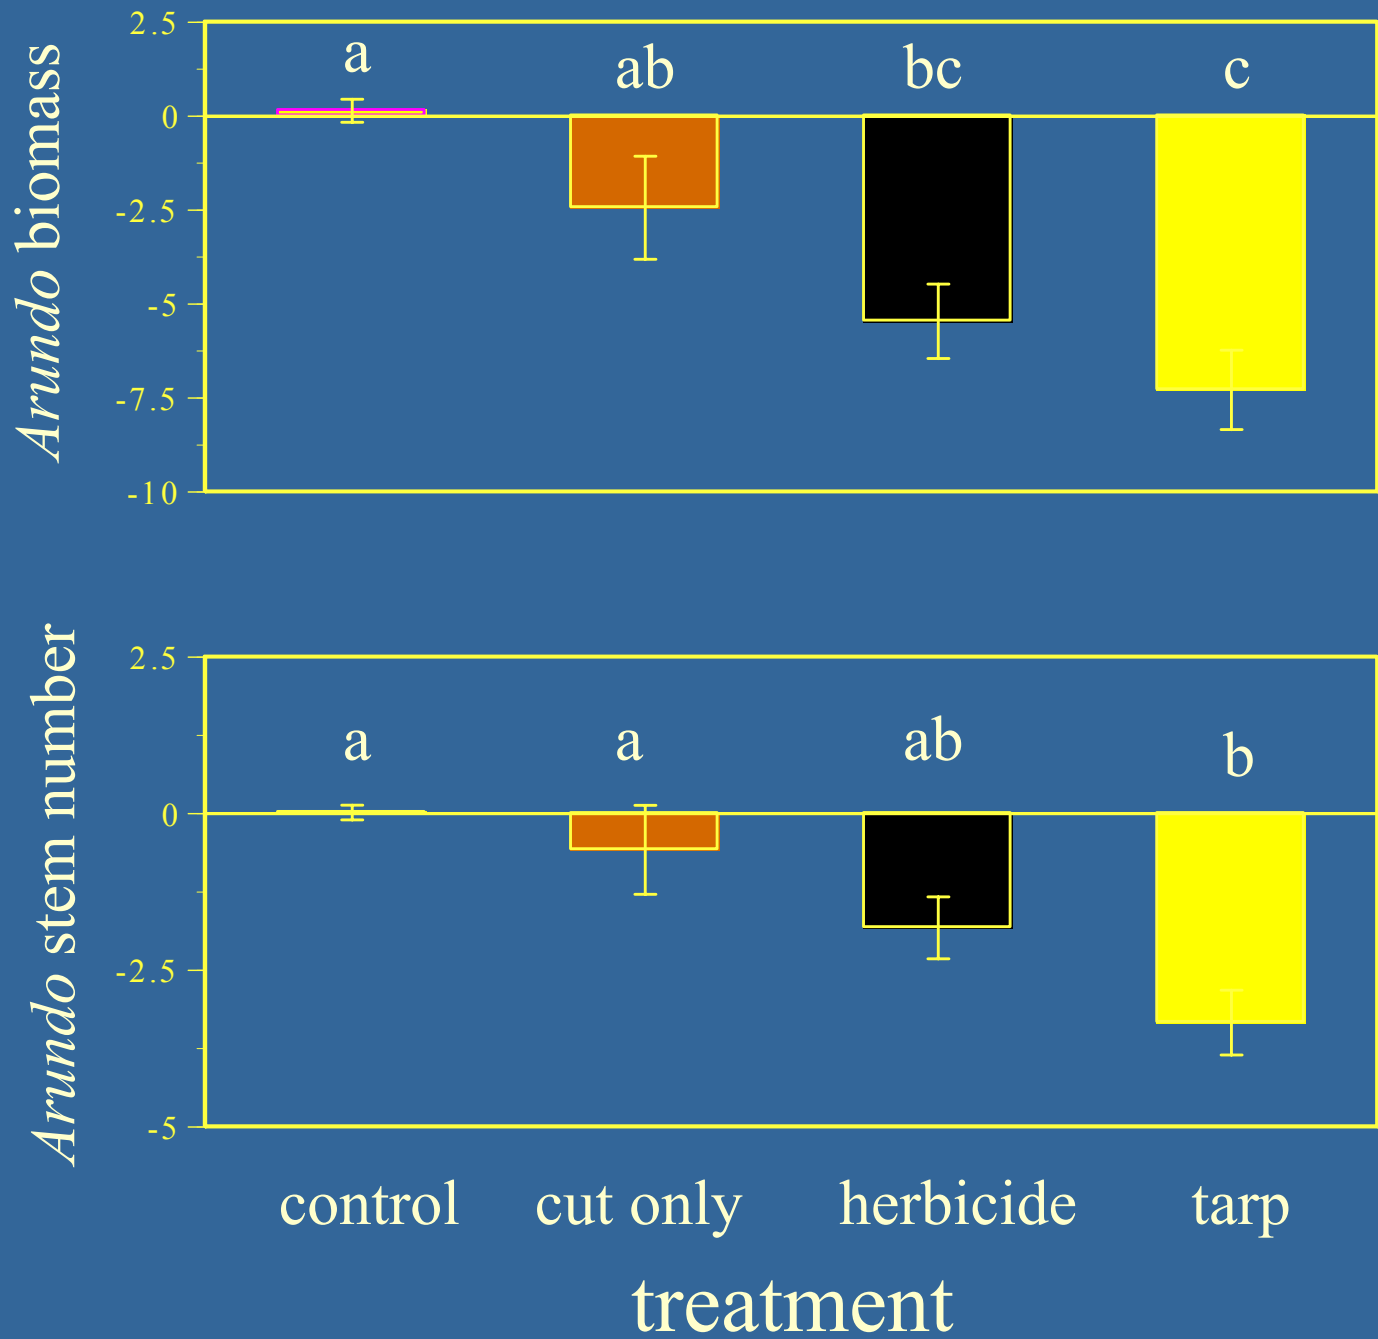
Relative change [ln(2000/1998)]
