# Restoring Montane Wet Meadows in Sequoia and Kings Canyon National Parks

Athena Demetry, Restoration Ecologist  
Sequoia and Kings Canyon National Parks

# Halstead Meadow

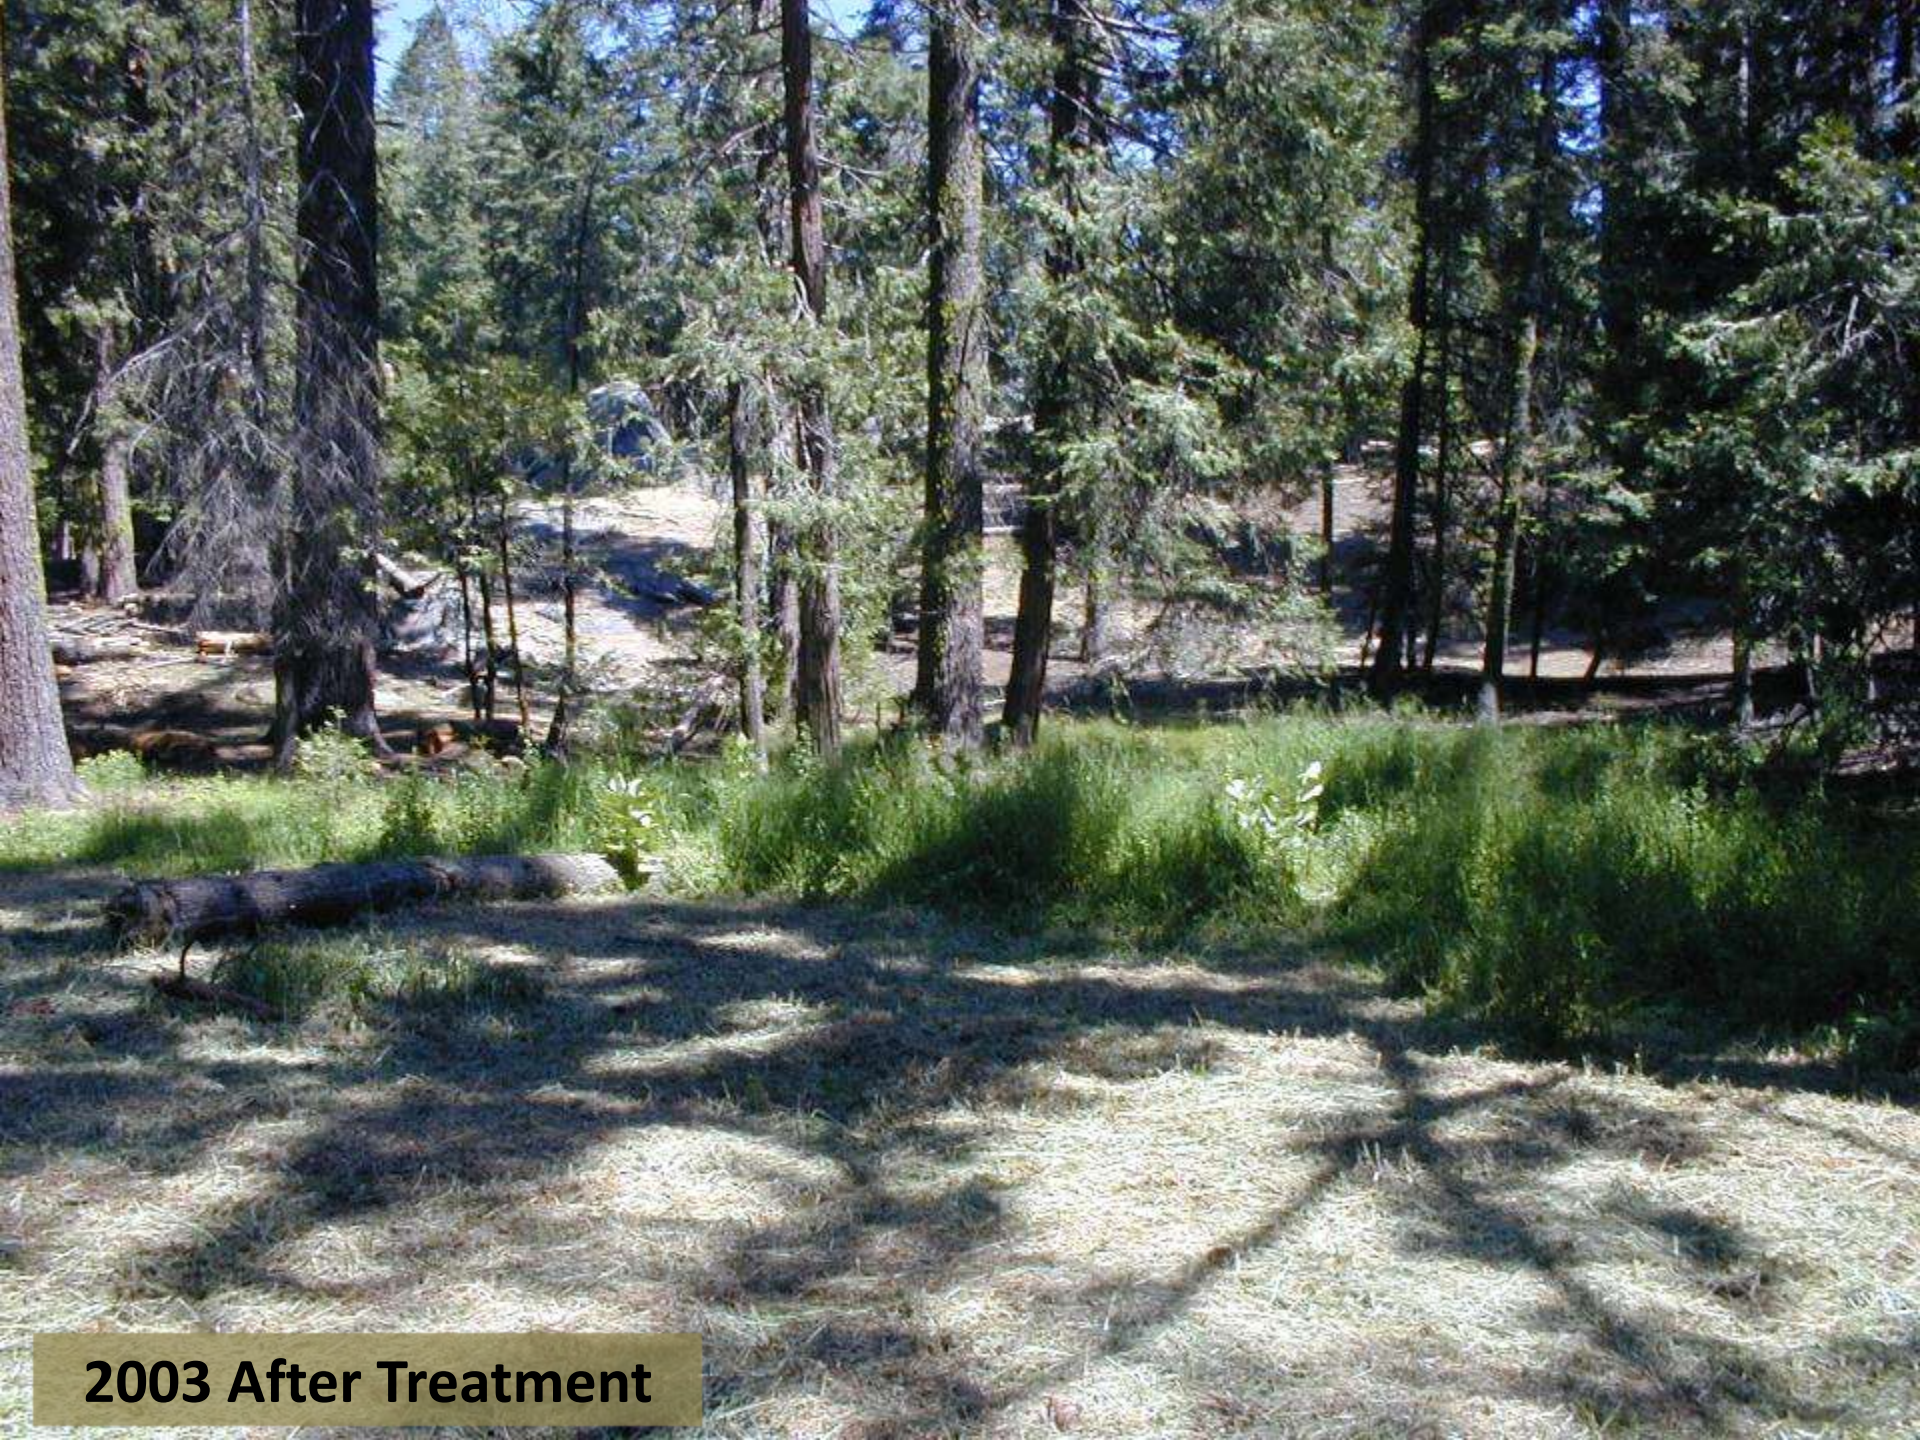
**2003 Before Treatment**

- Cut, resprout, treat with glyphosate years 1 -2
- Year 3, glyphosate plus hand-pull to **preserve native species recolonization**

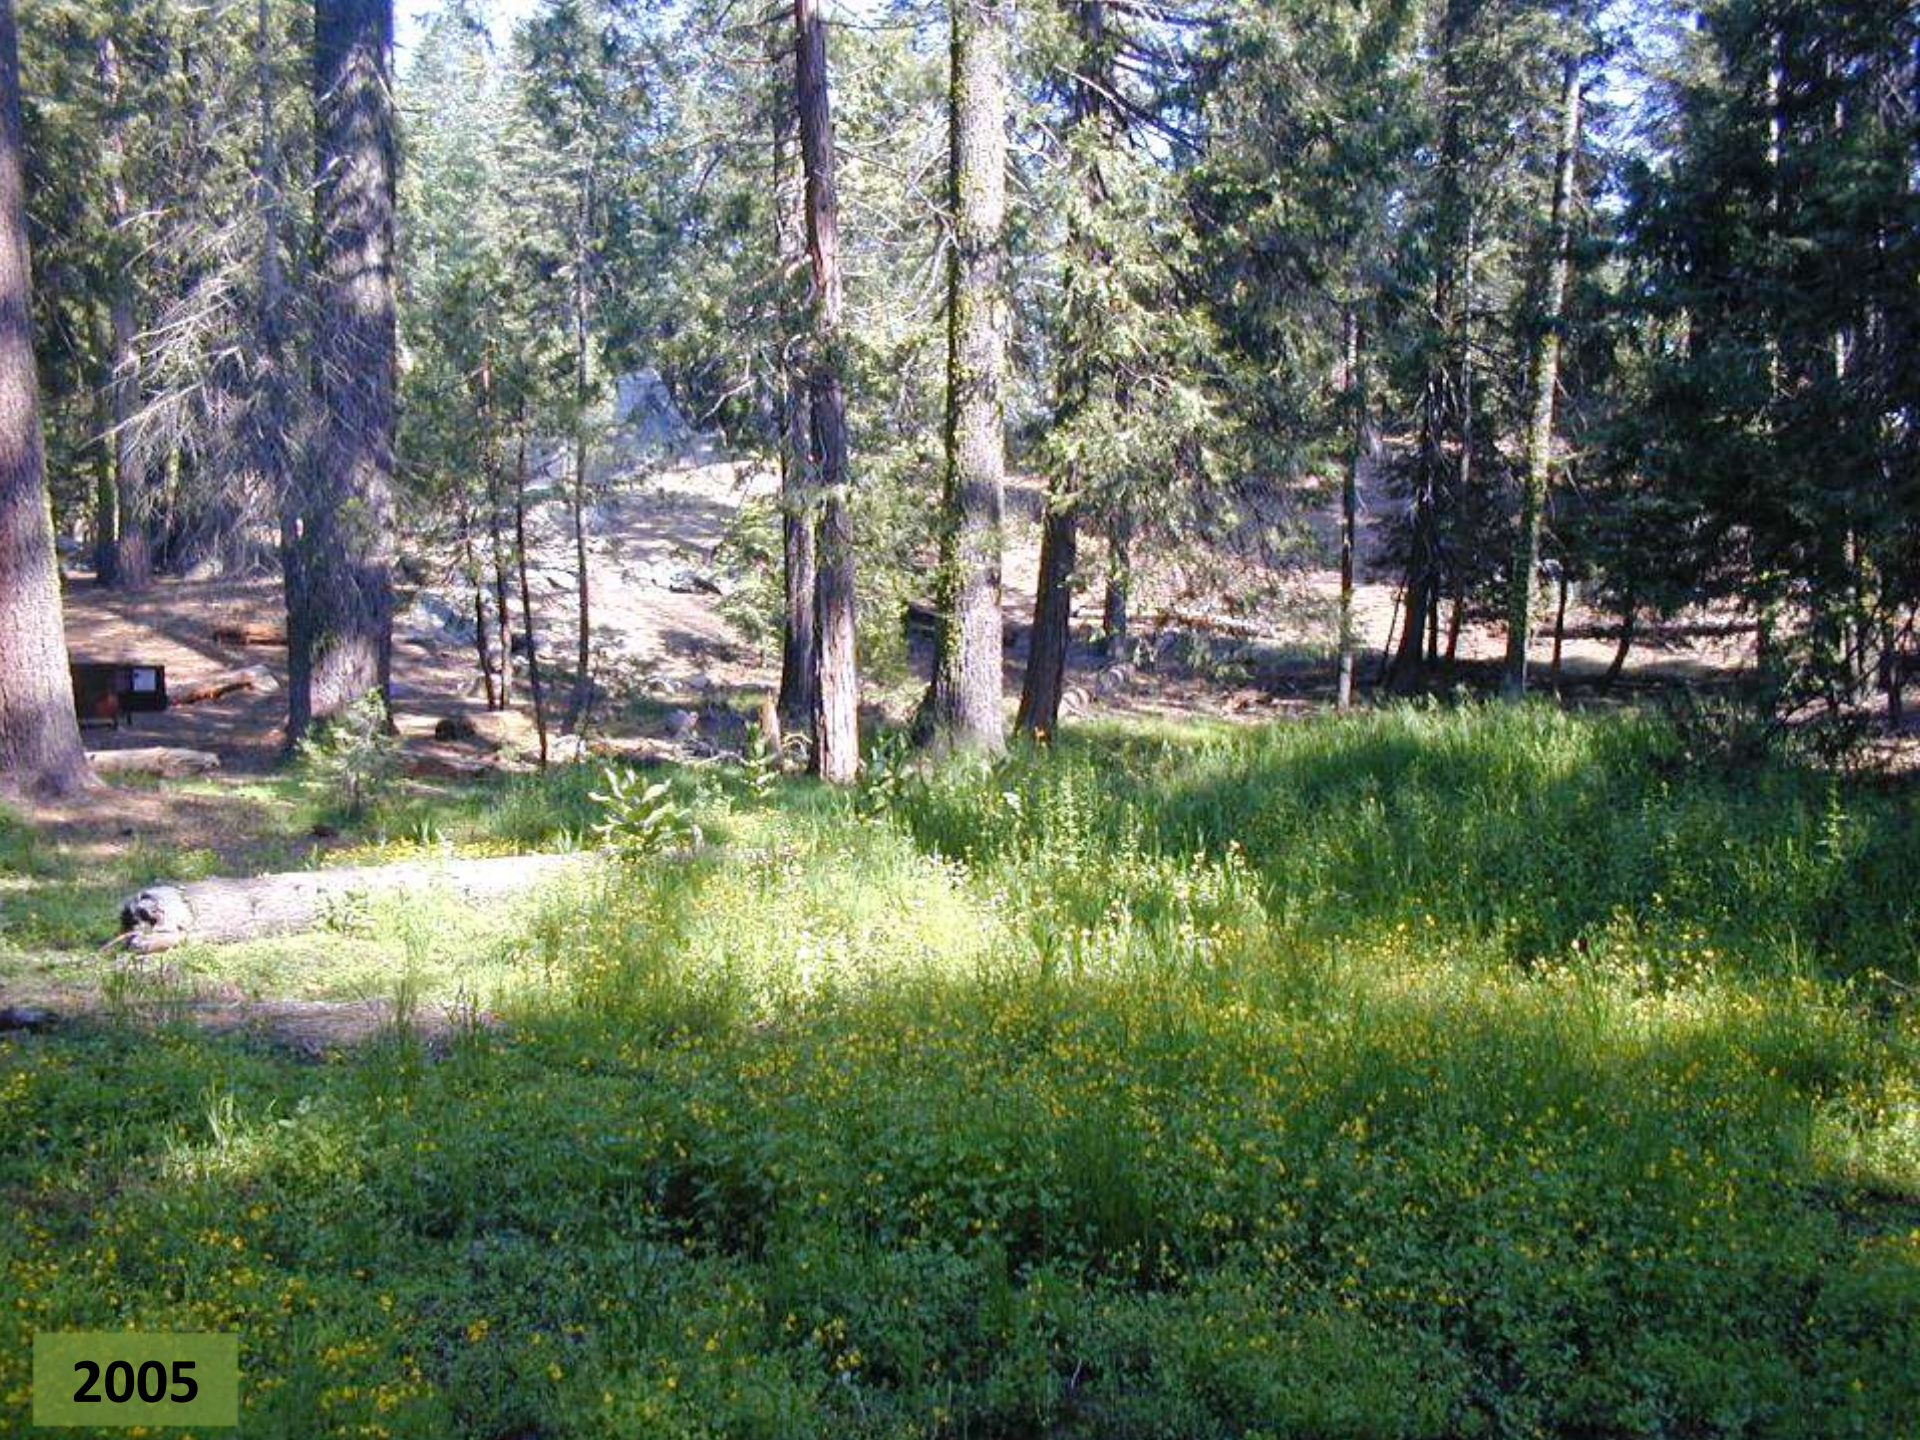
**2003 After Treatment**

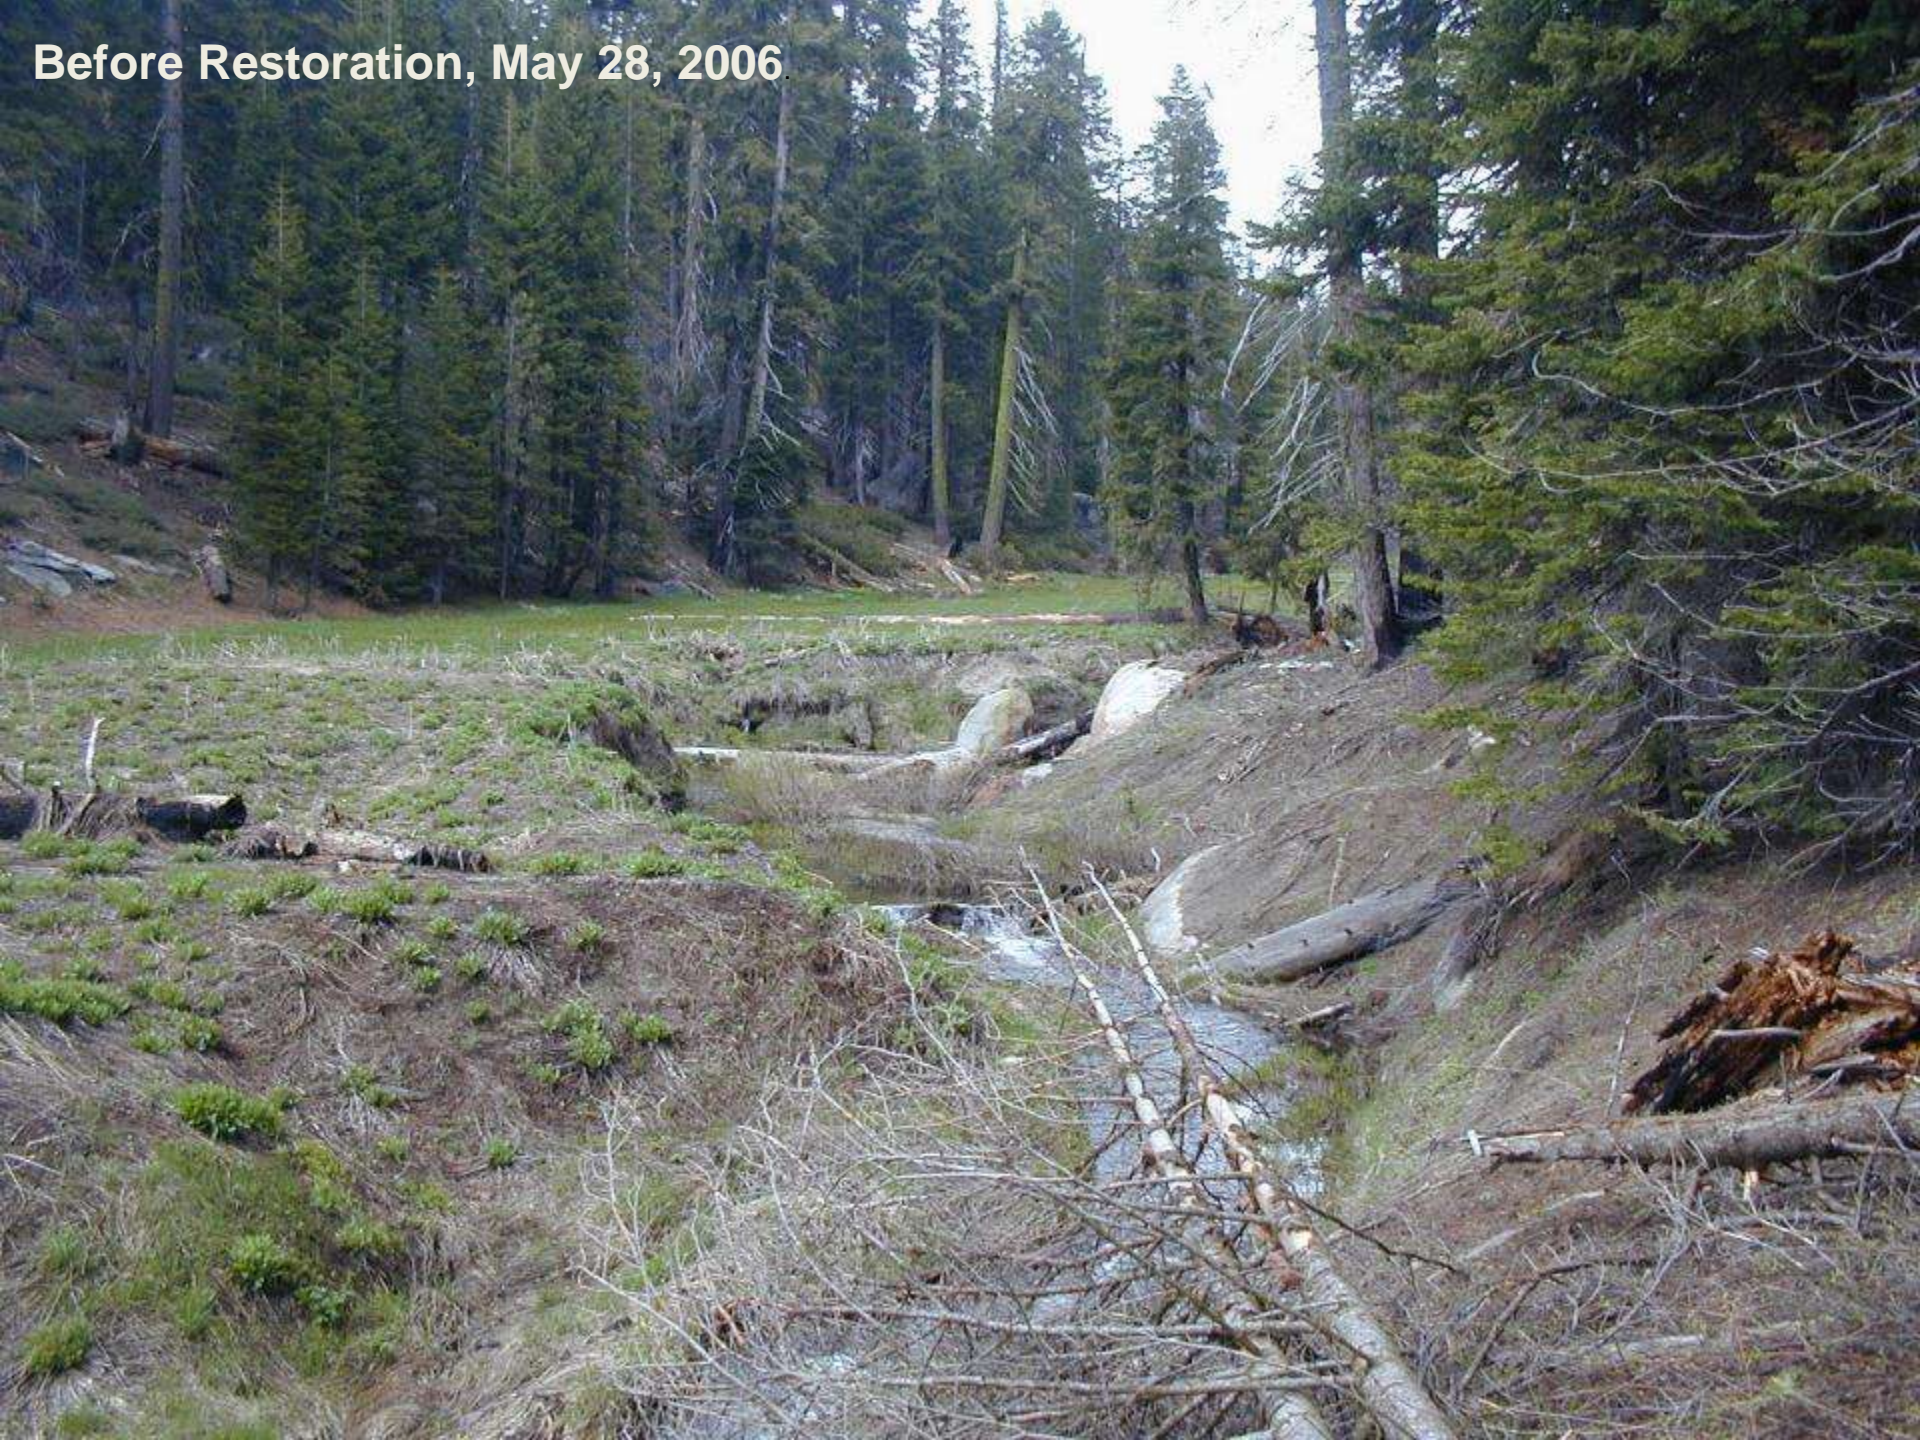
**Before Restoration, May 28, 2006**

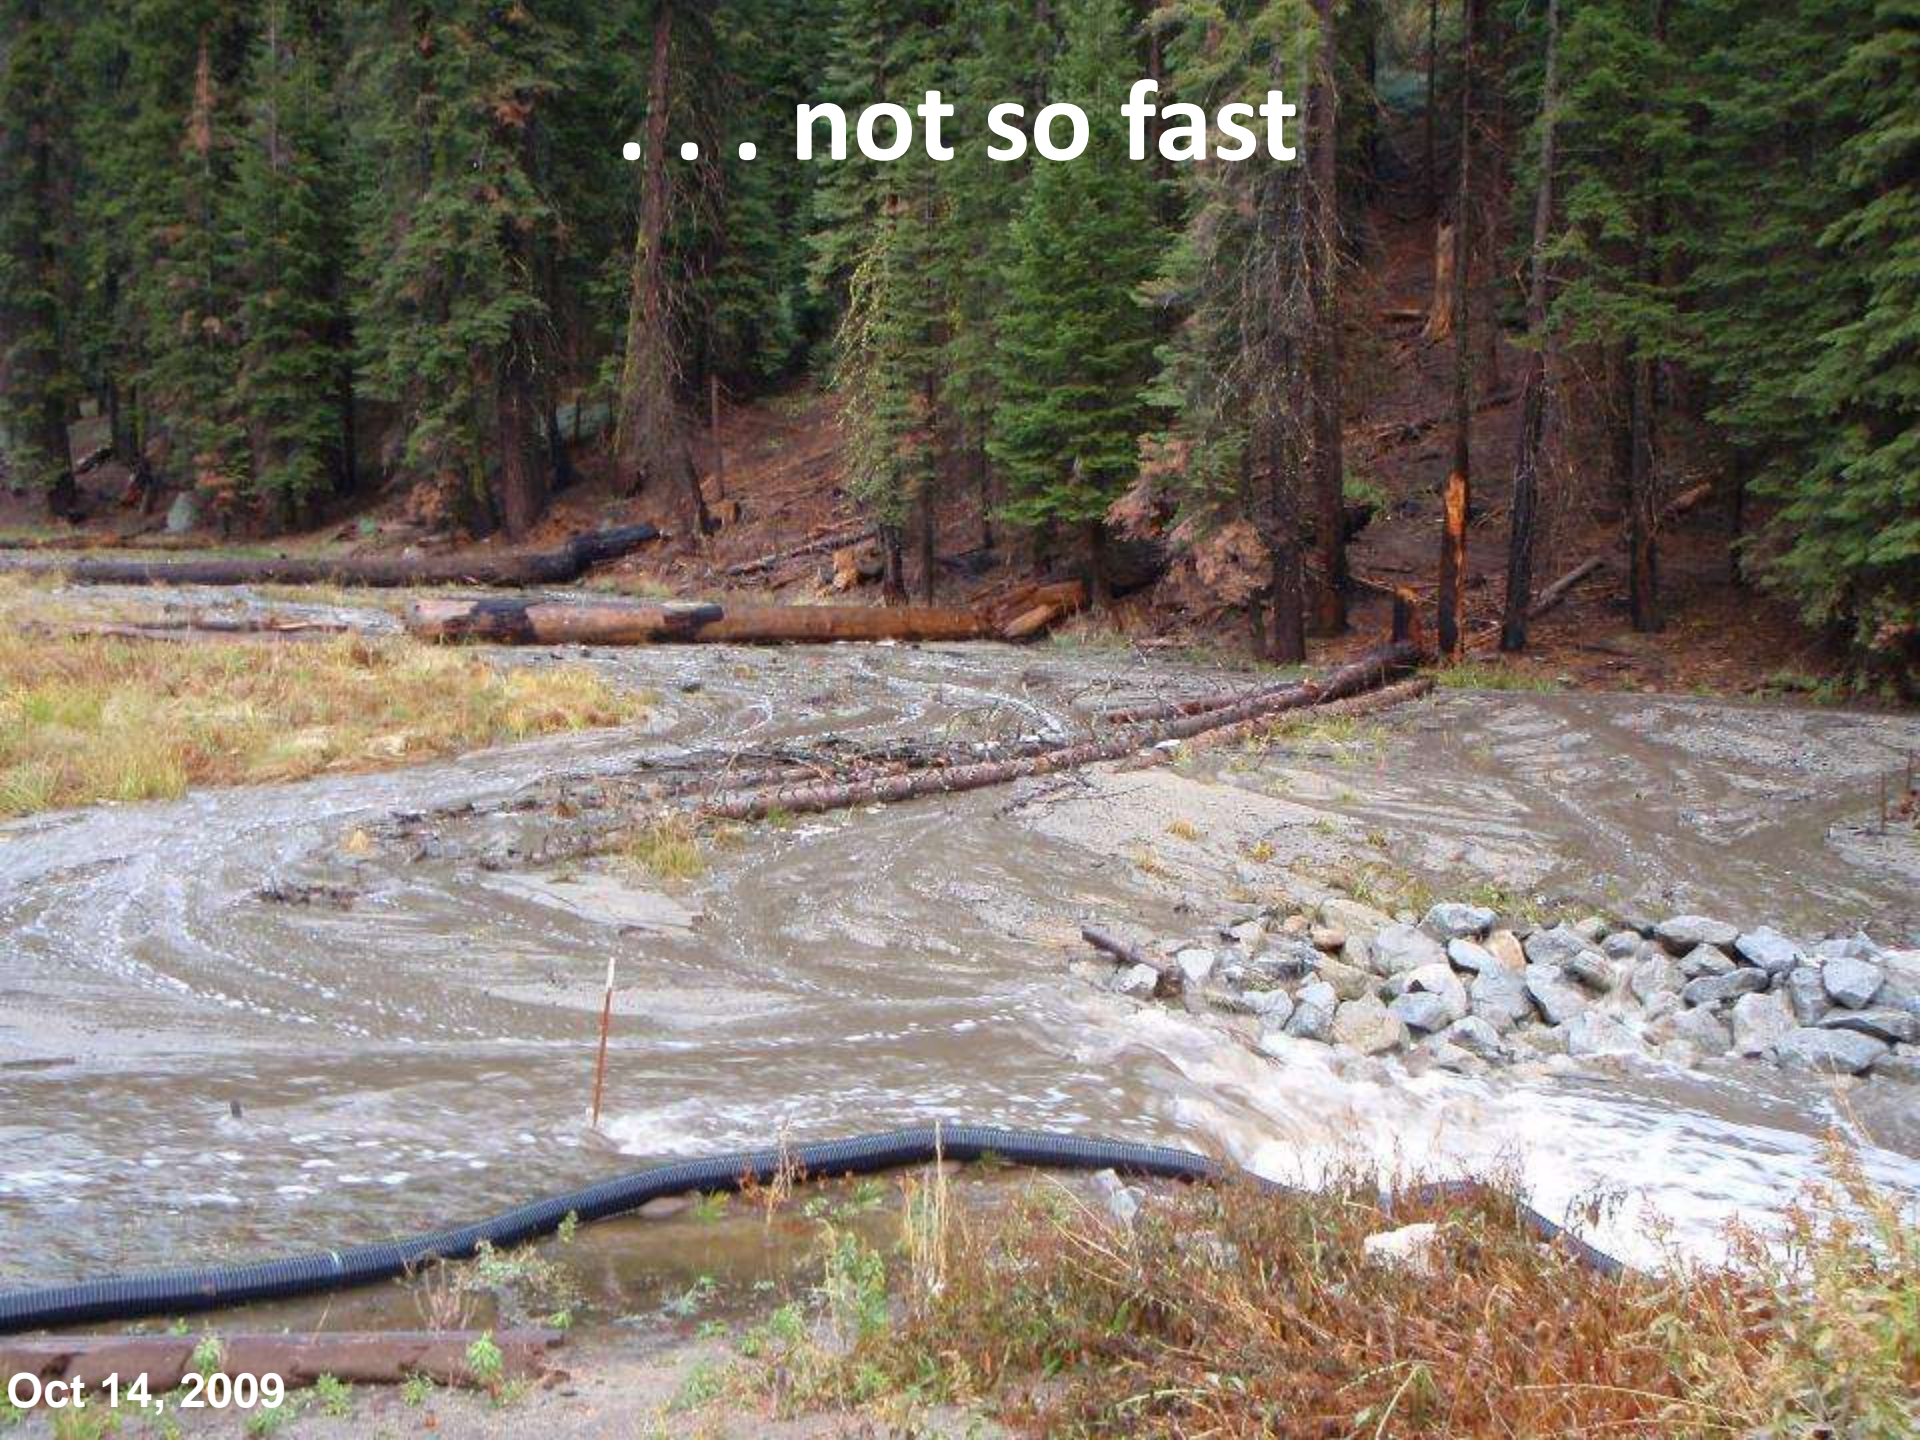
Two years after planting, August 2009

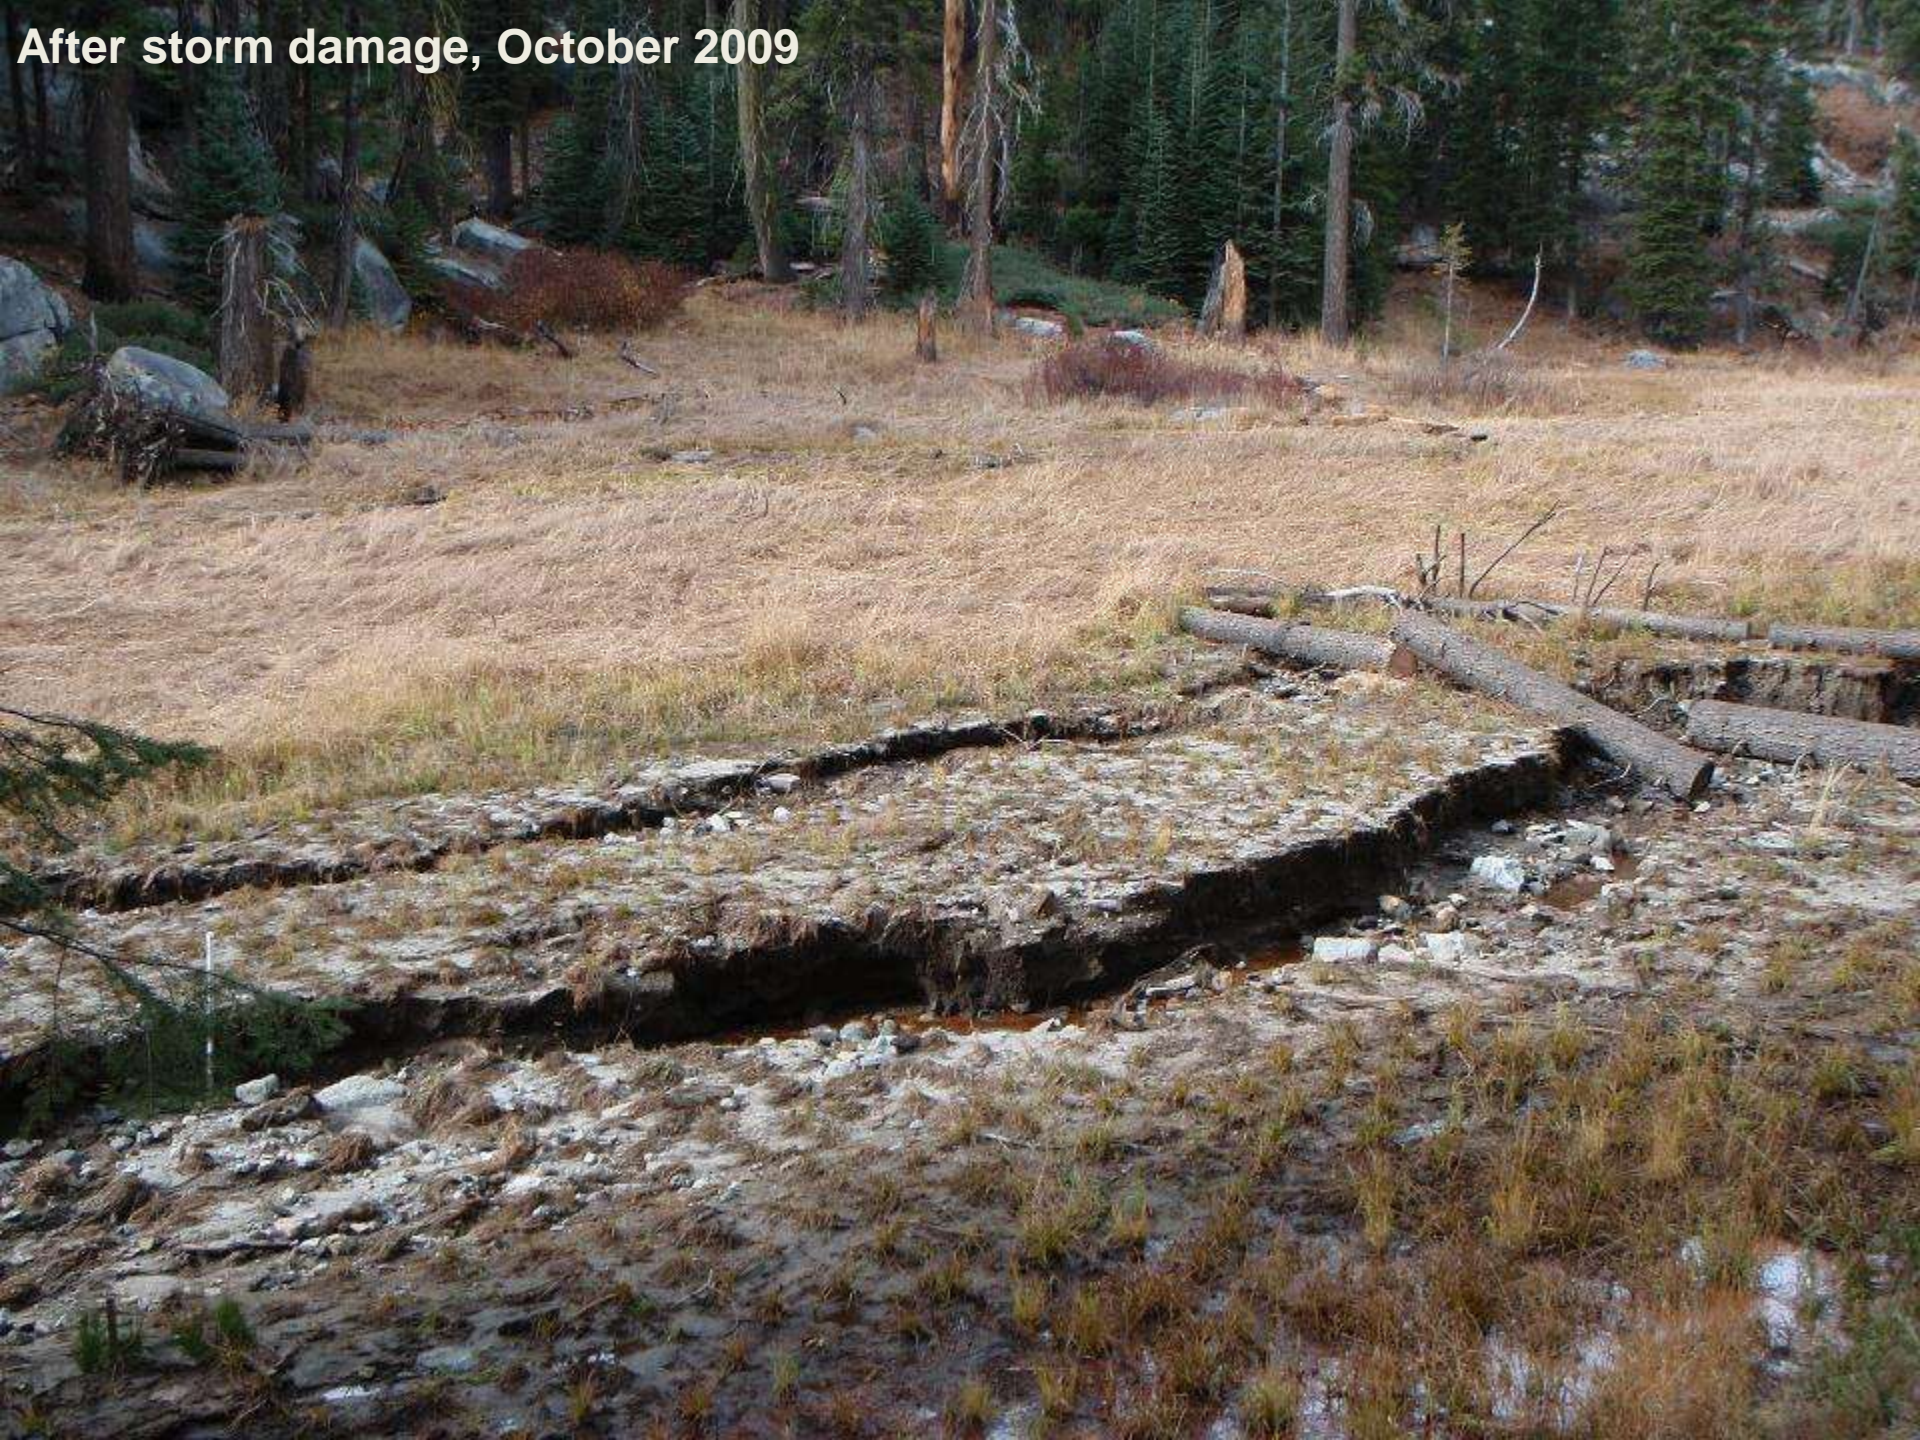
After storm damage, October 2009

- Logs cause new gullies to form during high water flow
- Overcompaction of fill slowed plant growth
- **Need rapid plant cover to armor against storm damage soon after earth moving**

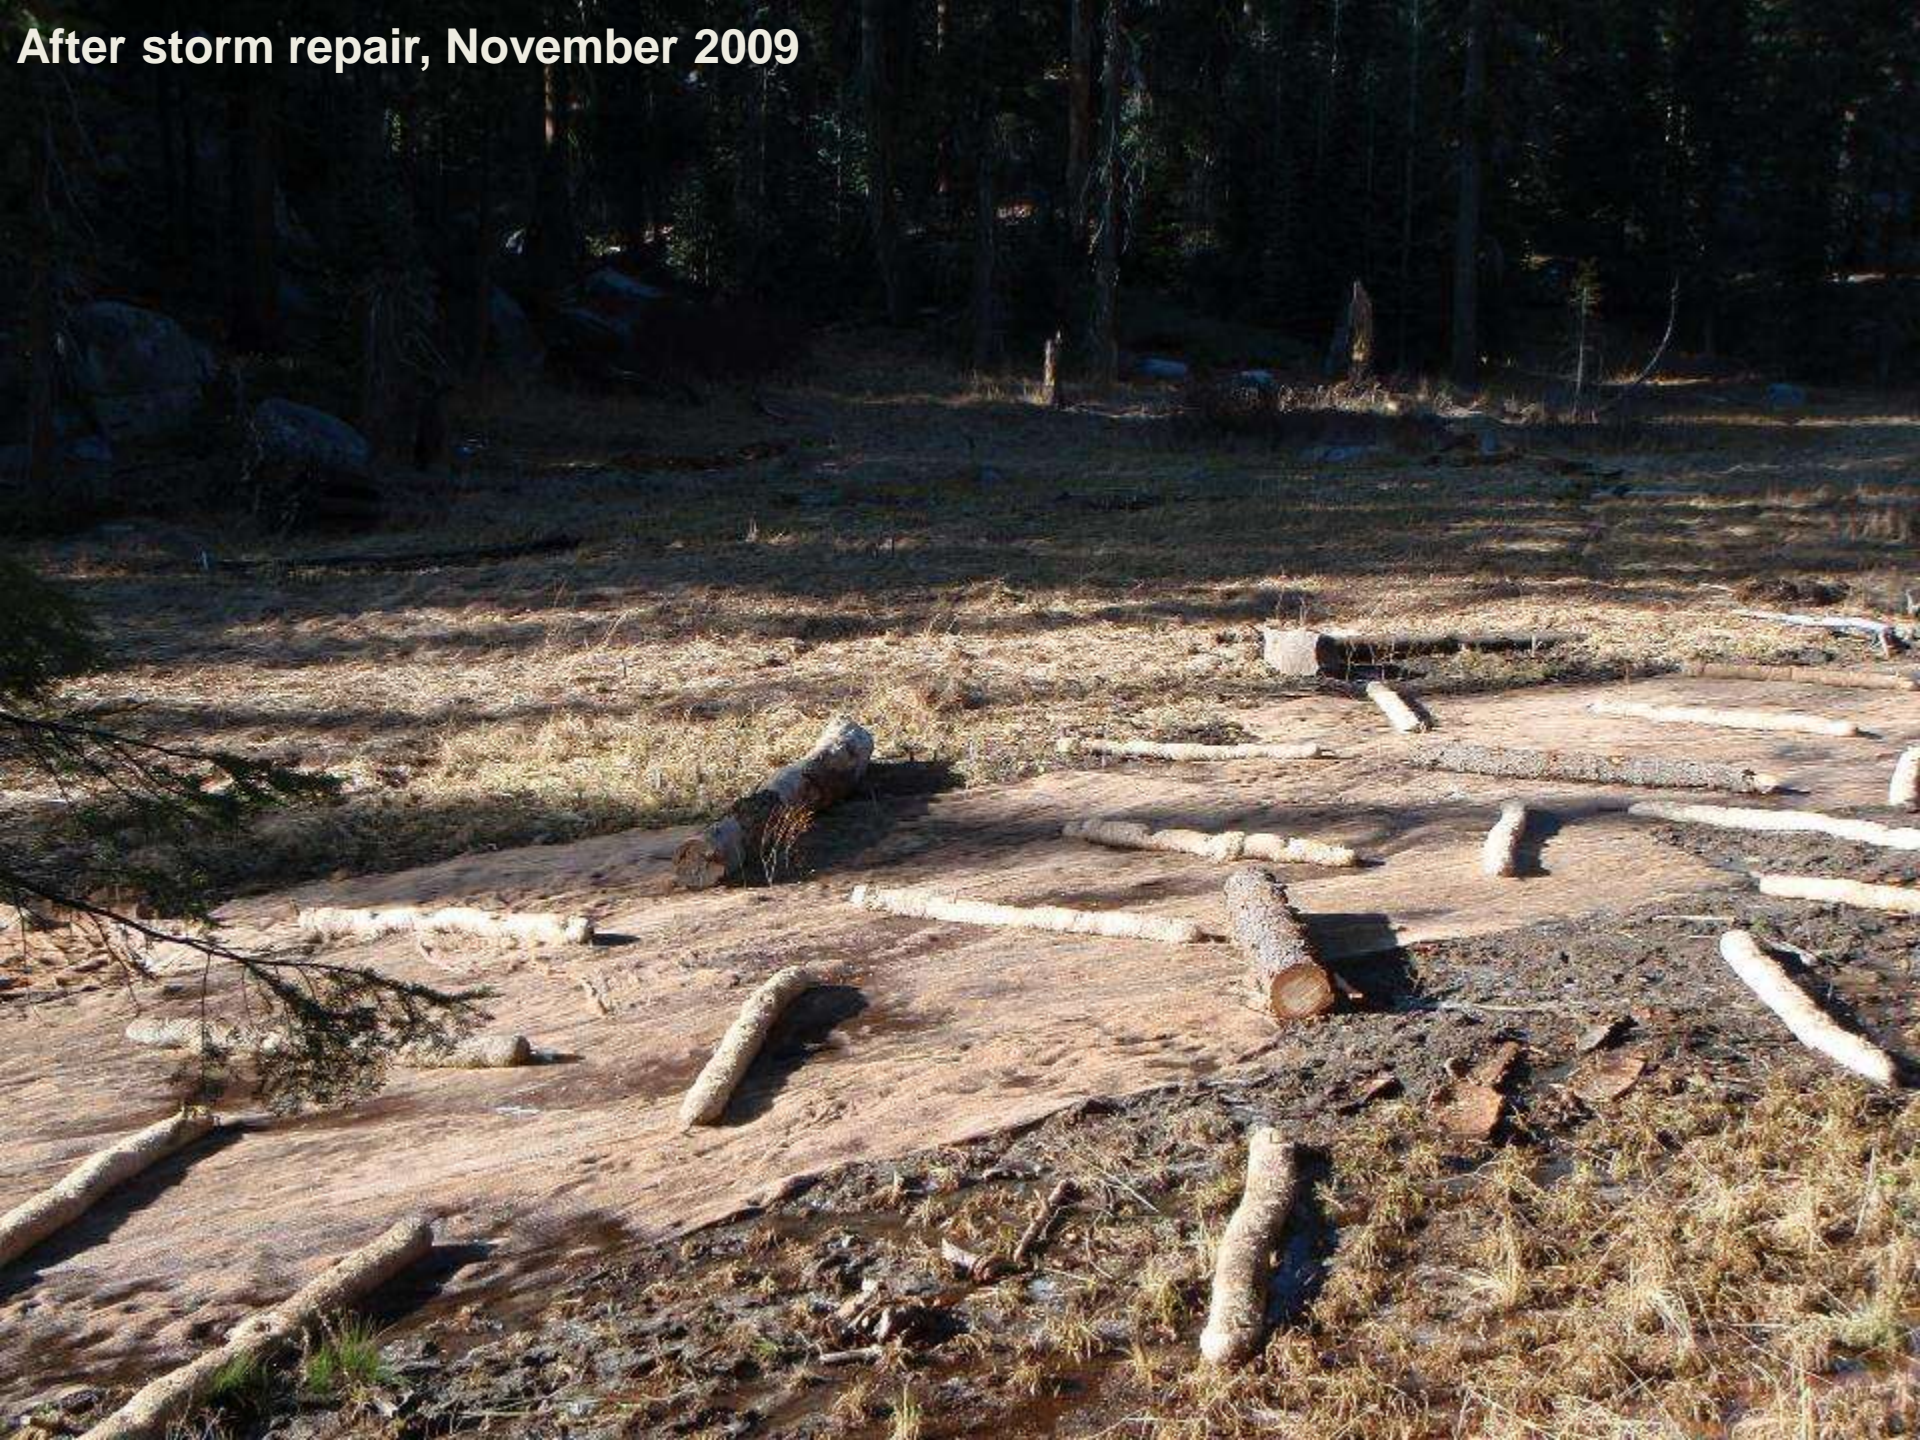
**After storm repair, November 2009**

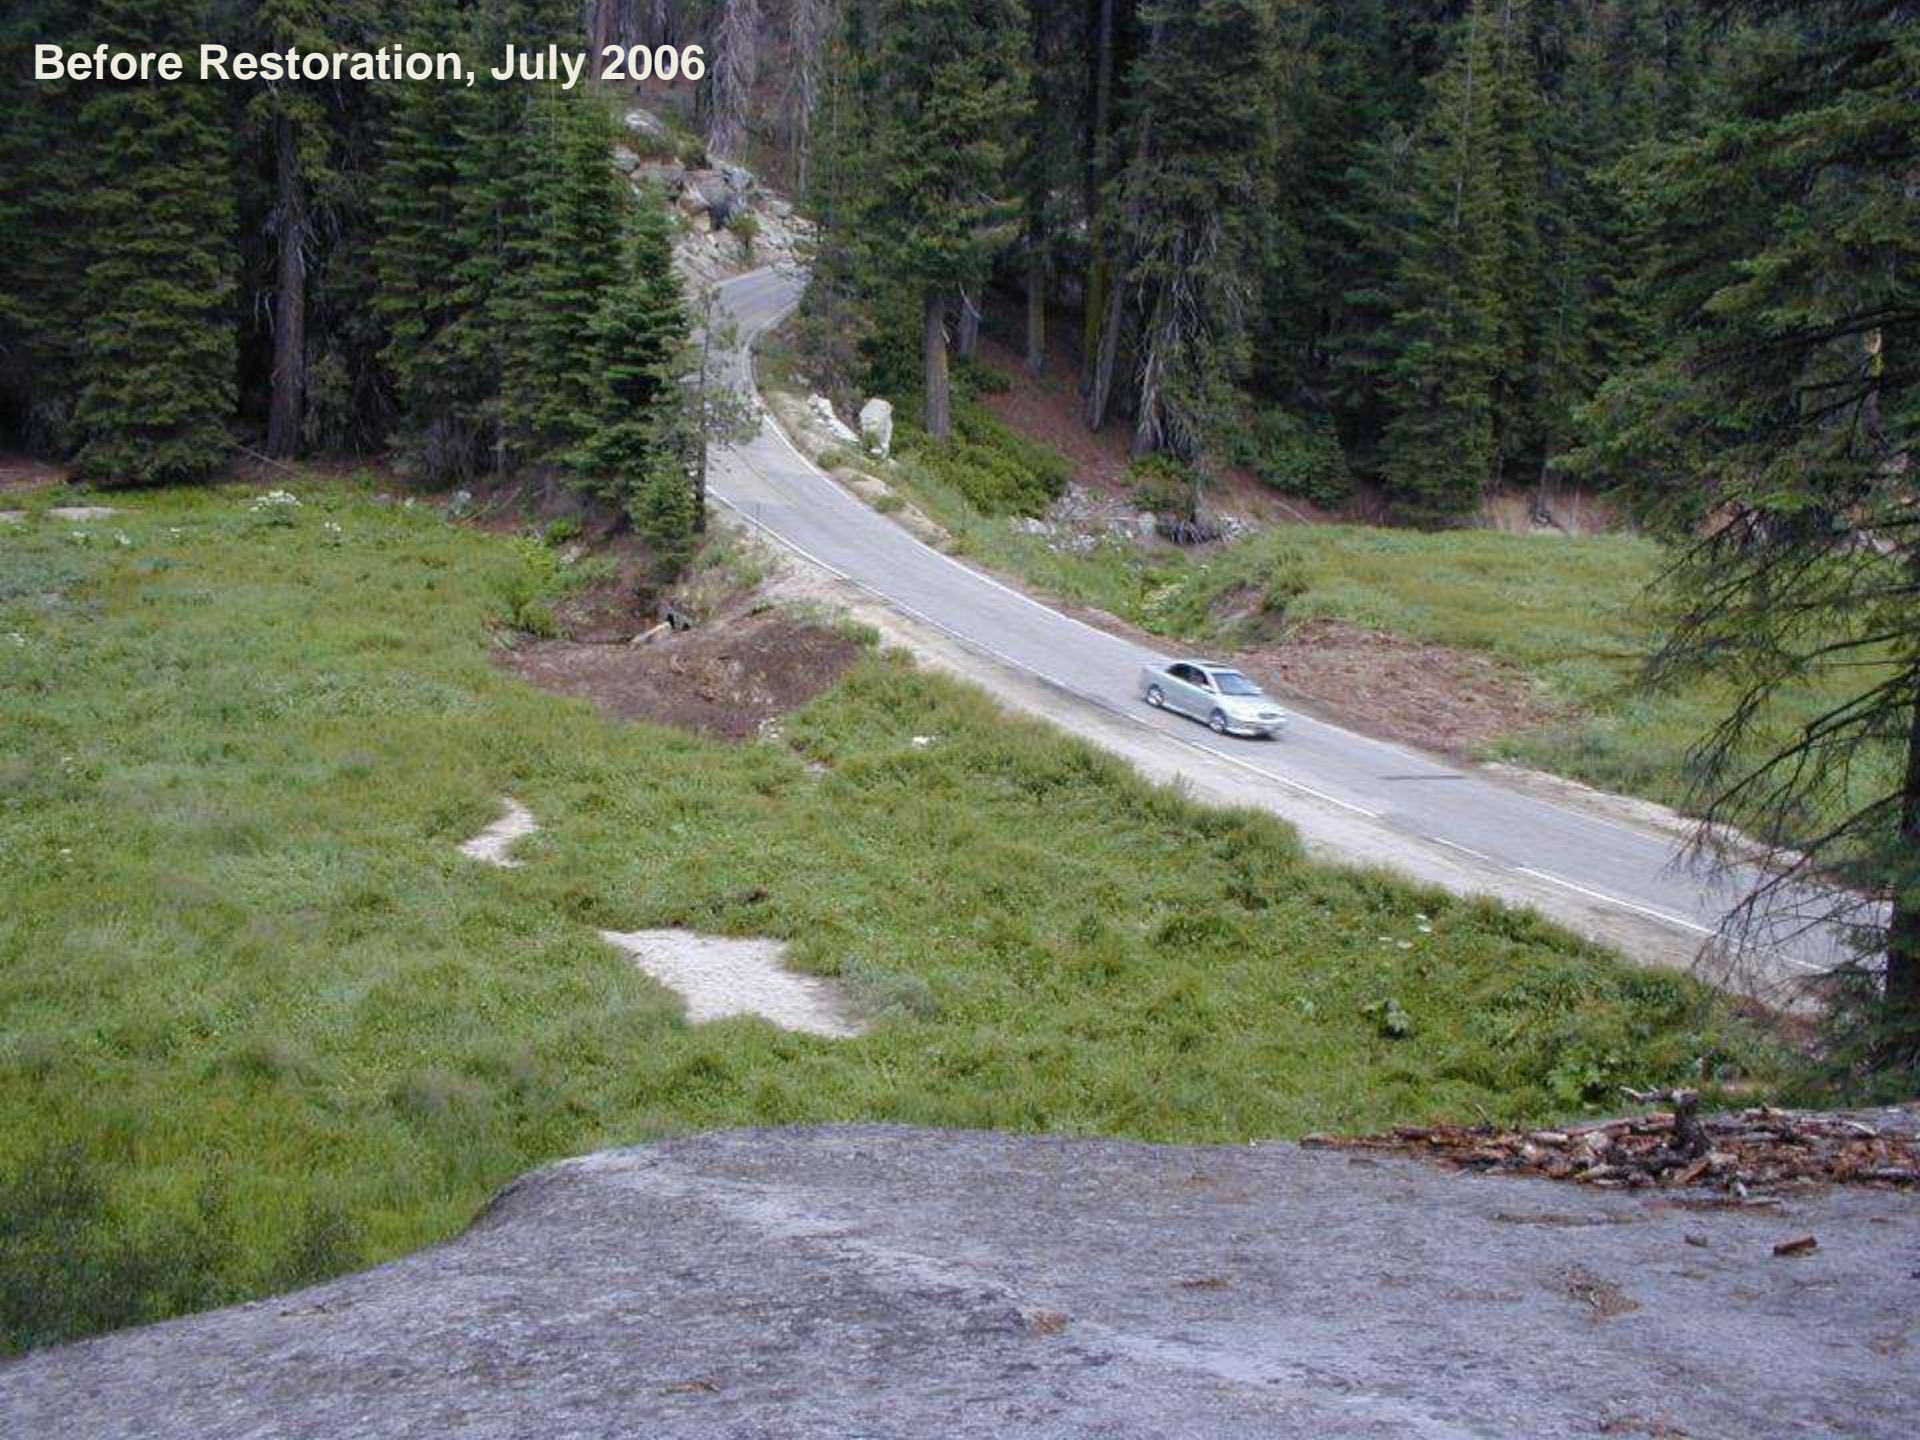
**Before Restoration, July 2006**

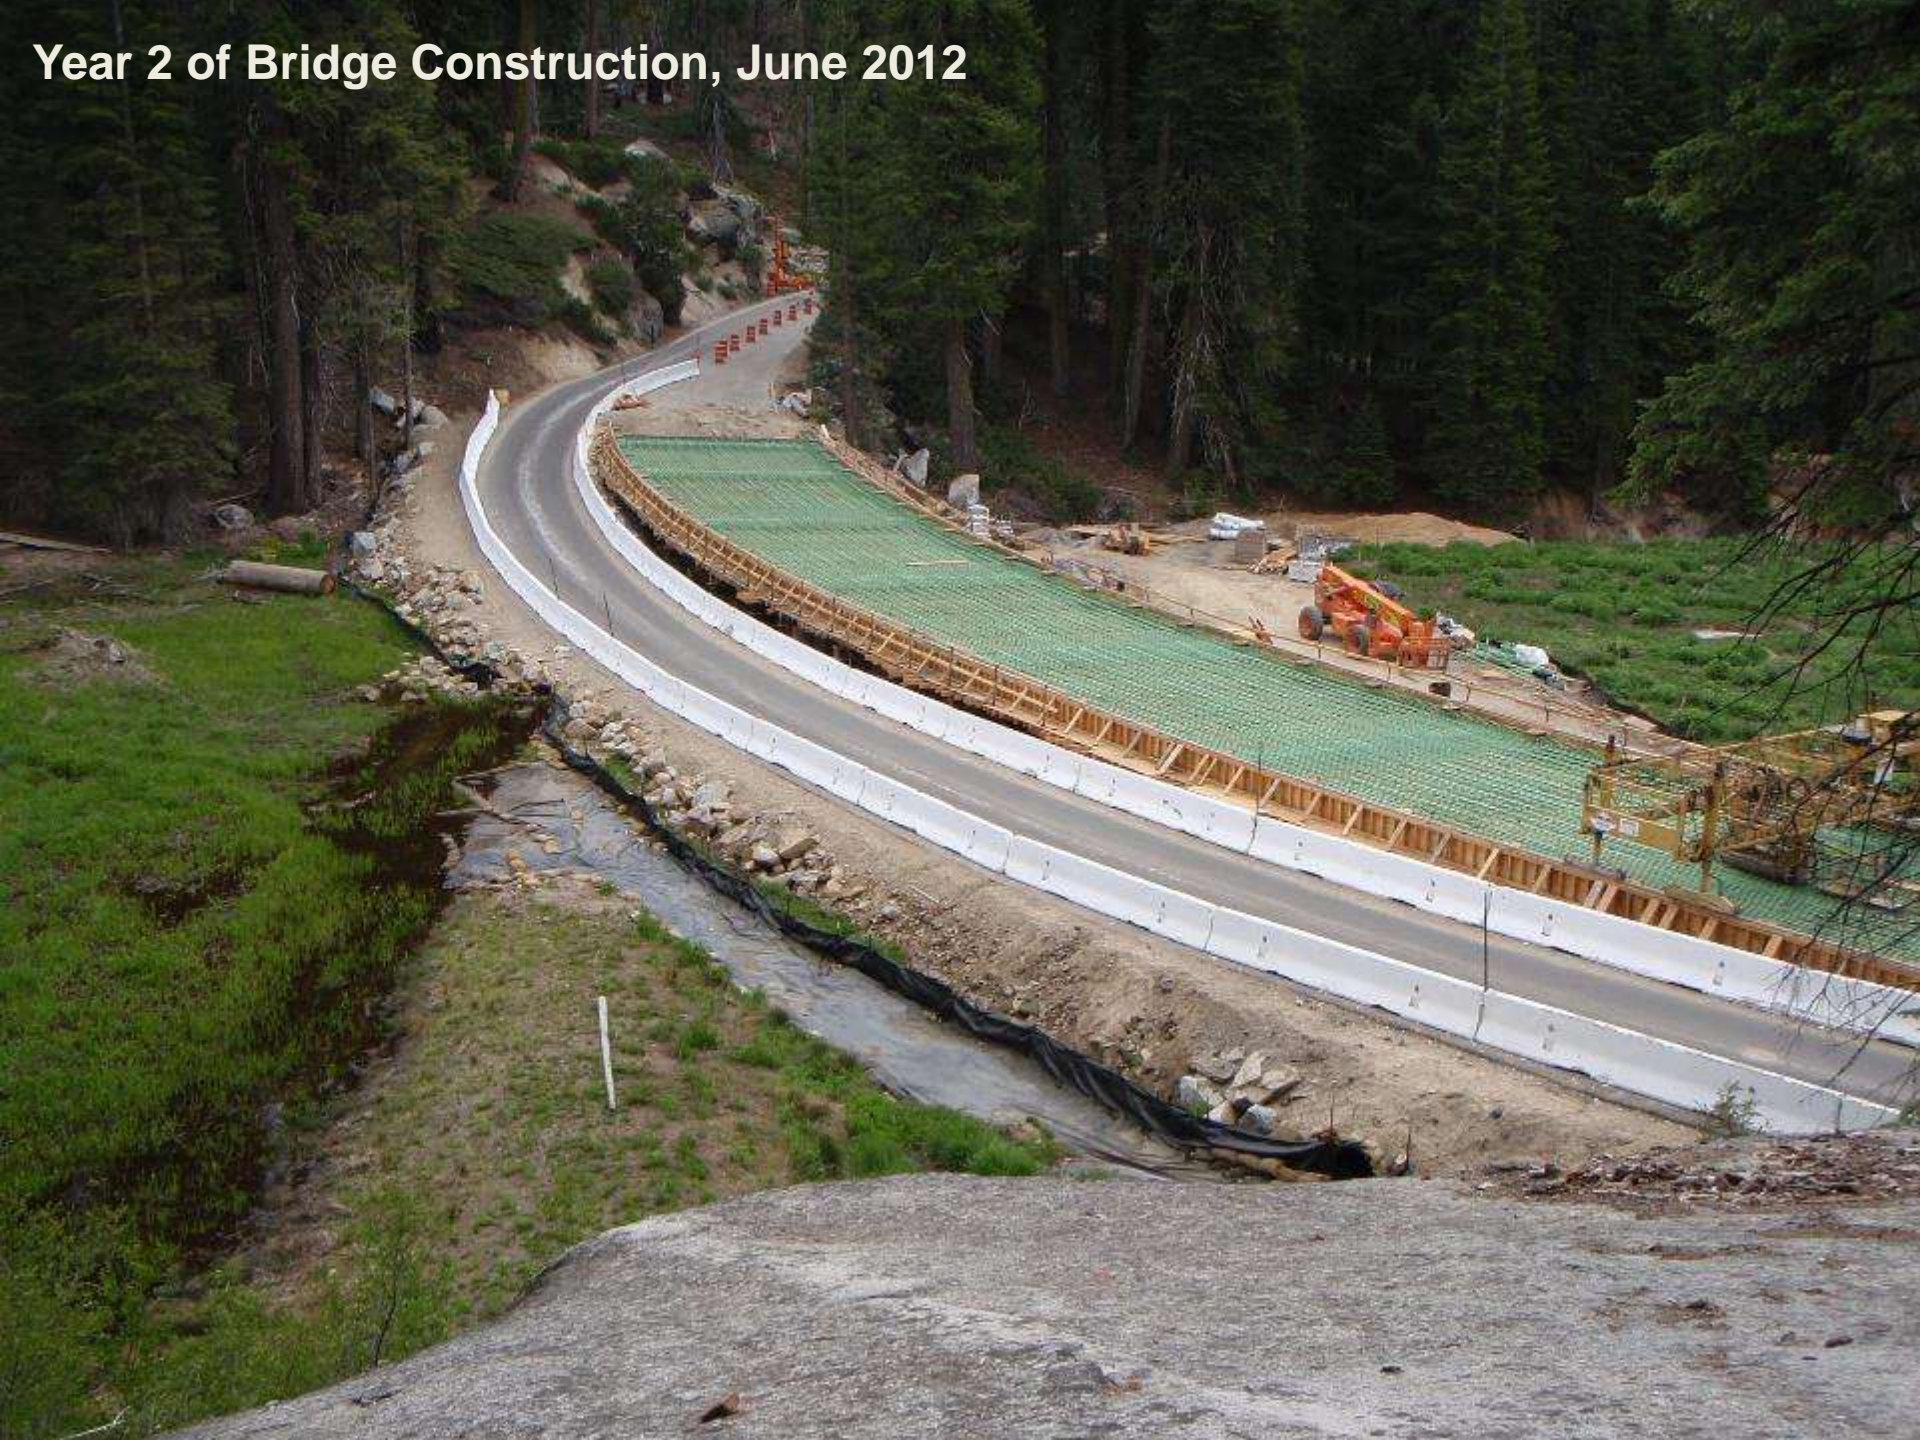
**Year 2 of Bridge Construction, June 2012**
