# Restoring Montane Wet Meadows in Sequoia and Kings Canyon National Parks

Athena Demetry, Restoration Ecologist  
Sequoia and Kings Canyon National Parks

# Halstead Meadow

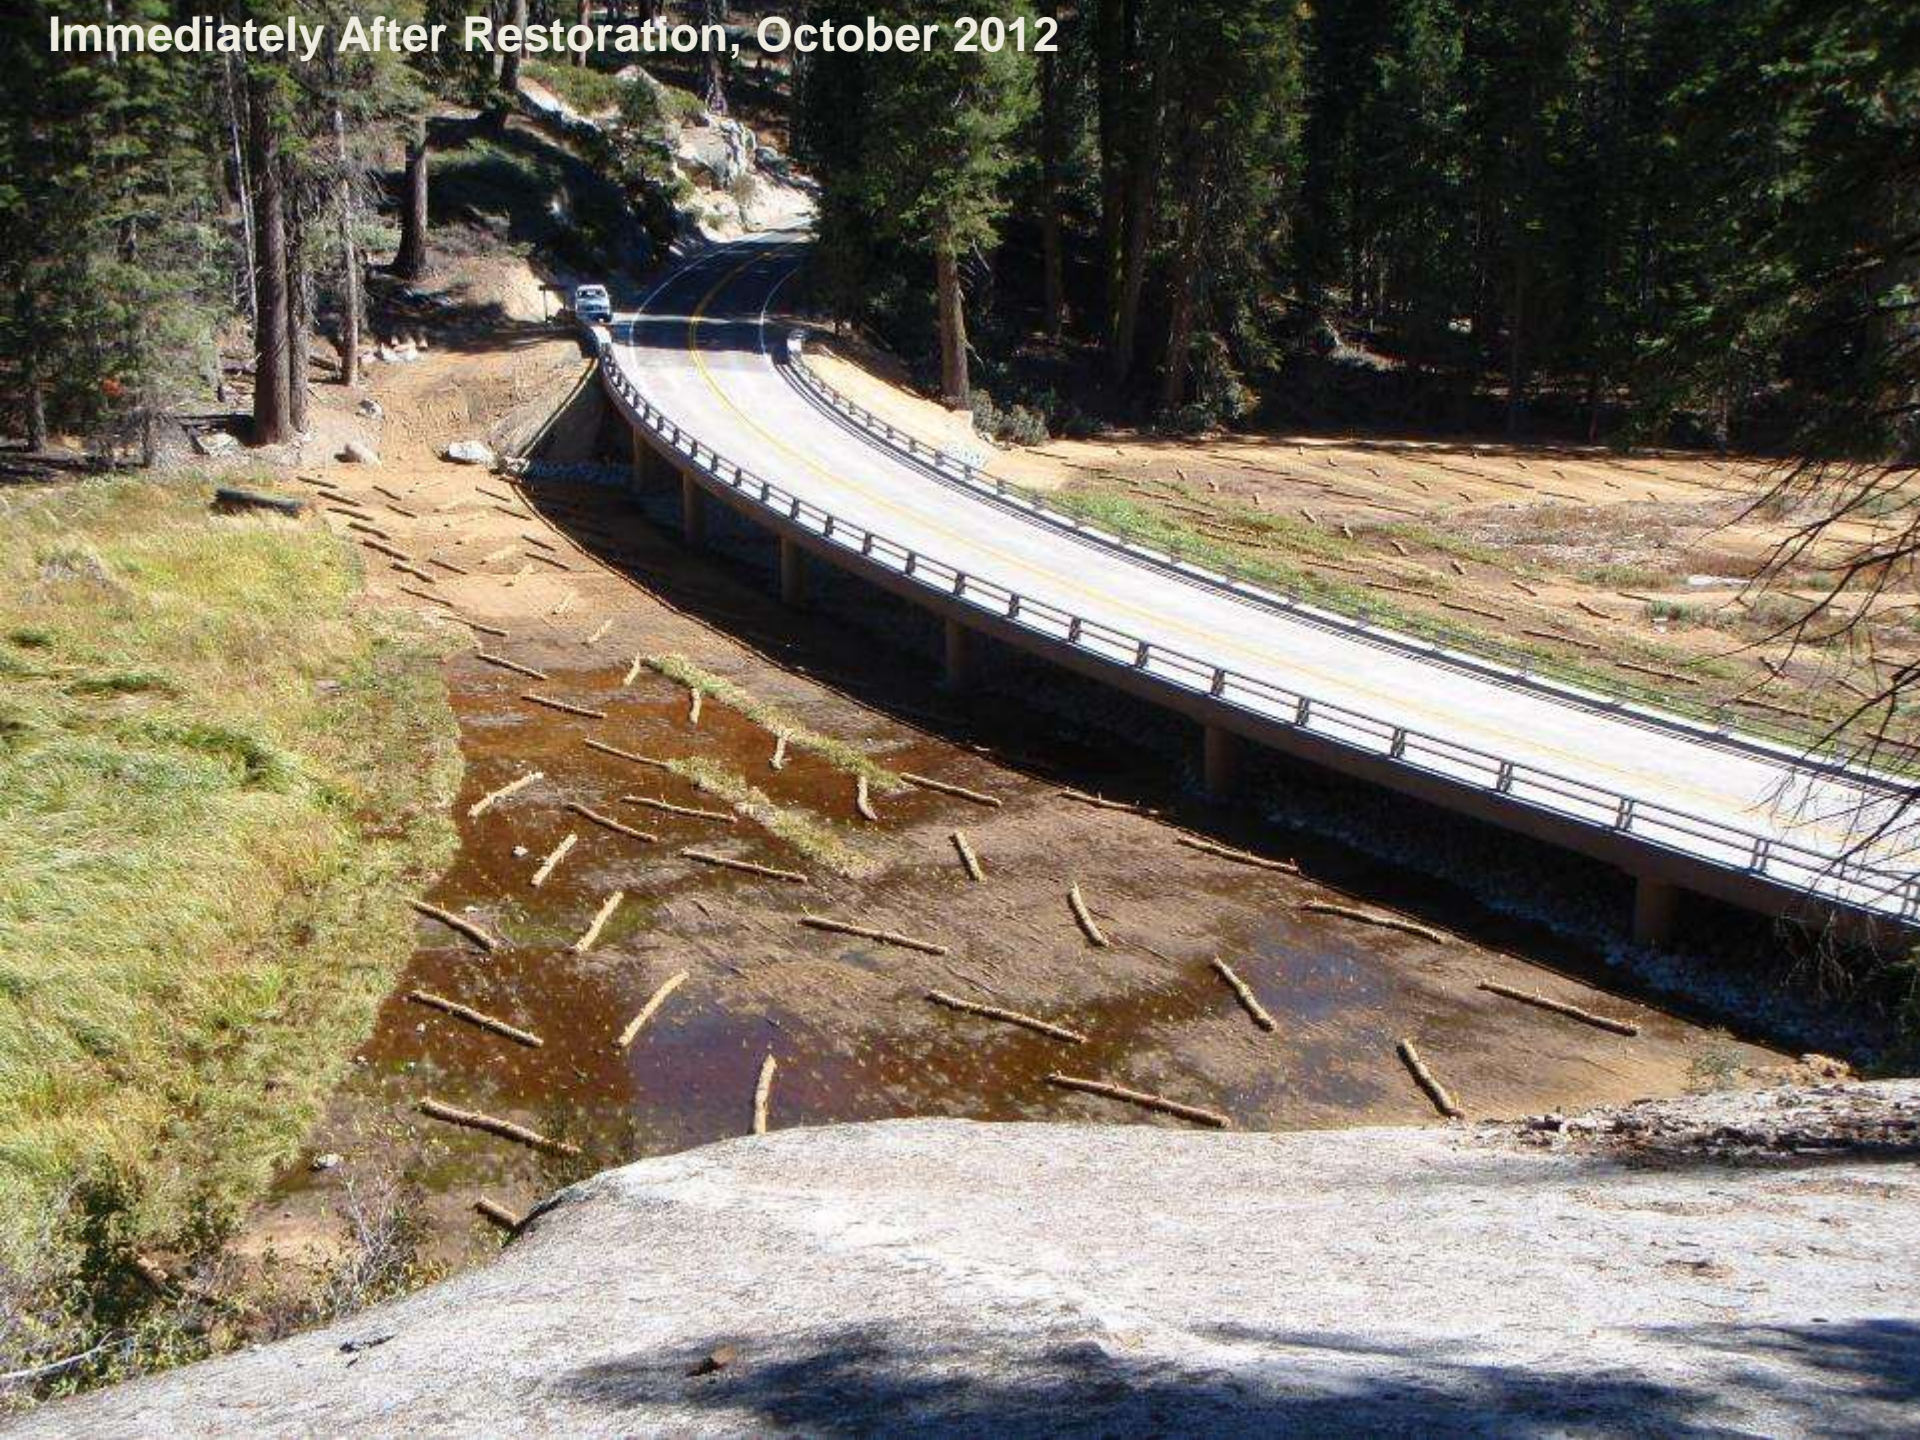
**Immediately After Restoration, October 2012**

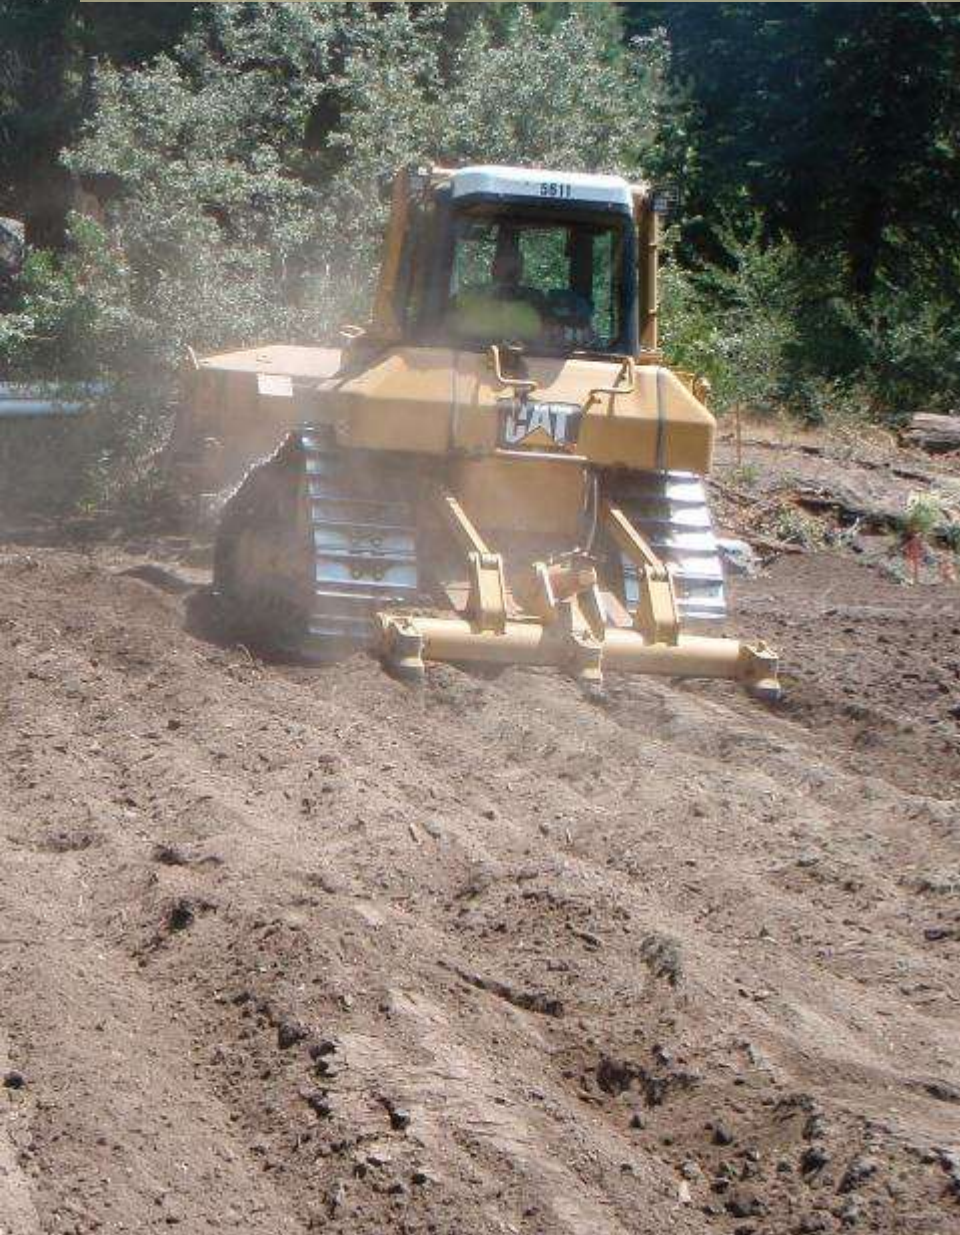
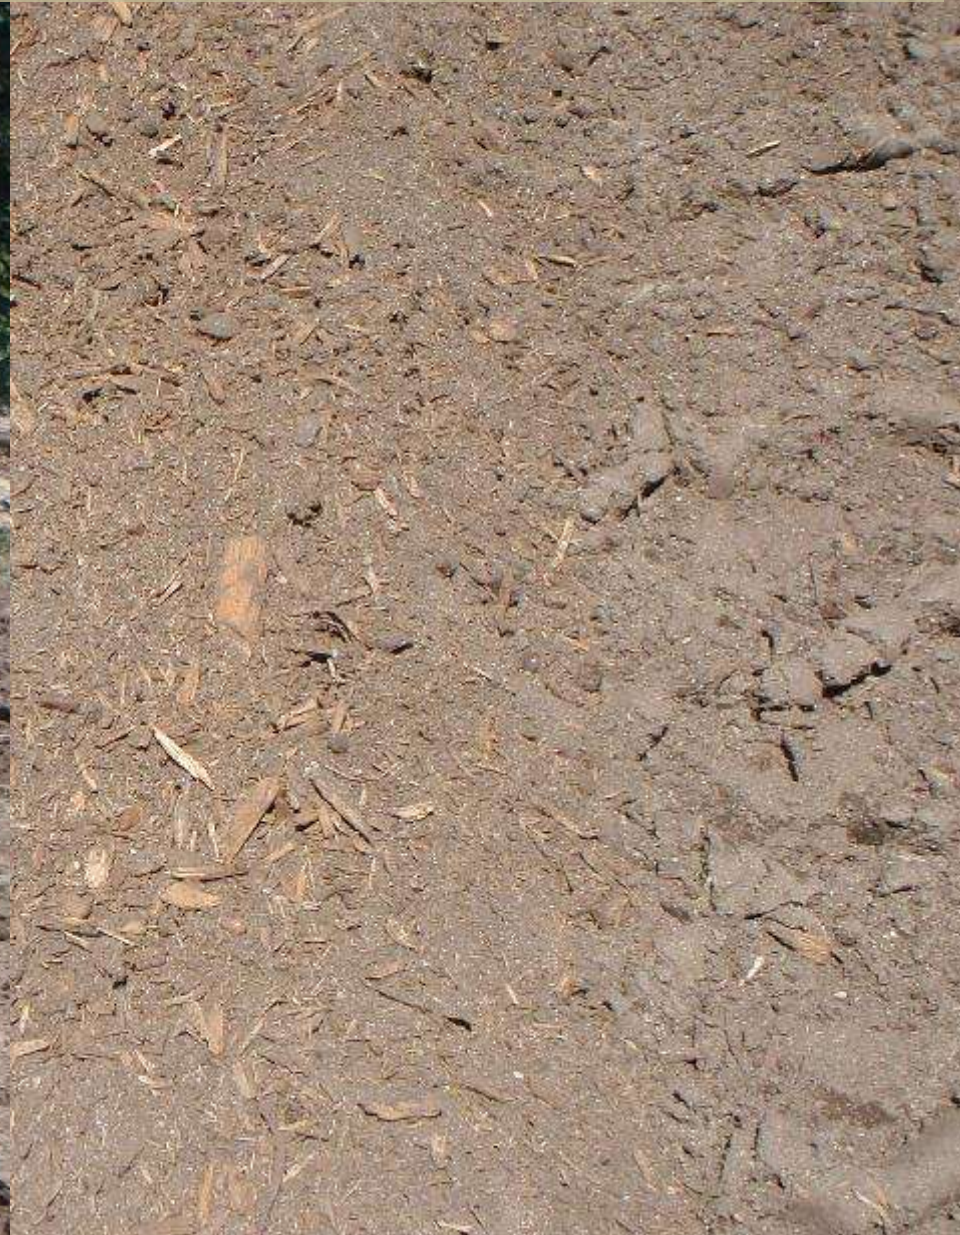
**Problem: Over-compaction of fill, slowed plant growth**  
**Solution: Ripped surface soil to loosen; incorporated wood chips**

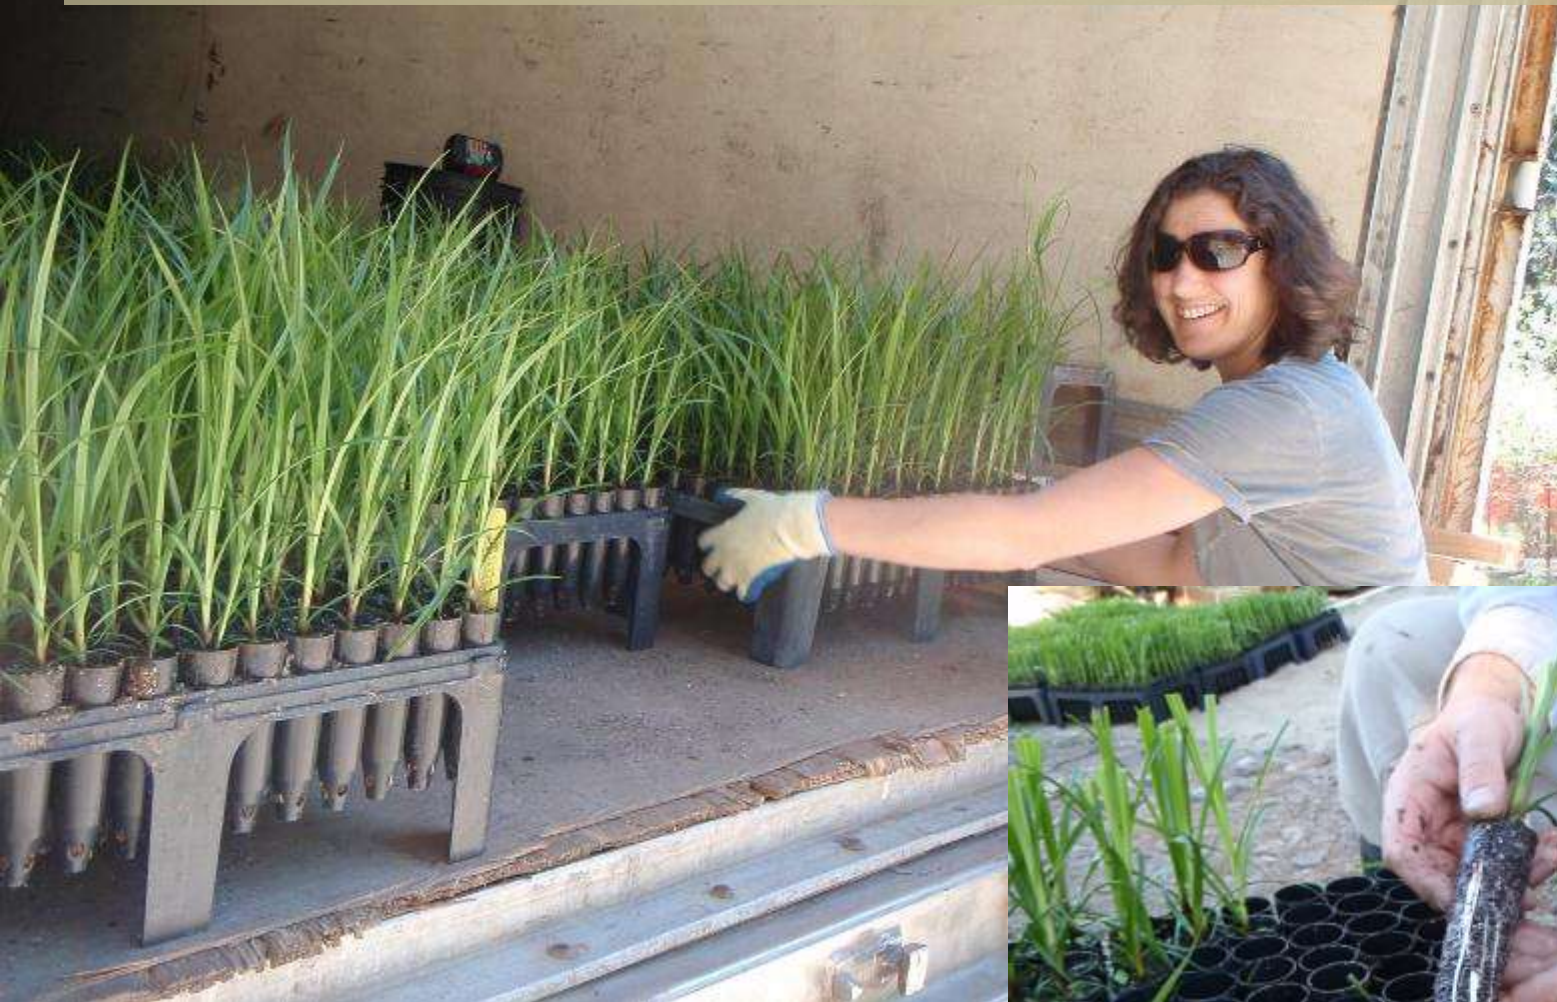
**Problem: Low-quality plants, slow spread**

**Solution: One plant per tube; larger plants rather than more plants**

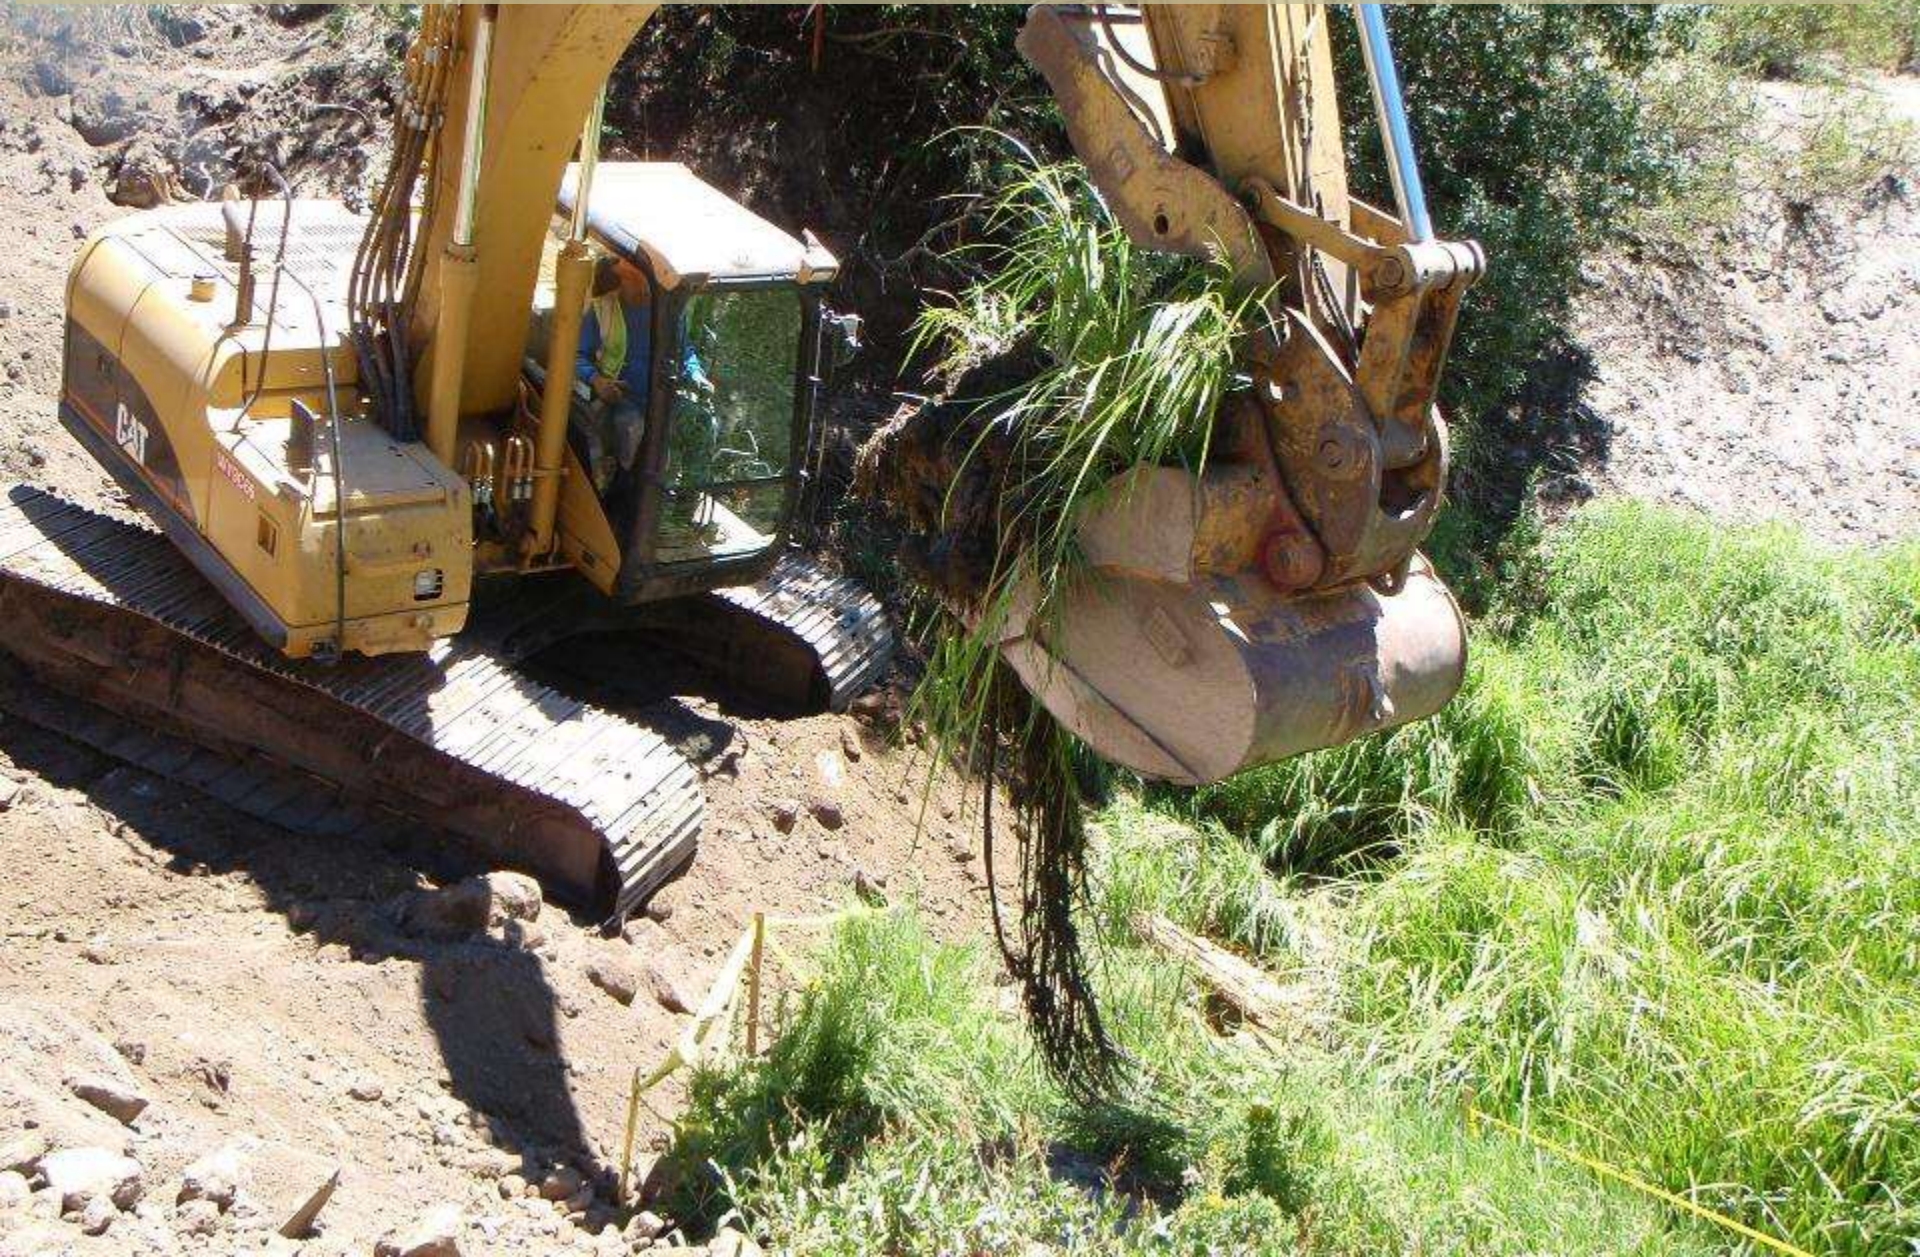
**Problem: Need faster plant cover in high-flow areas**

**Solution: Salvage high-quality sod from gully bottoms before filling...**

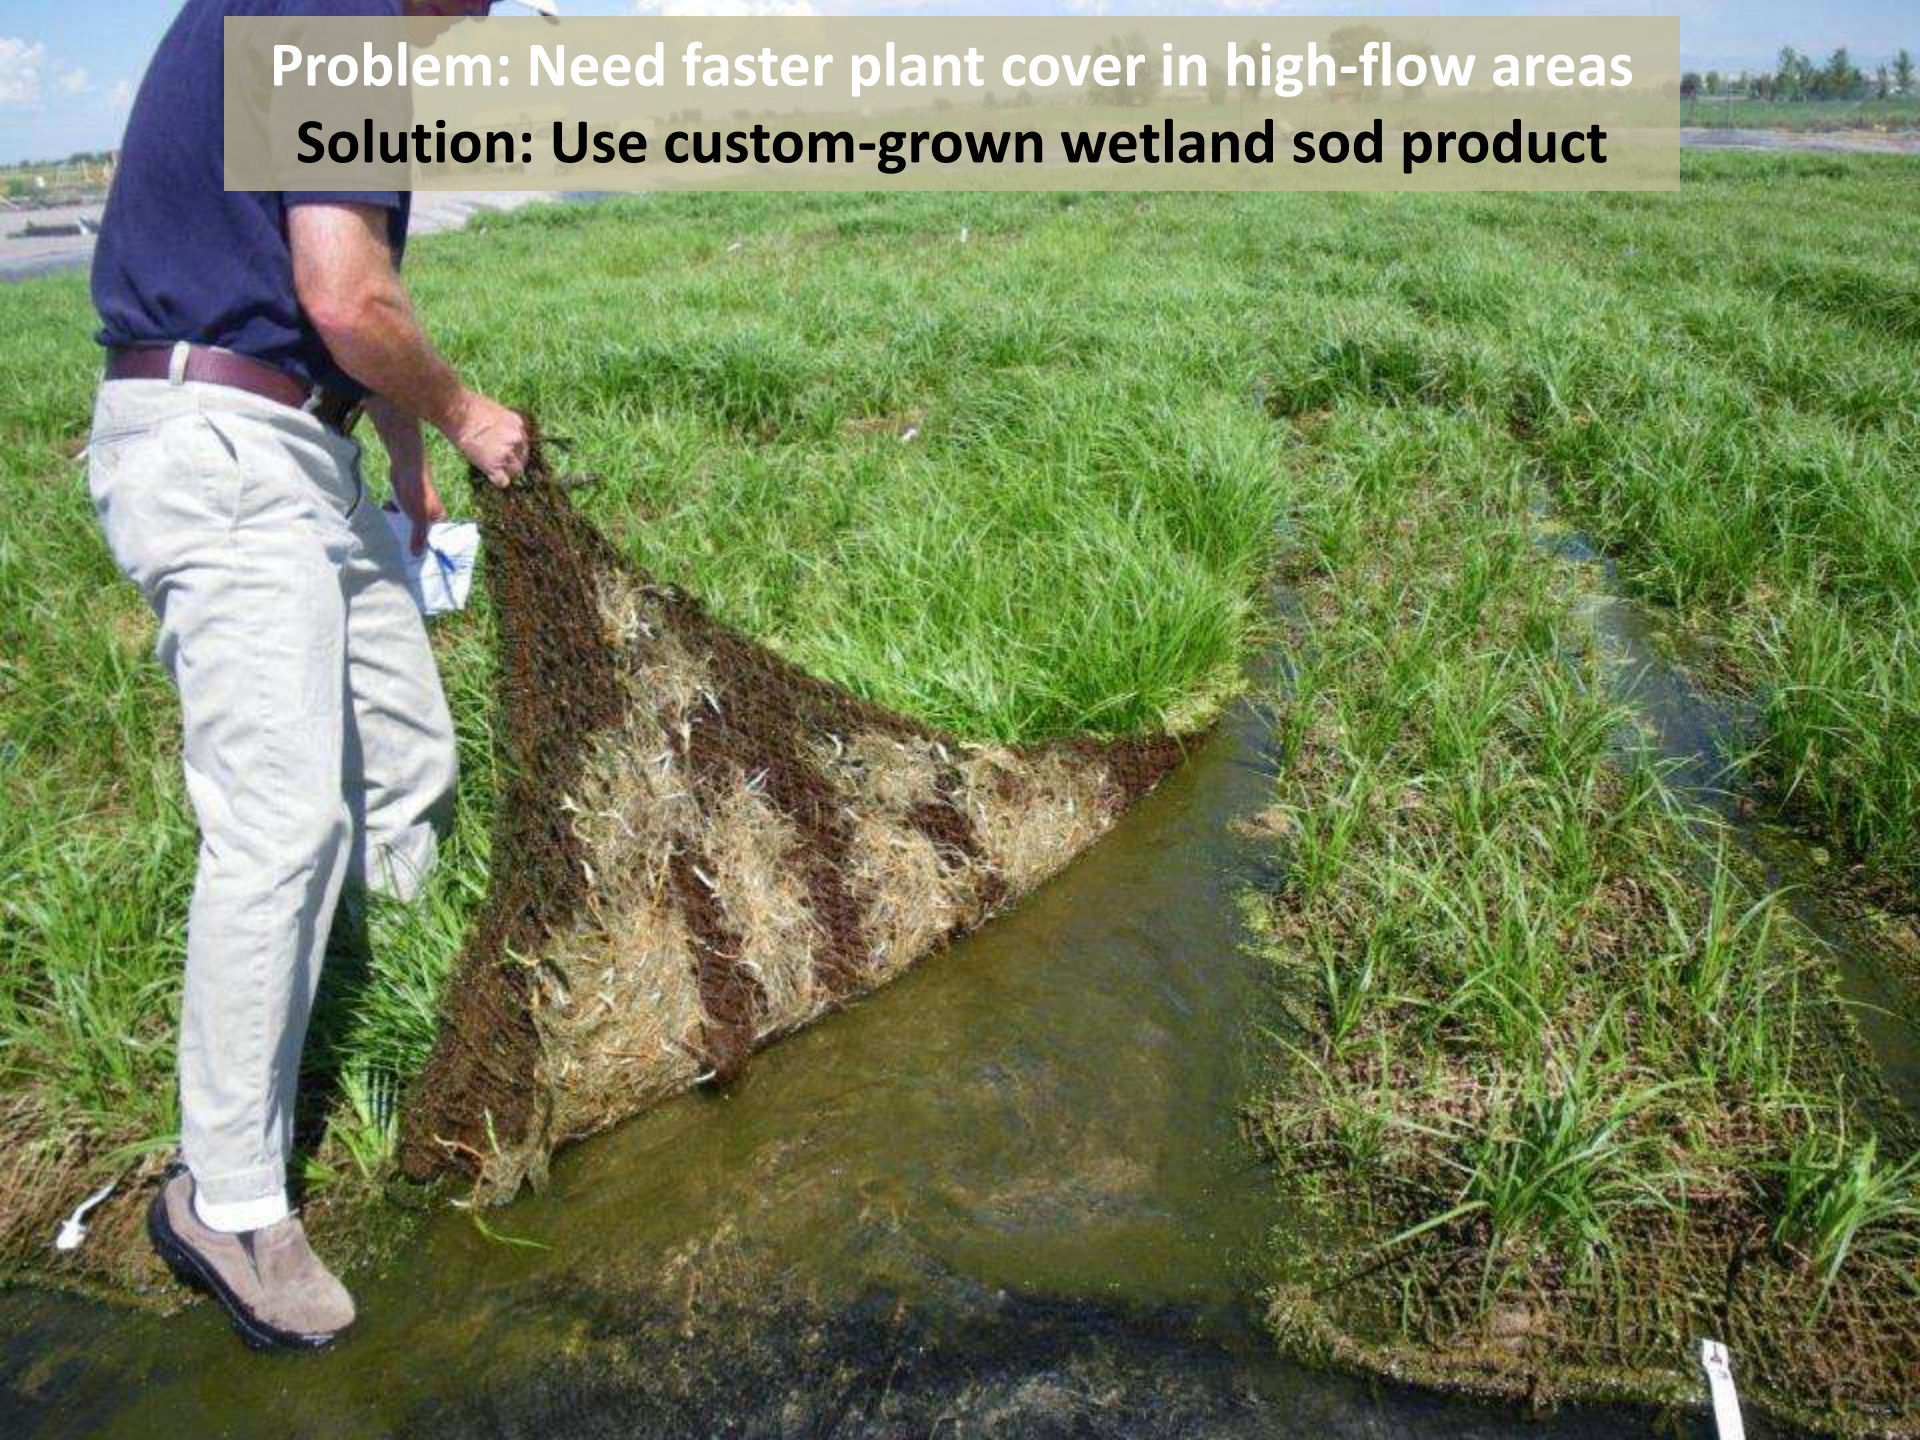
**Problem: Need faster plant cover in high-flow areas**  
**Solution: Use custom-grown wetland sod product**

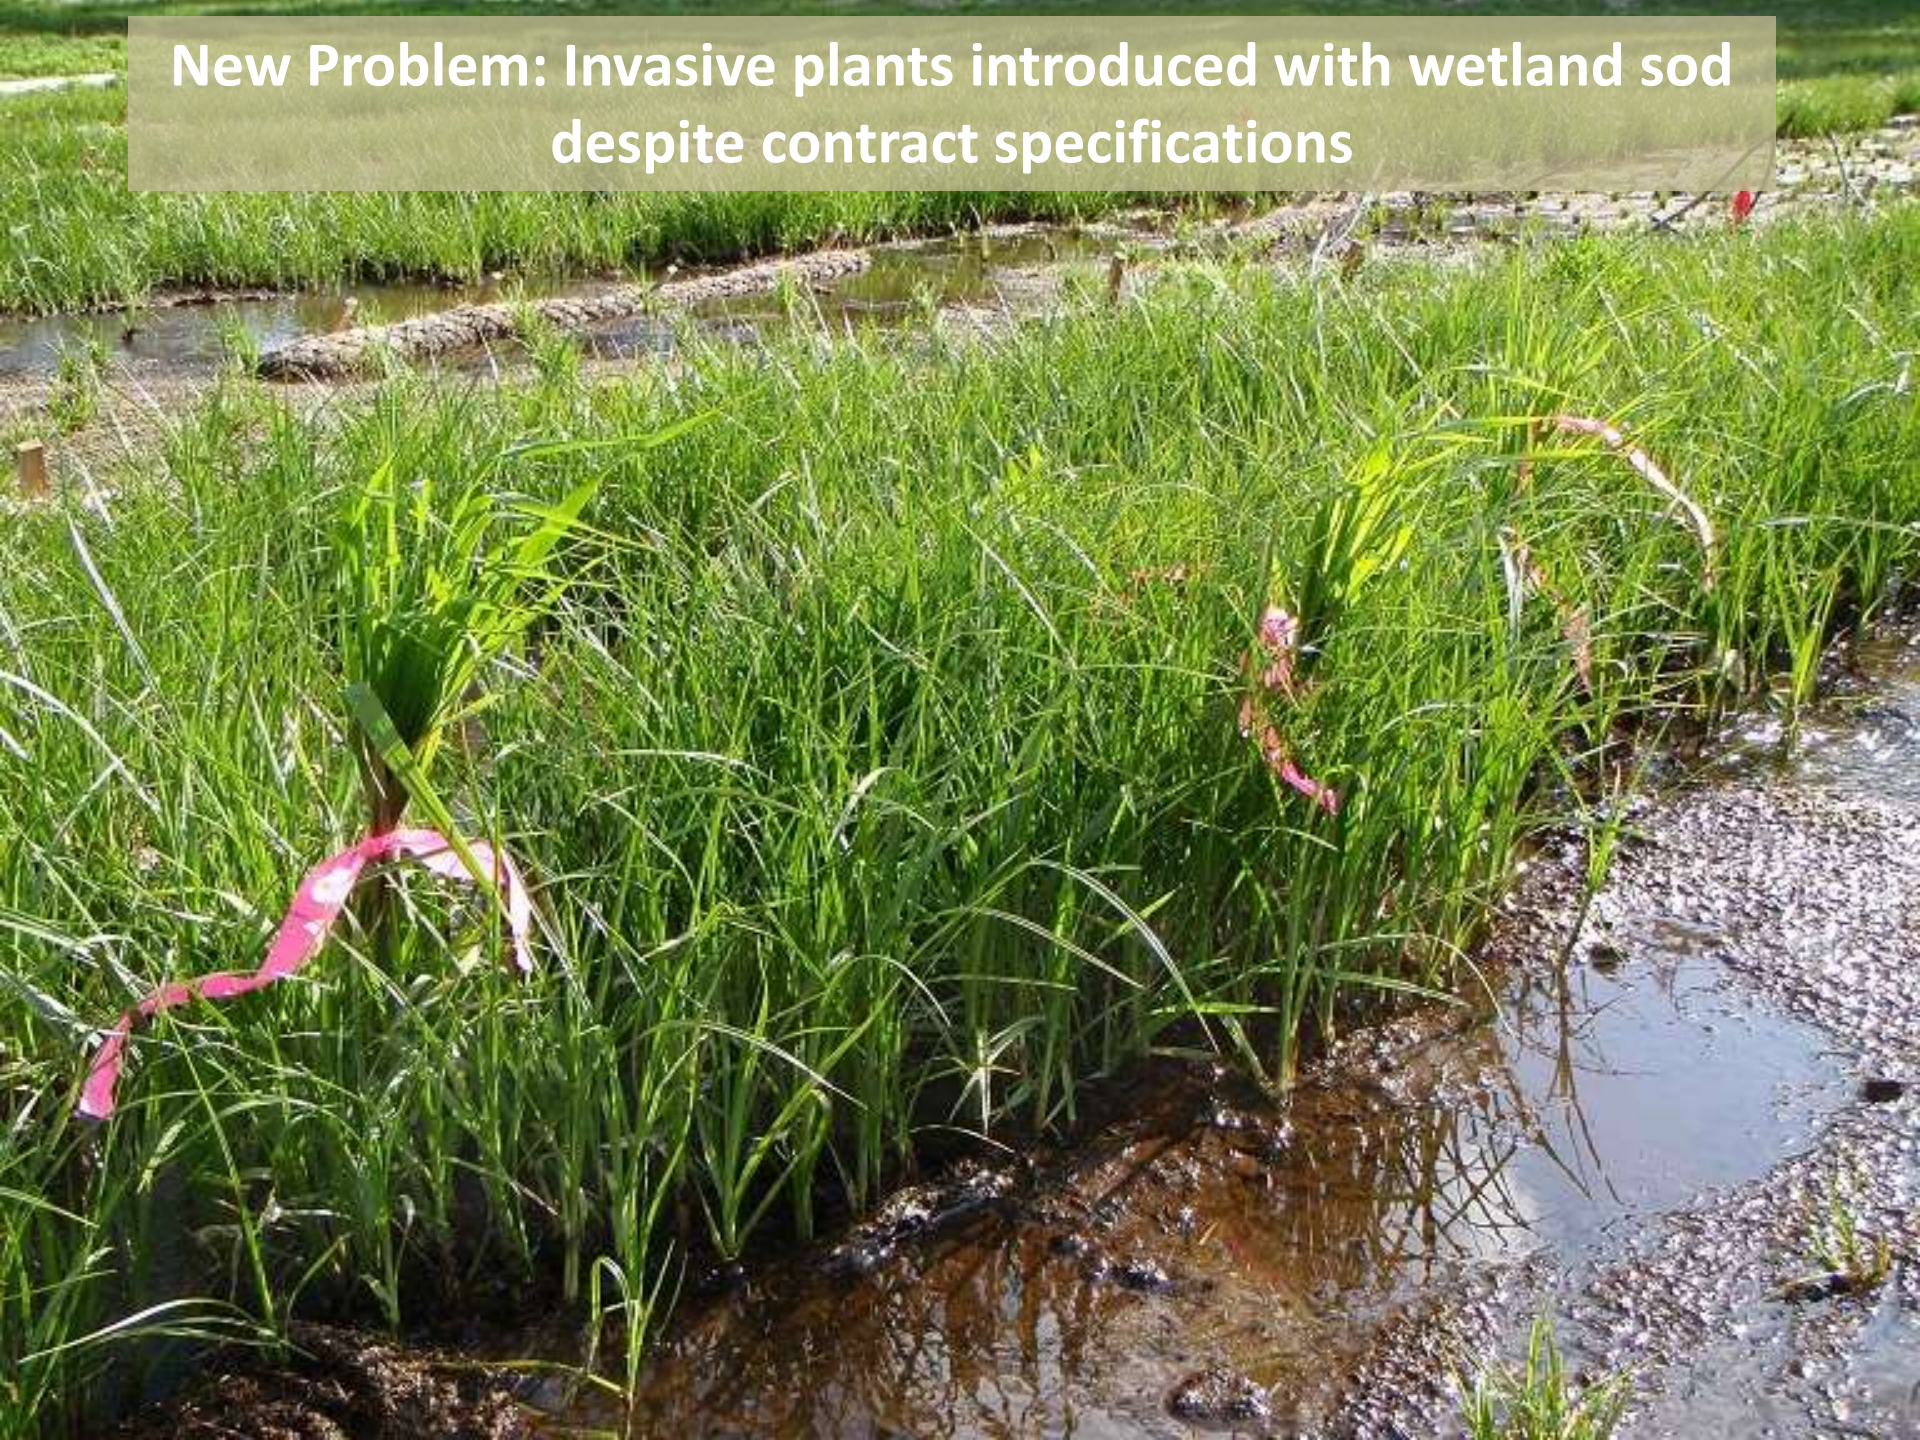
**New Problem: Invasive plants introduced with wetland sod despite contract specifications**

- Grown in open, artificial ponds in Idaho
- Planned for moderate risk of nonnative plant introduction (3 years survey/control funding).
- Actual risk was higher:
  - Sod held over one year longer than planned
  - Ditch water, not well water used
  - Created a SEED BANK in coir matting

**MAKE DETAILED INQUIRY INTO GROWING PRACTICES**
