Utilizing Differential Quantitative Mapping Technologies and Traditional Botanical Knowledge to Assist Brazilian waterweed Management in the Sacramento-San Joaquin Delta:

An Example from Frank's Tract

• Scott A. Ruch, ReMetrix LLC Berkeley, CA

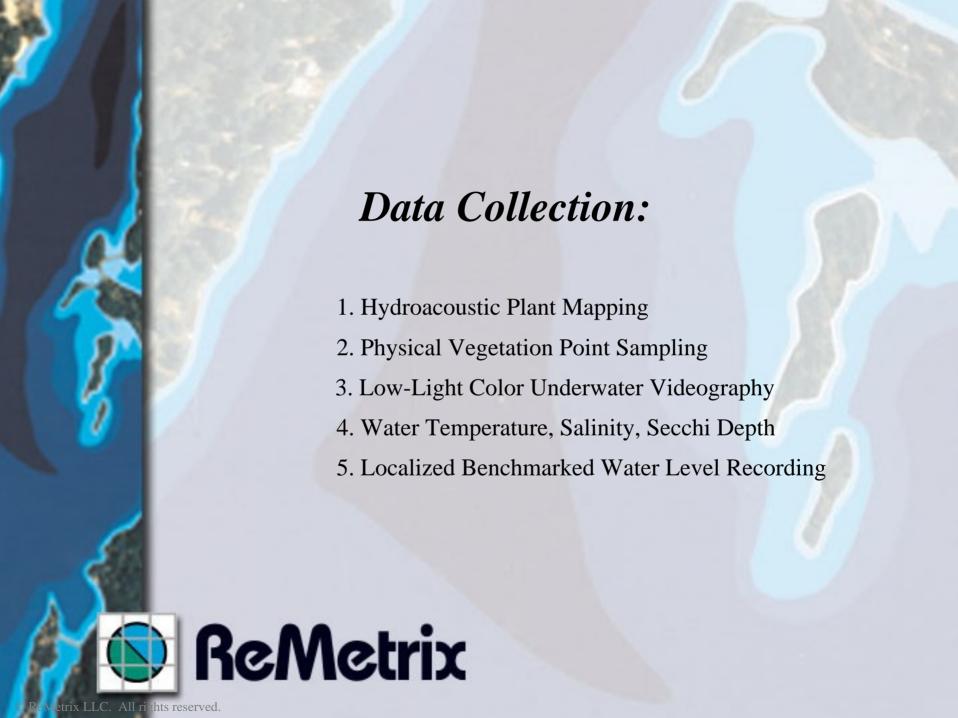
Study Area 2003 - 2005: 18 Observed Treatment and 6 Control Sites

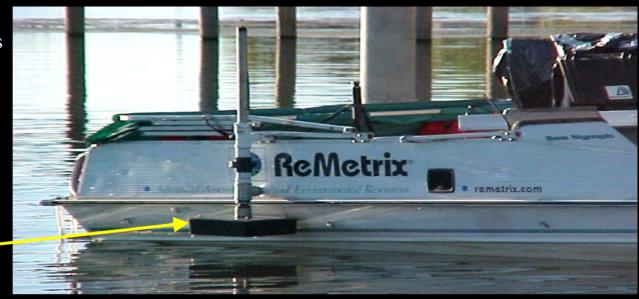
The Leaky-Boat Pioneering Years

transducer

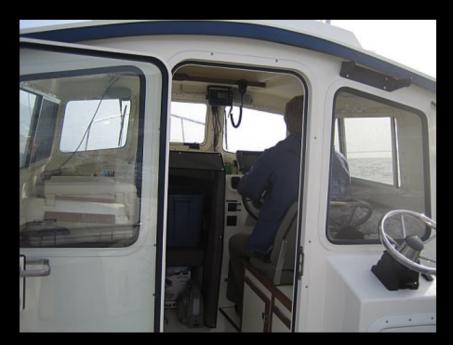
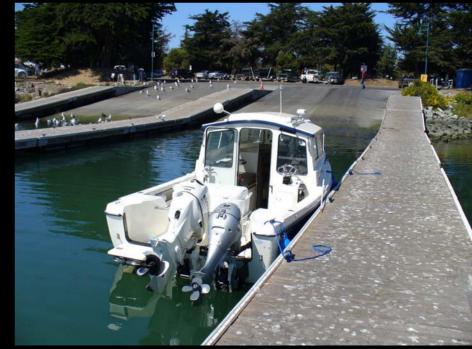
The Efficient, Integrated Present

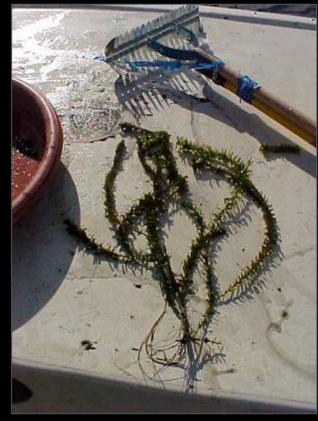
DGPS Point Sampling Technique
