Central Valley *Arundo*: Distribution, Impacts, and Management

March 2020

Final Report to the
State of California
Wildlife Conservation Board
Agreement WC-1561MM

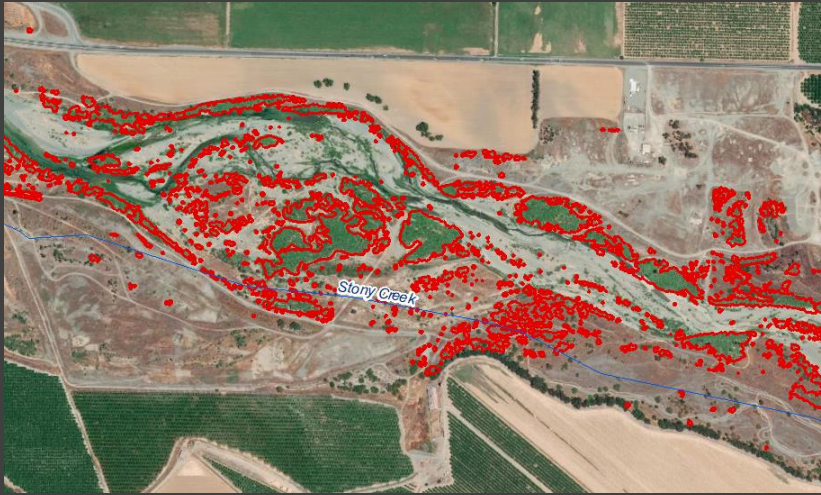
Top: *Arundo* distribution mapping from Cal-IPC dataset.

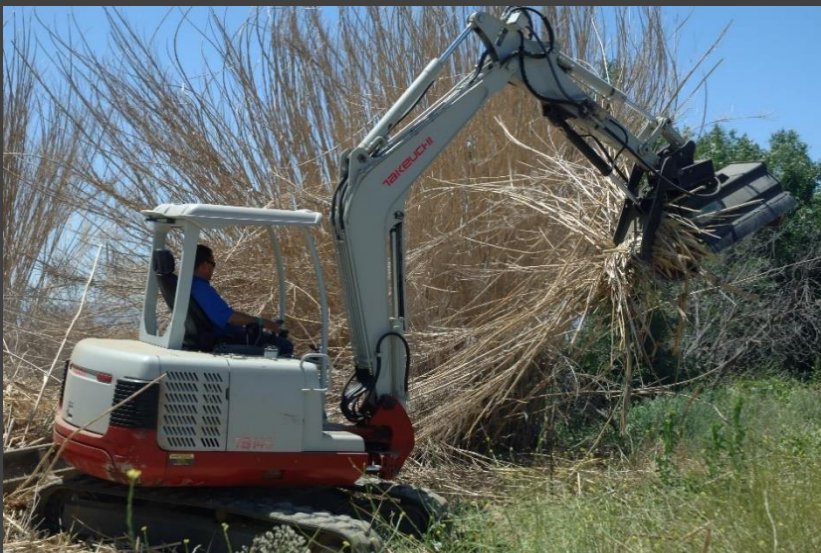
Middle: *Arundo* controlled as part of management by the California Dept of Water Resources. Photo: Paul Hames, DWR. 2009.
