Restoring coastal grassland on deeply scraped soils in Monterey County, CA

Andrea Woolfolk, Mary Paul, and Bill Fortner
Elkhorn Slough National Estuarine Research Reserve

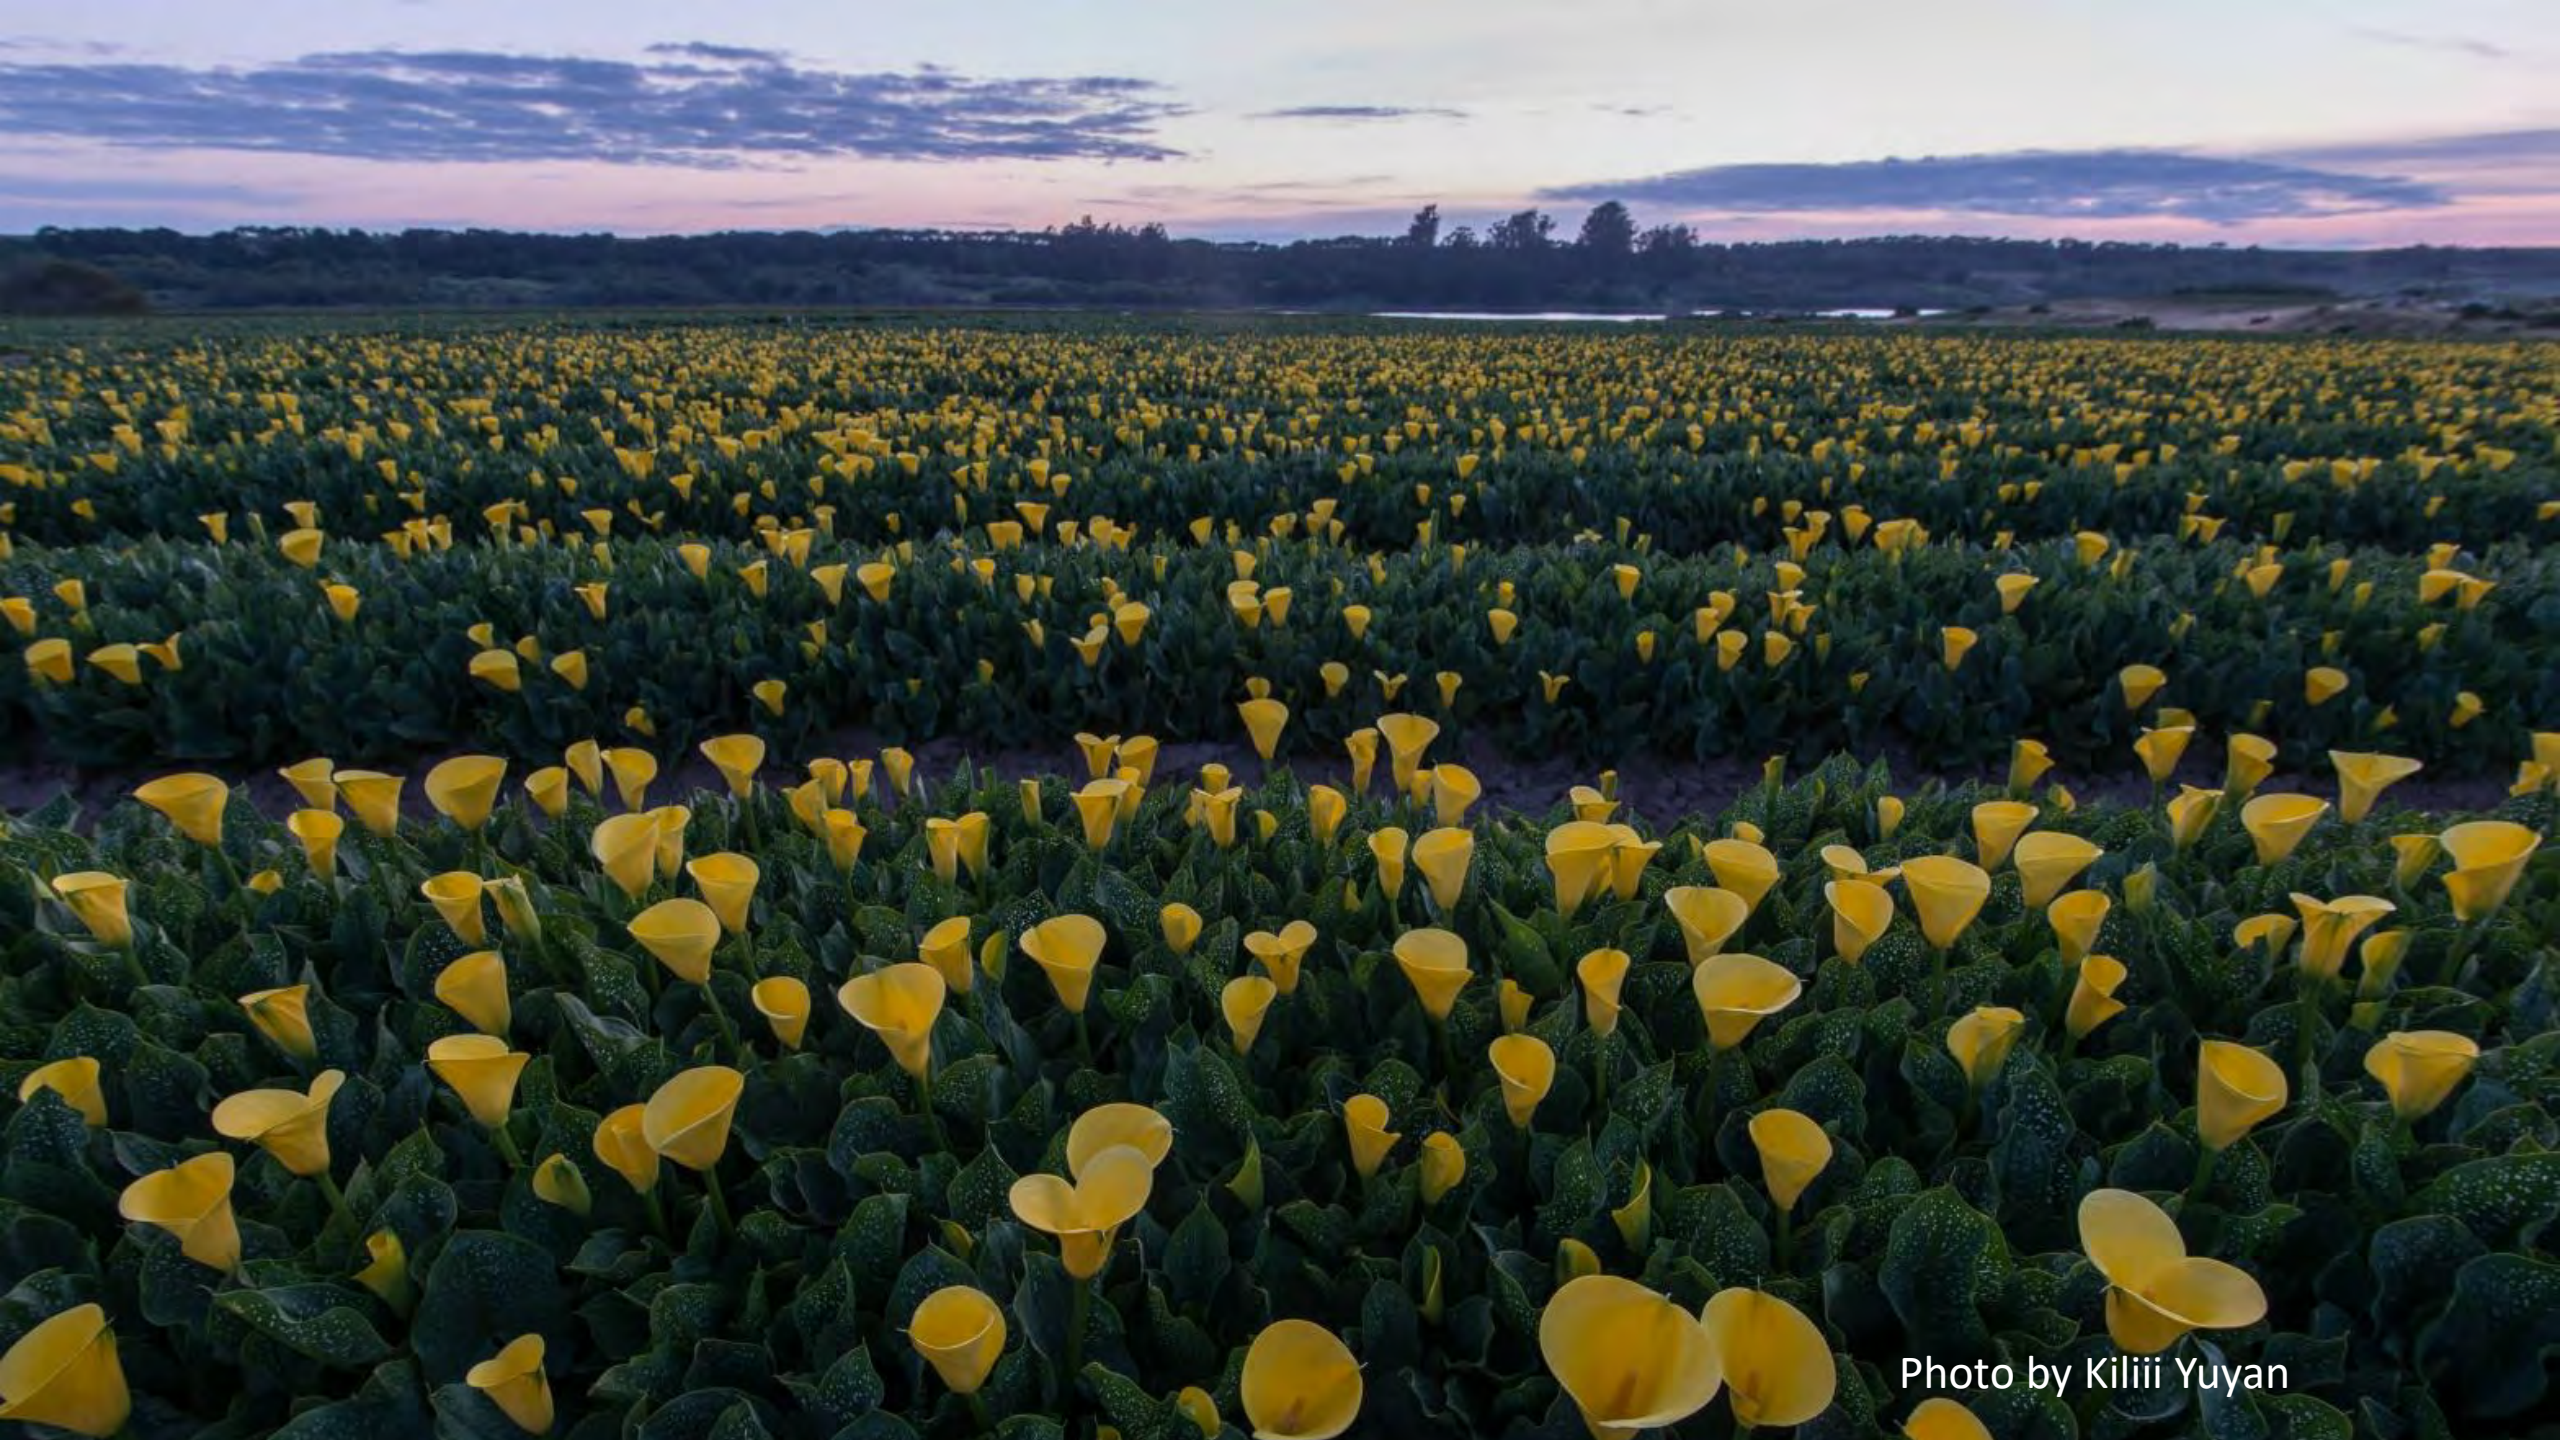
A wide-angle photograph of a former salt marsh at Hester, now converted into a mudflat. The foreground is dominated by a muddy, cracked surface with scattered clumps of green grass and patches of yellowish-green algae. Several weathered wooden posts are stuck in the mud. In the middle ground, a line of taller, reddish-brown grasses separates the mudflat from a grassy hill. The background features a dense line of evergreen trees under a grey, overcast sky. The overall scene depicts a landscape that has been significantly altered by human intervention.

Former salt marsh at Hester:
converted to mudflat after diking and draining

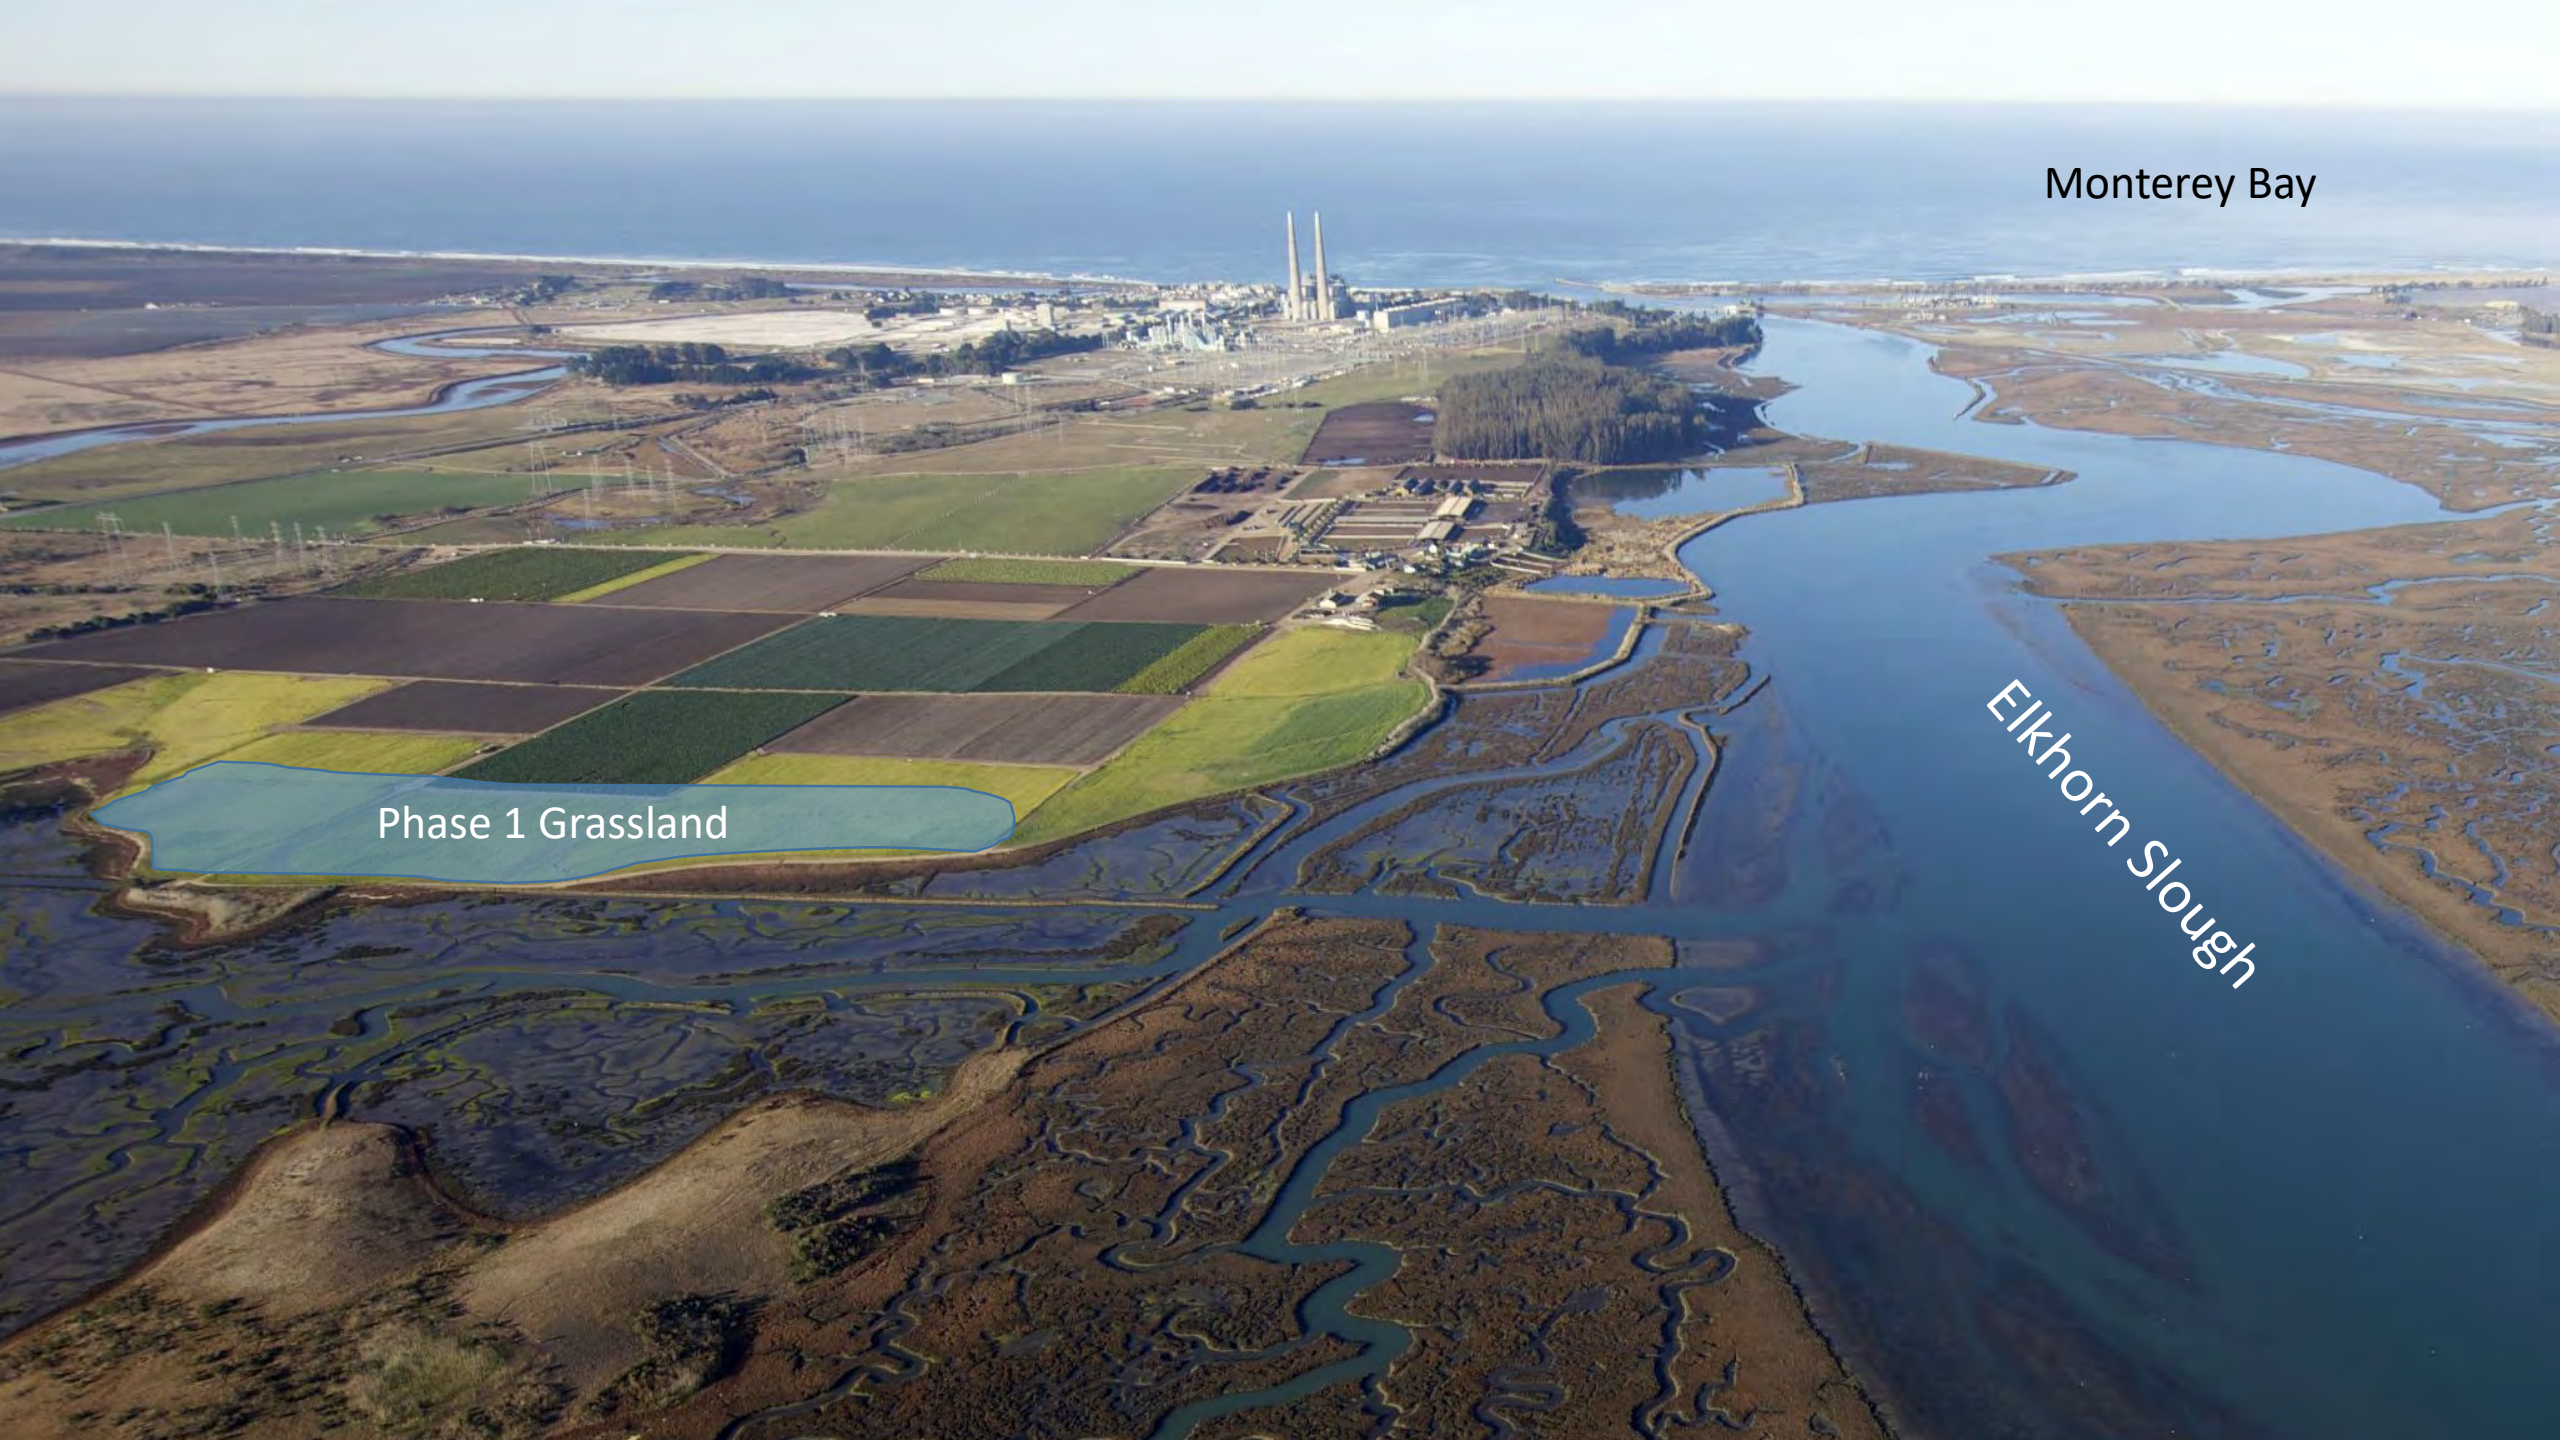
Phase 1 Area, 2018: Five acres

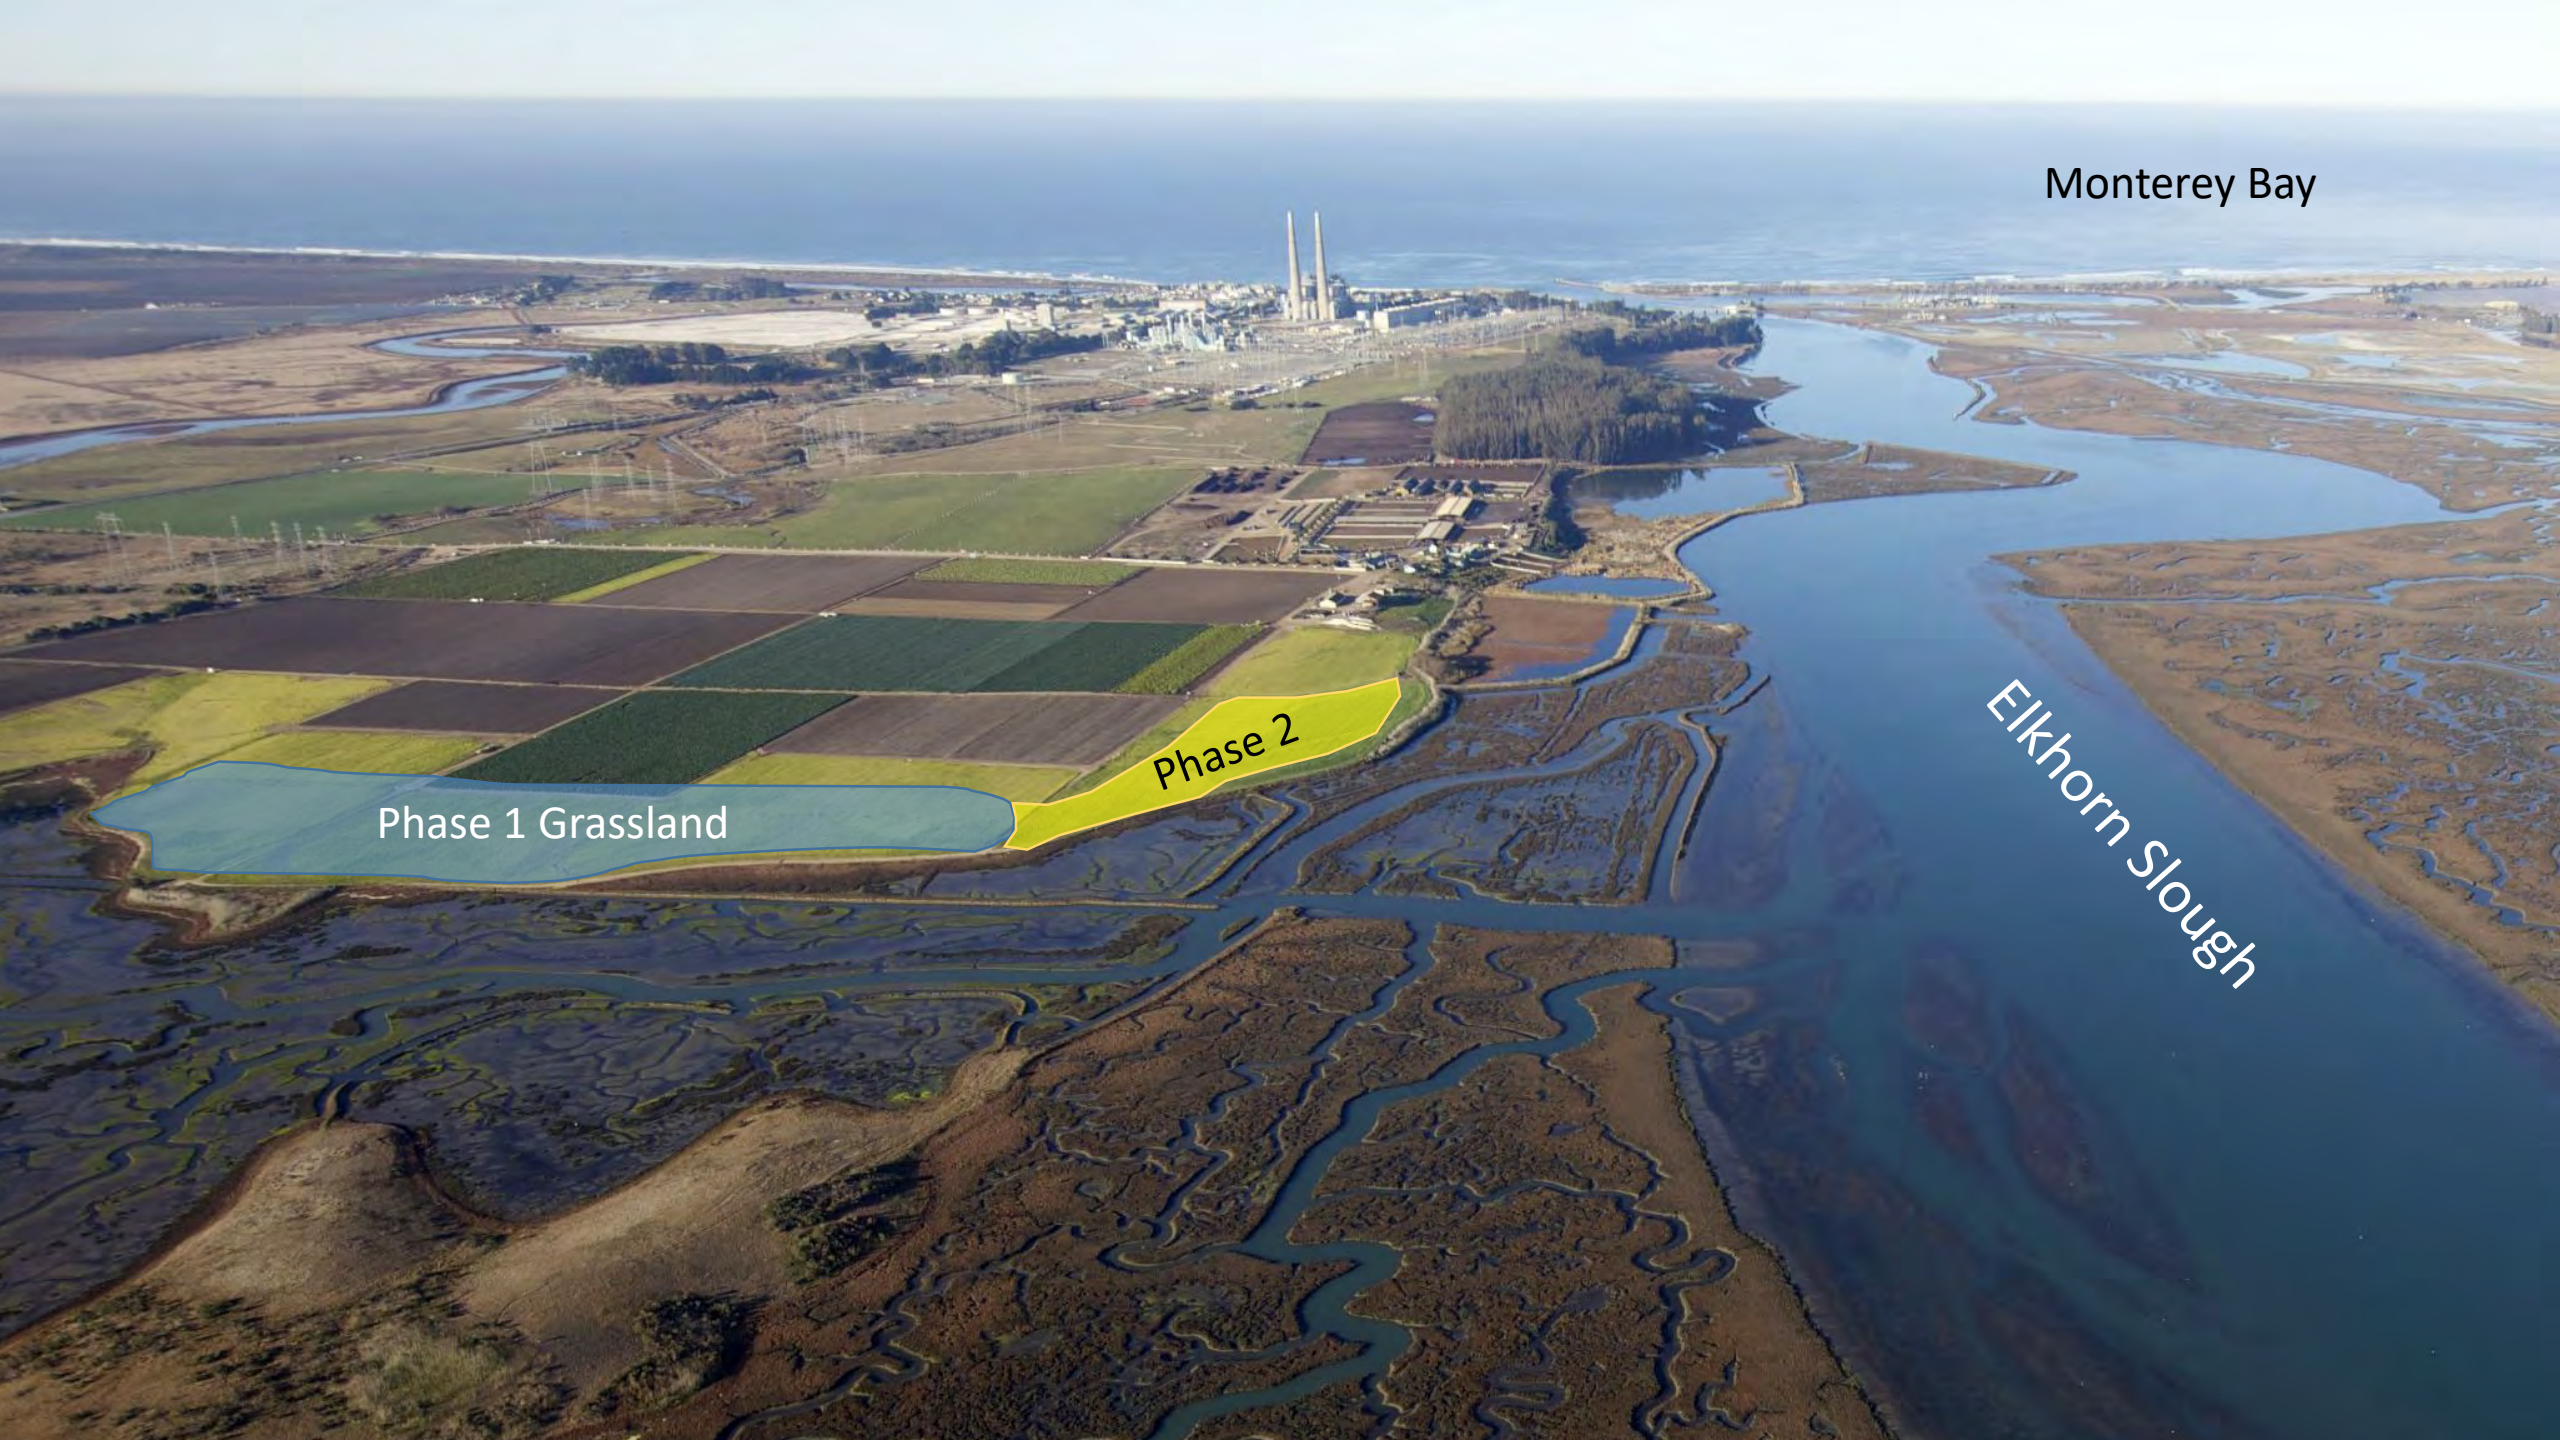
Phase 2 Area, 2021: three acres

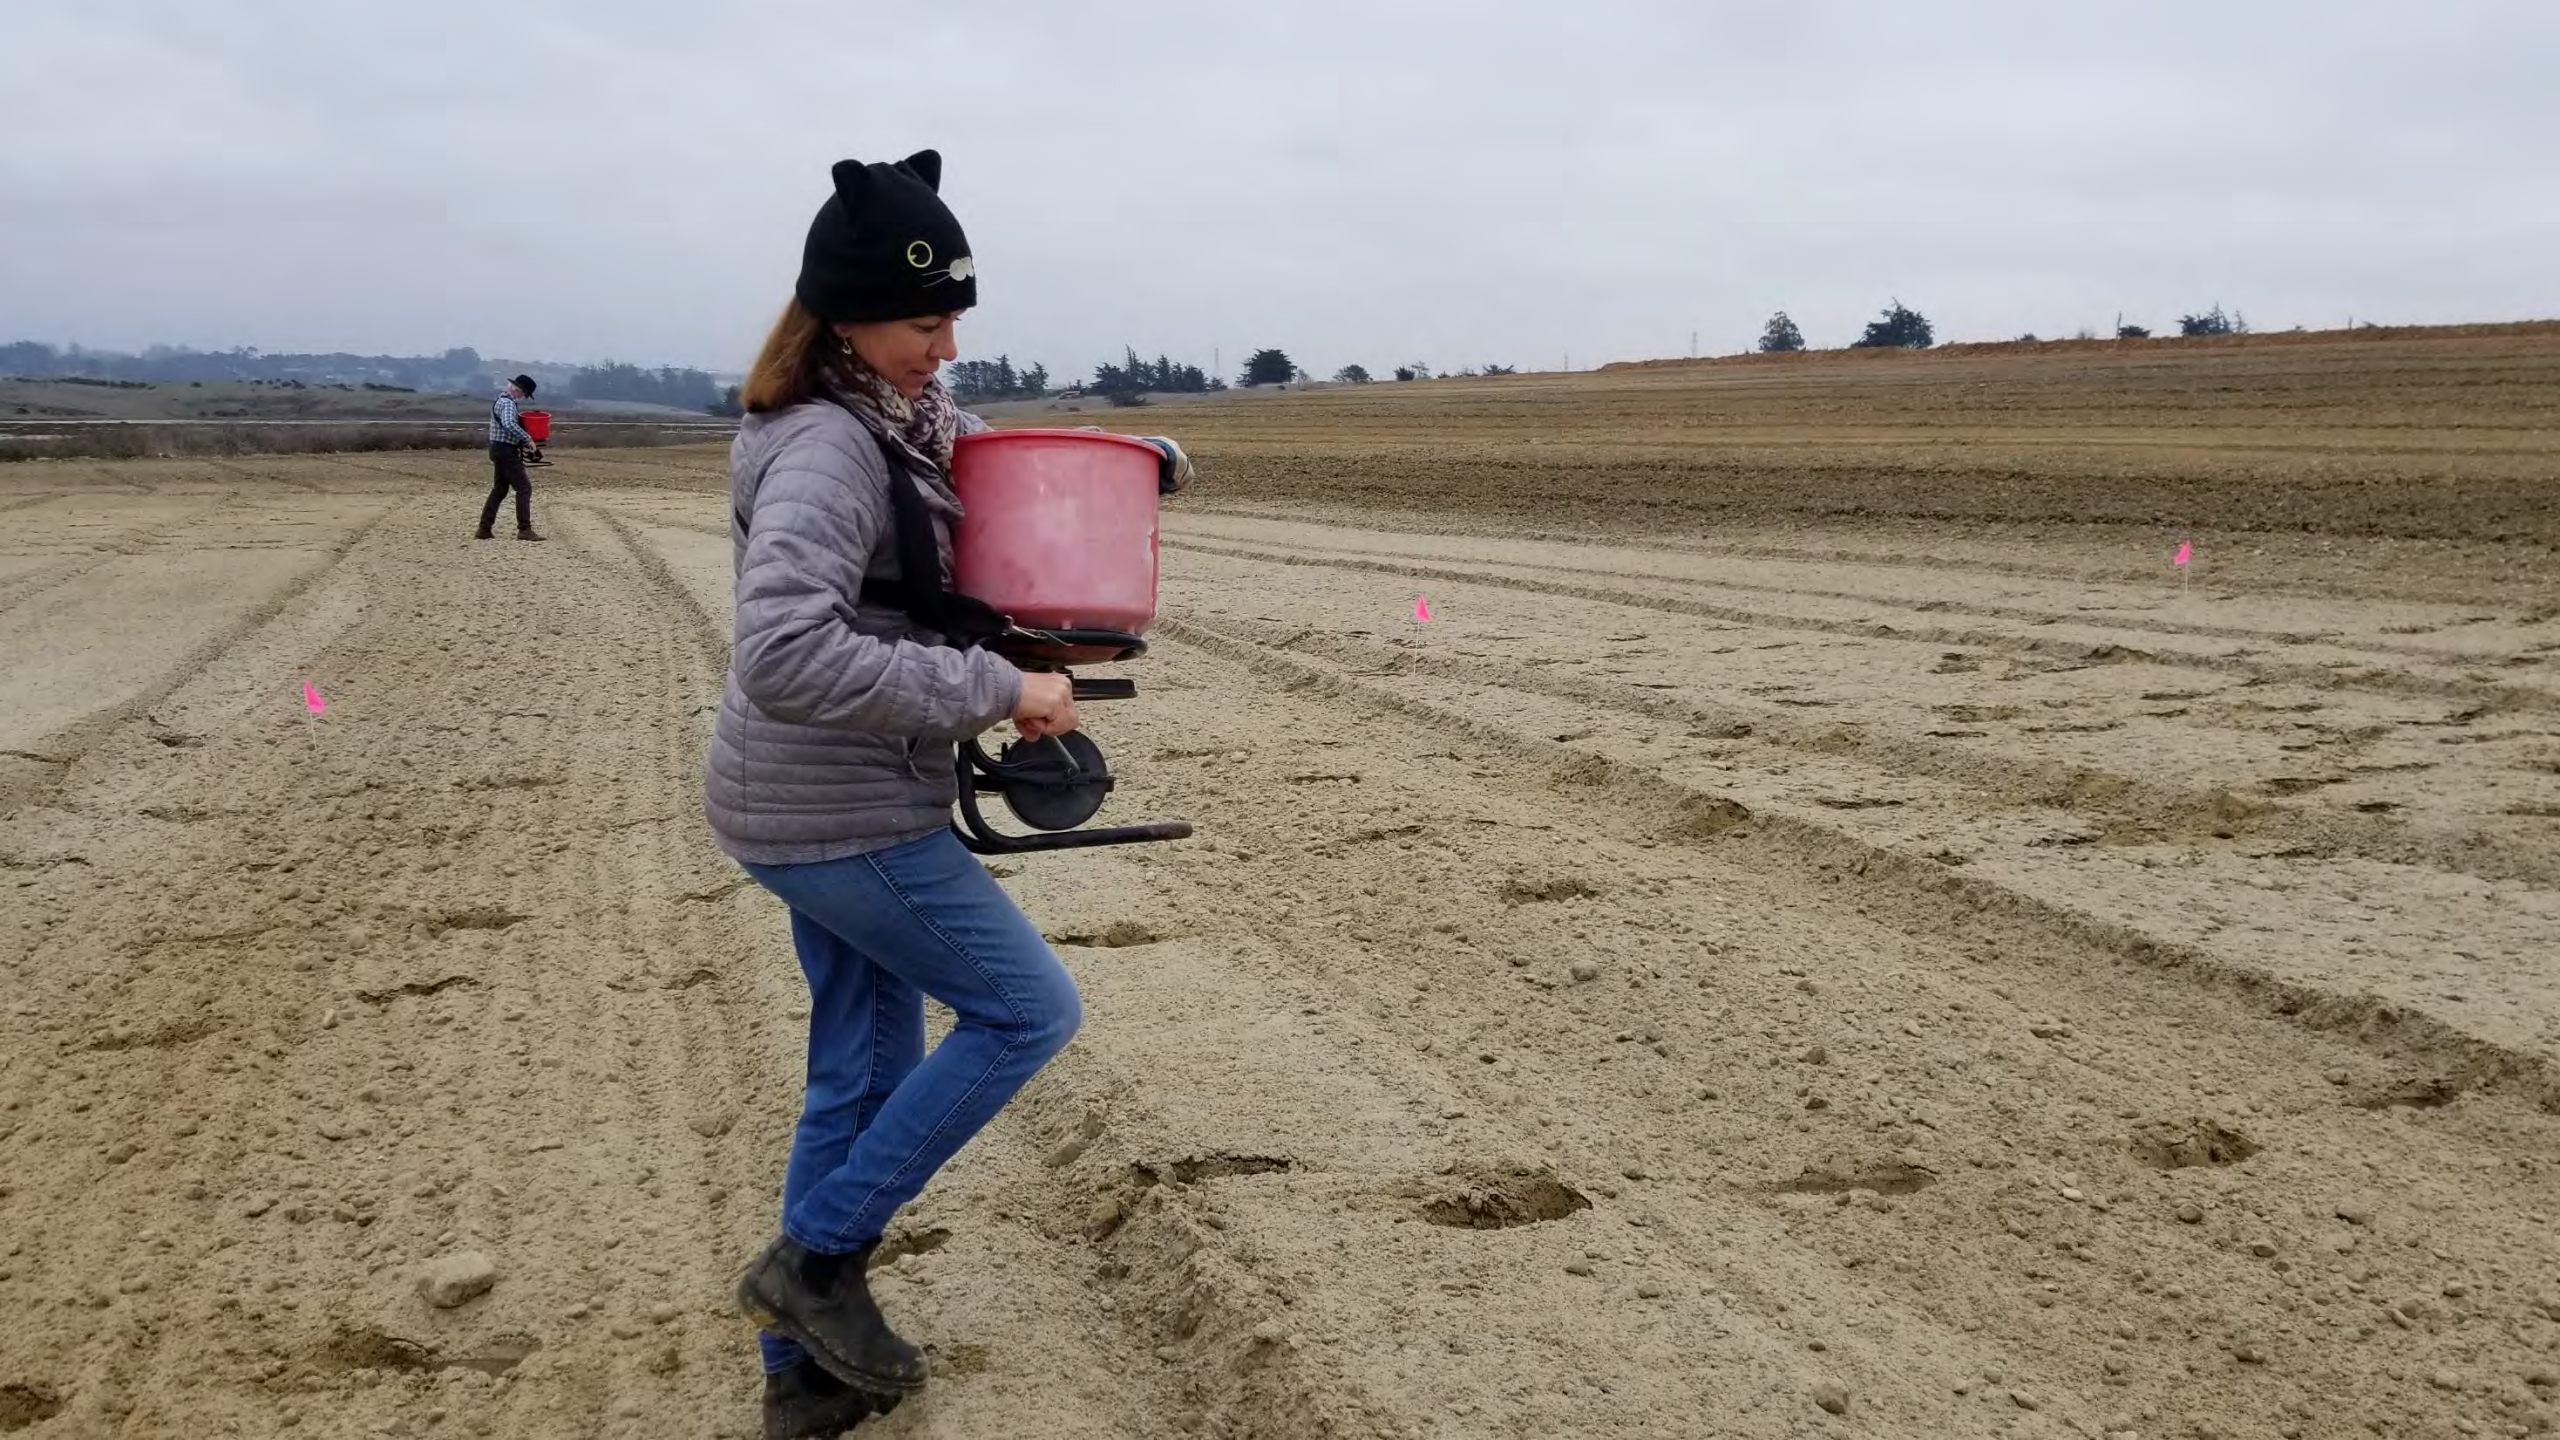
A wide-angle photograph of a field of seeded meadow barley in Phase 1. The plants are tall and green, with many dark, elongated seed heads visible. In the background, there are rolling green hills and several electricity pylons under a cloudy sky. A semi-transparent grey rectangular box is overlaid on the upper middle part of the image, containing the text "Can this approach work?".

Seeded meadow barley in Phase 1

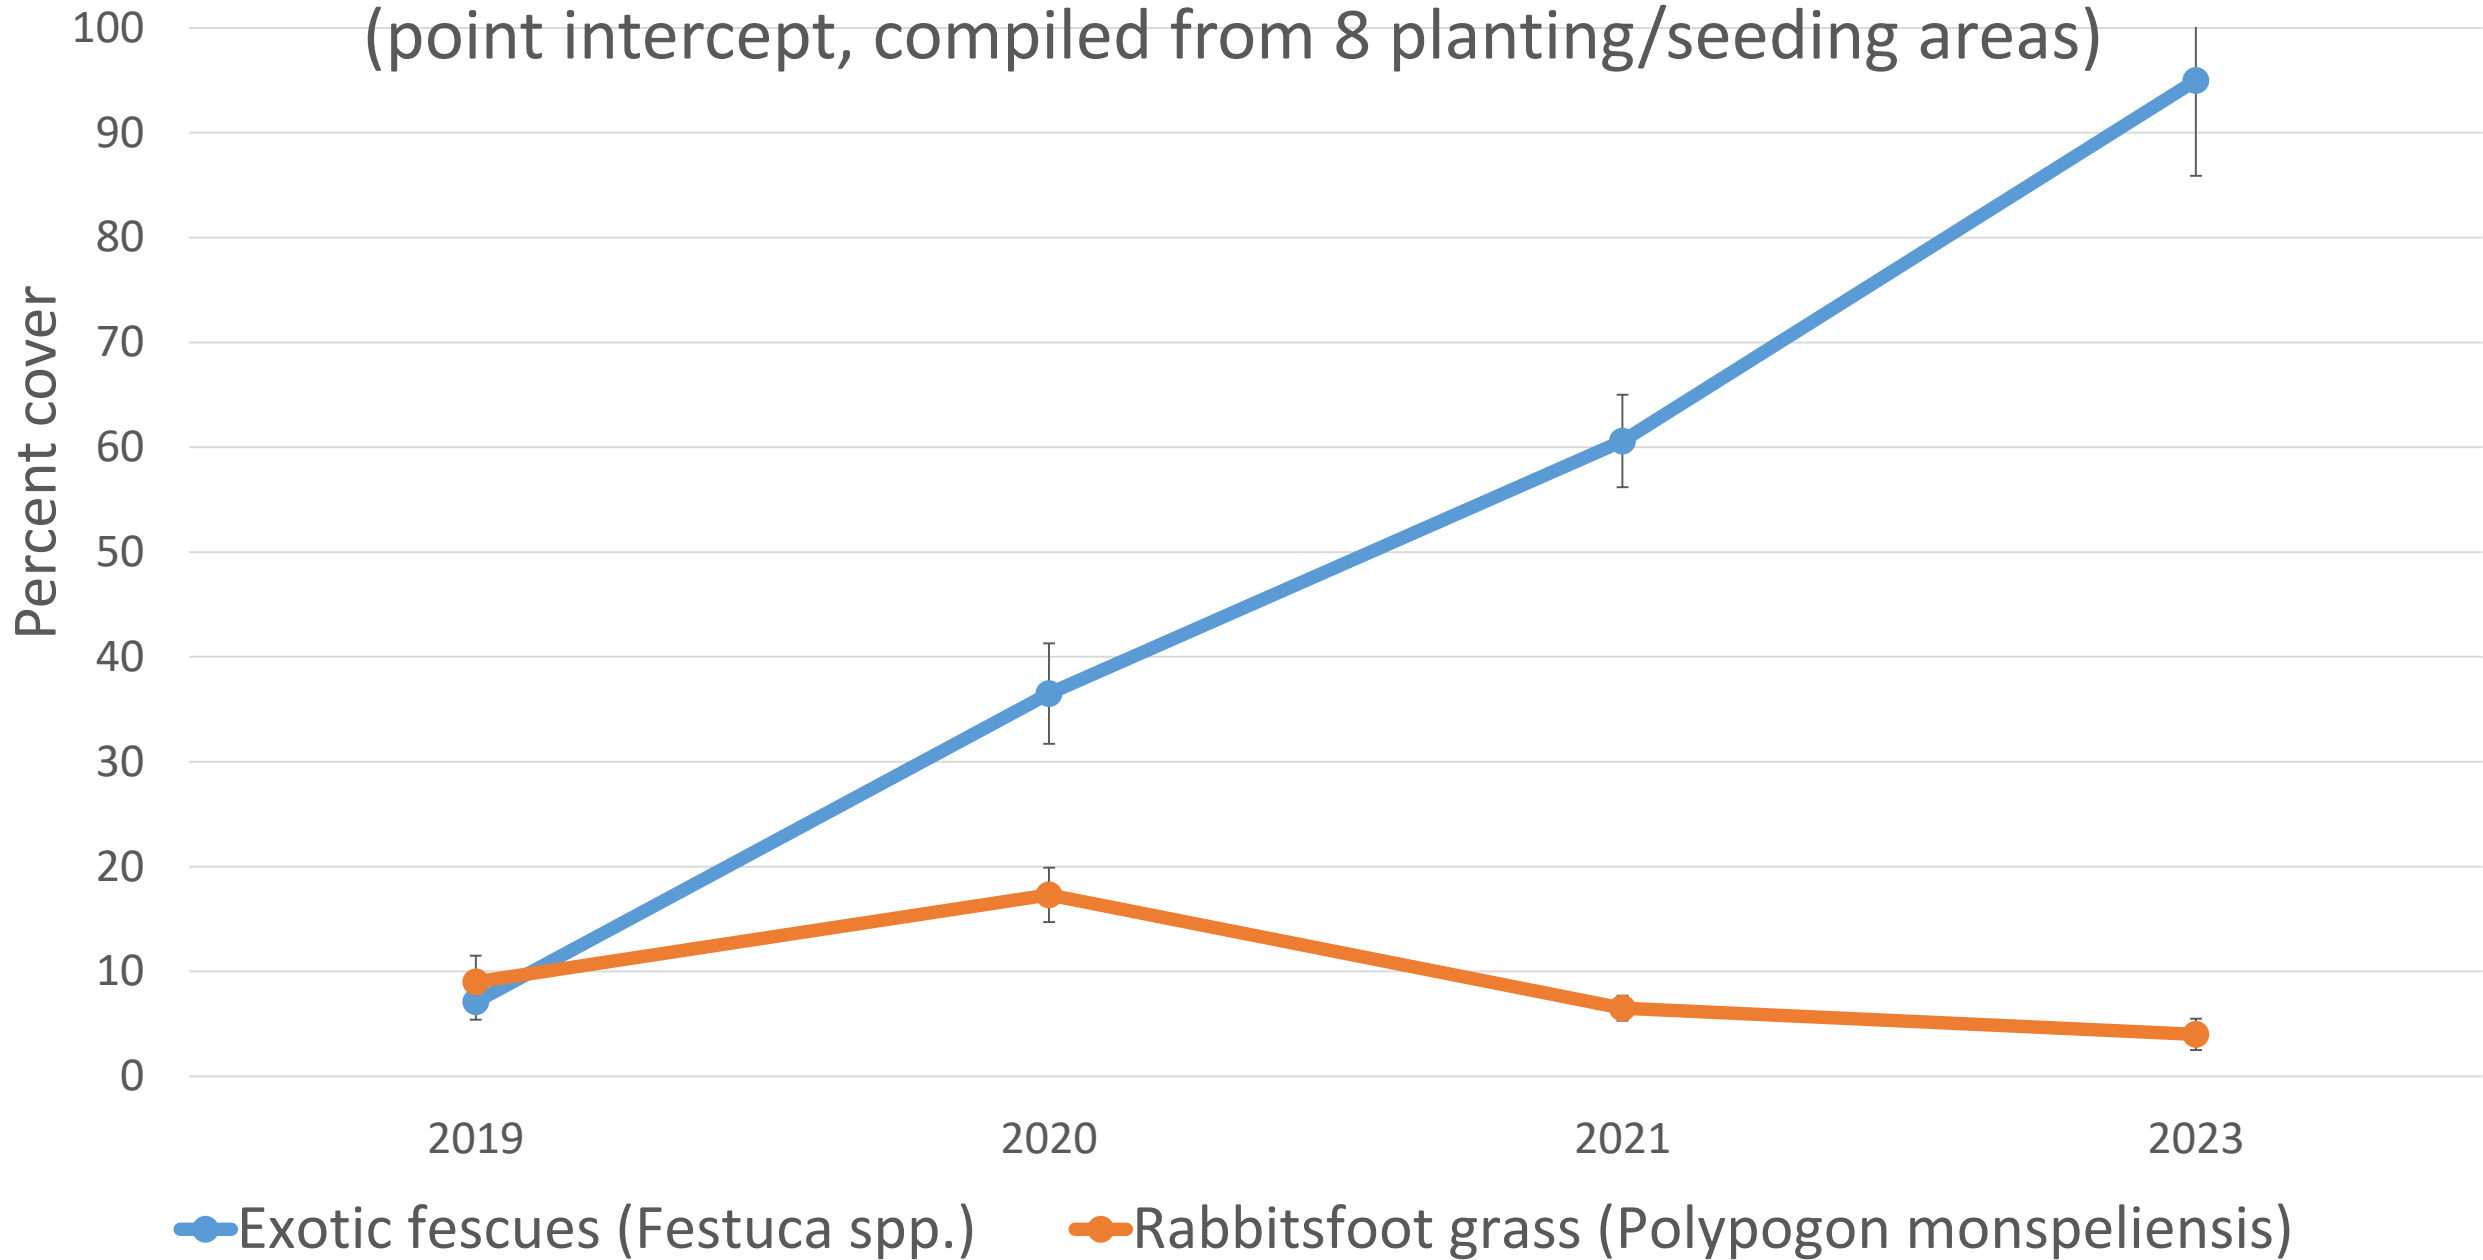
Weedy Plants in Phase 1

(point intercept, compiled from 8 planting/seeding areas)

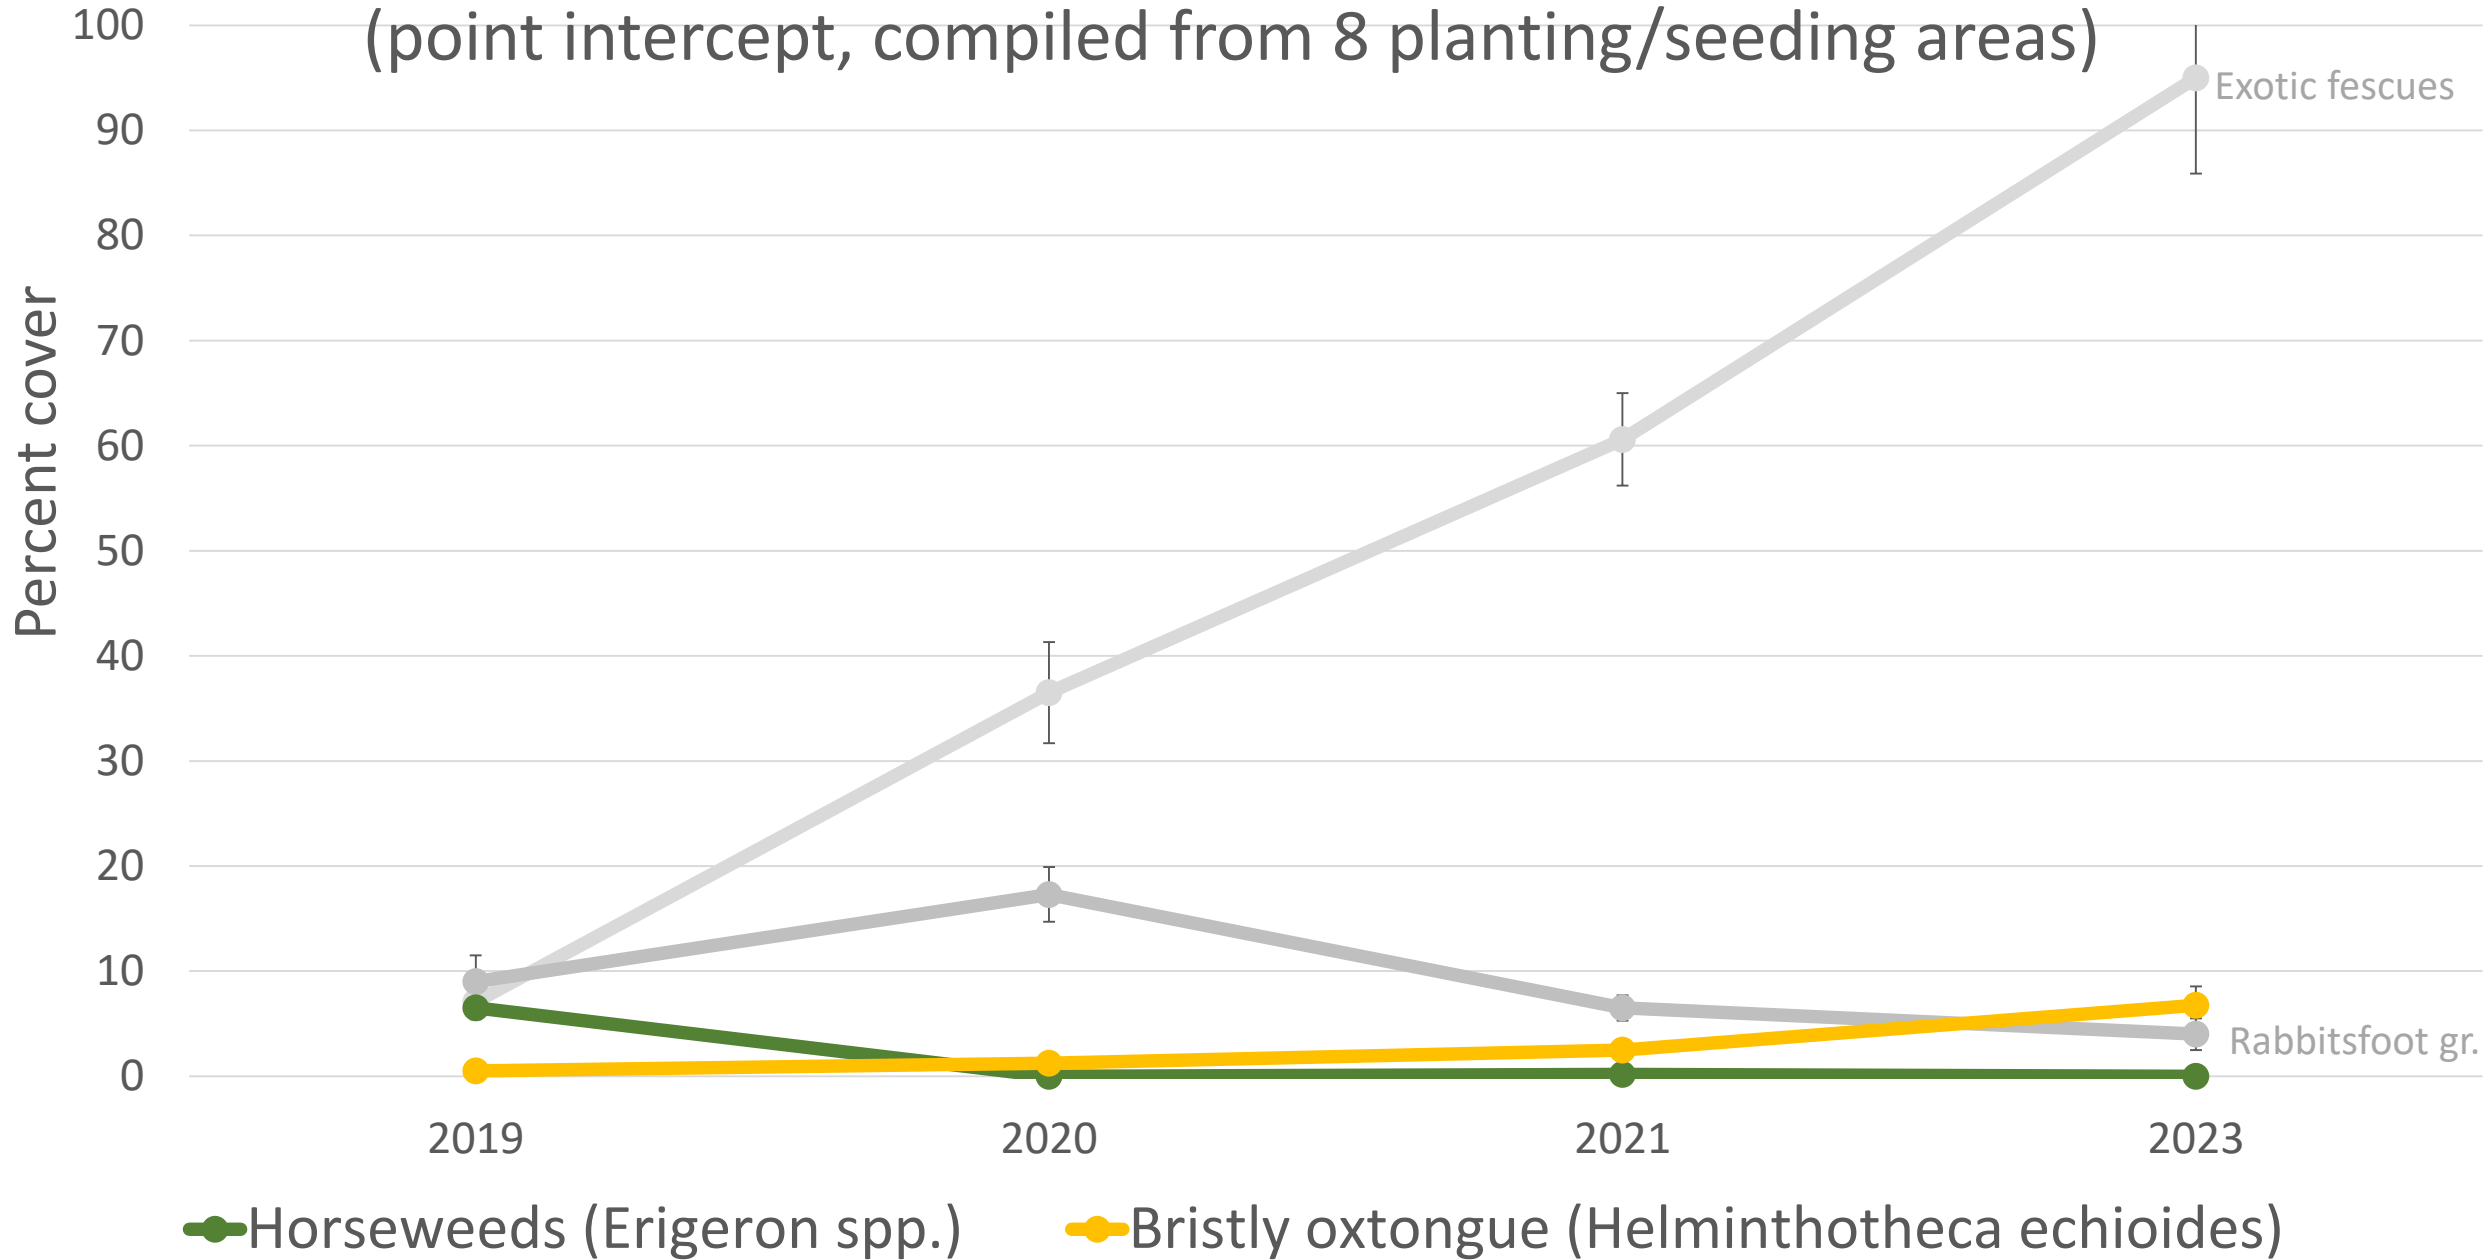
Weedy Plants in Phase 1

(point intercept, compiled from 8 planting/seeding areas)
