Restoring coastal grassland on deeply scraped soils in Monterey County, CA

Andrea Woolfolk, Mary Paul, and Bill Fortner
Elkhorn Slough National Estuarine Research Reserve

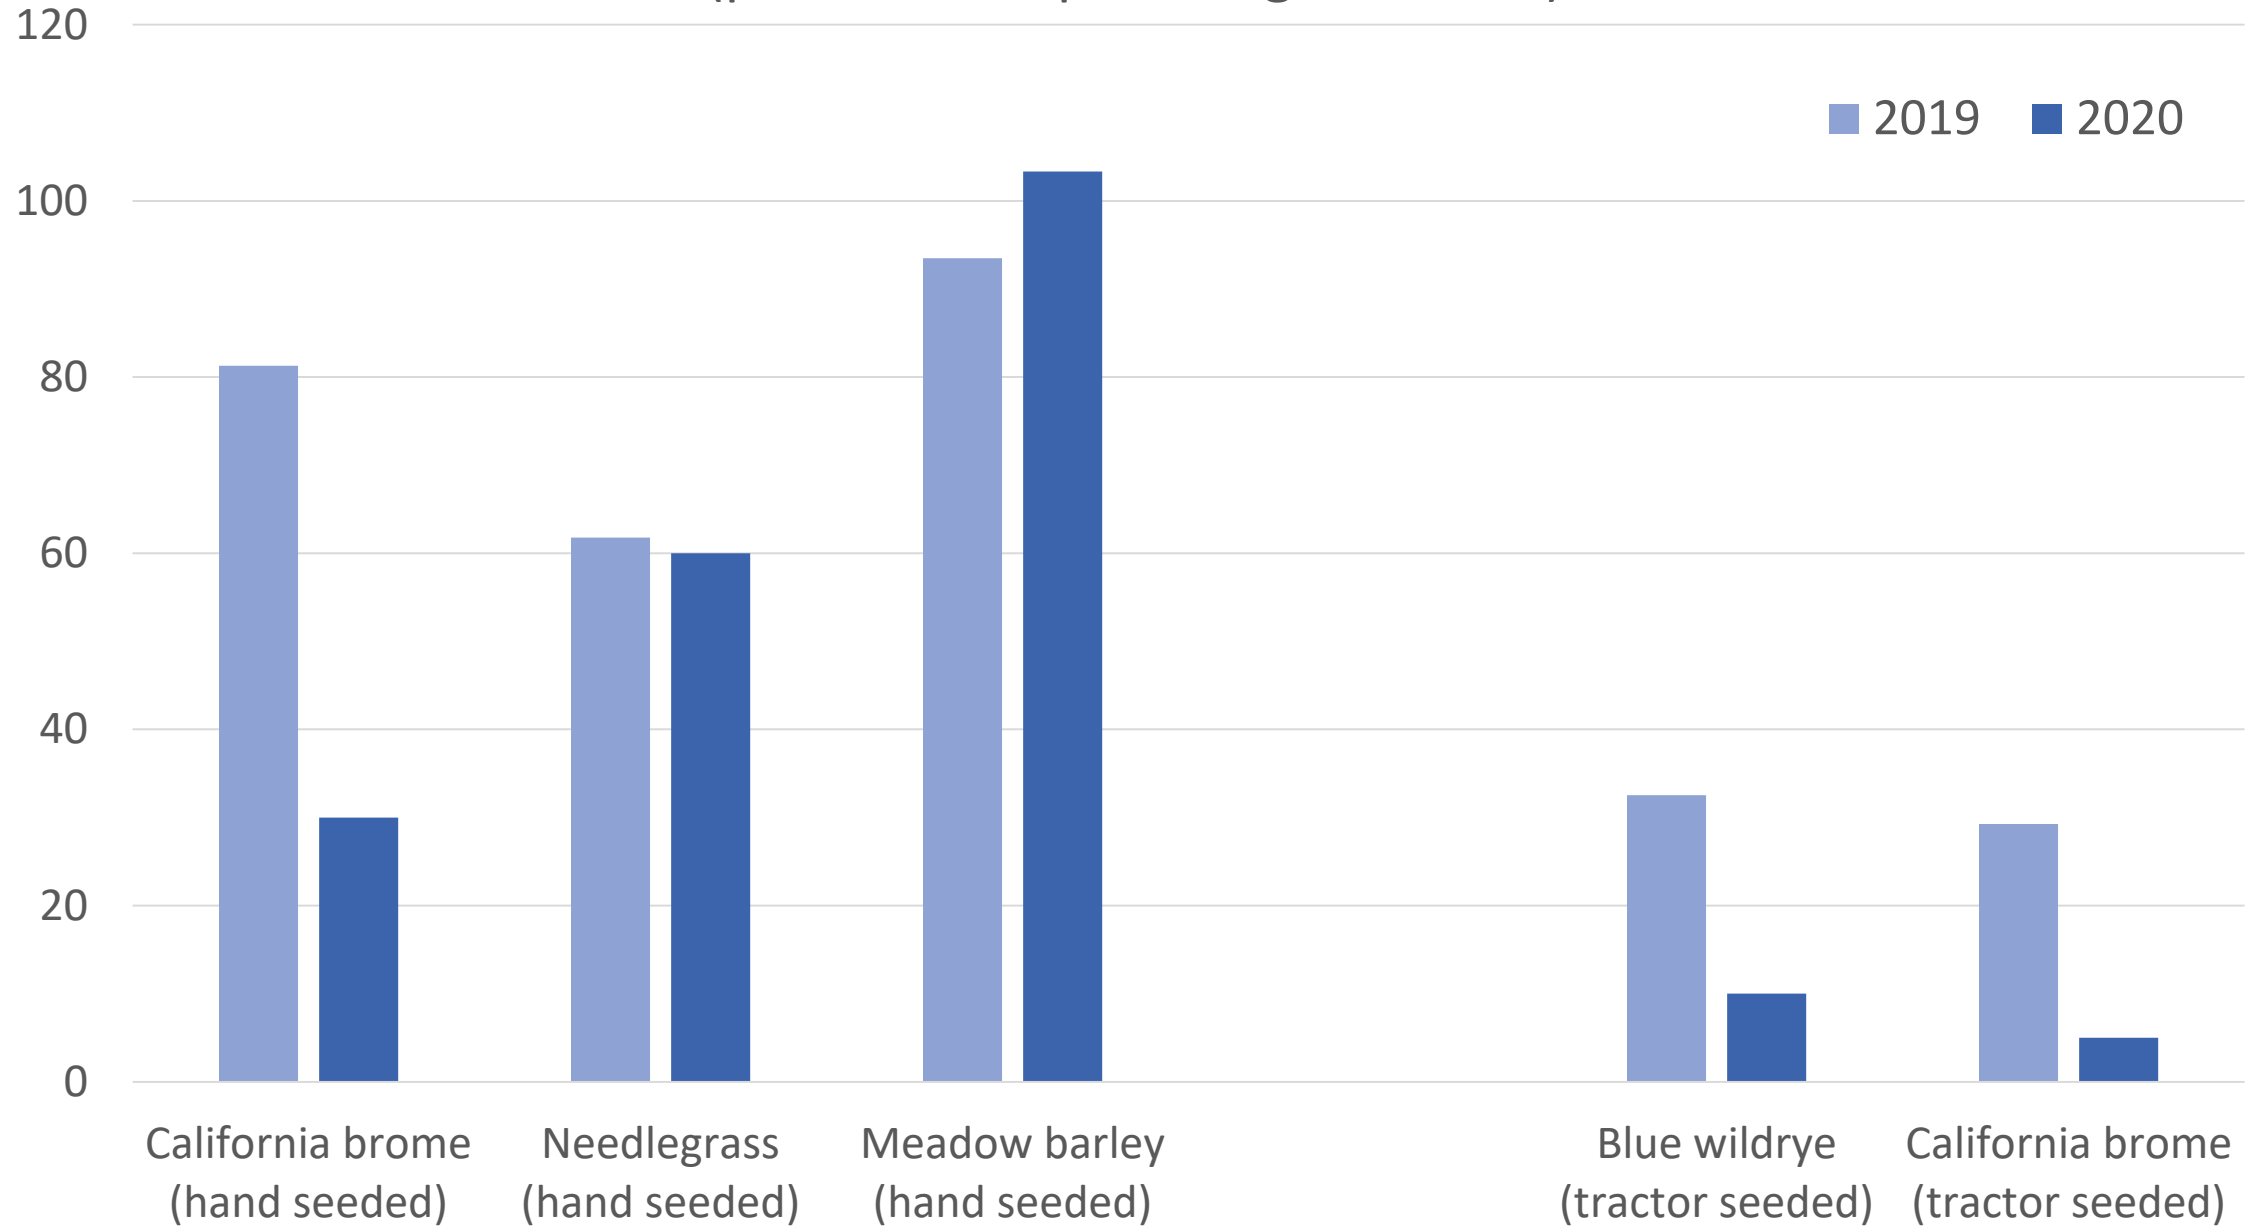
Phase 1 Area: Percent Cover of Seeded Grasses (point intercepts along transects)

We were surprised that our hand seeding did much better than the tractor seeding

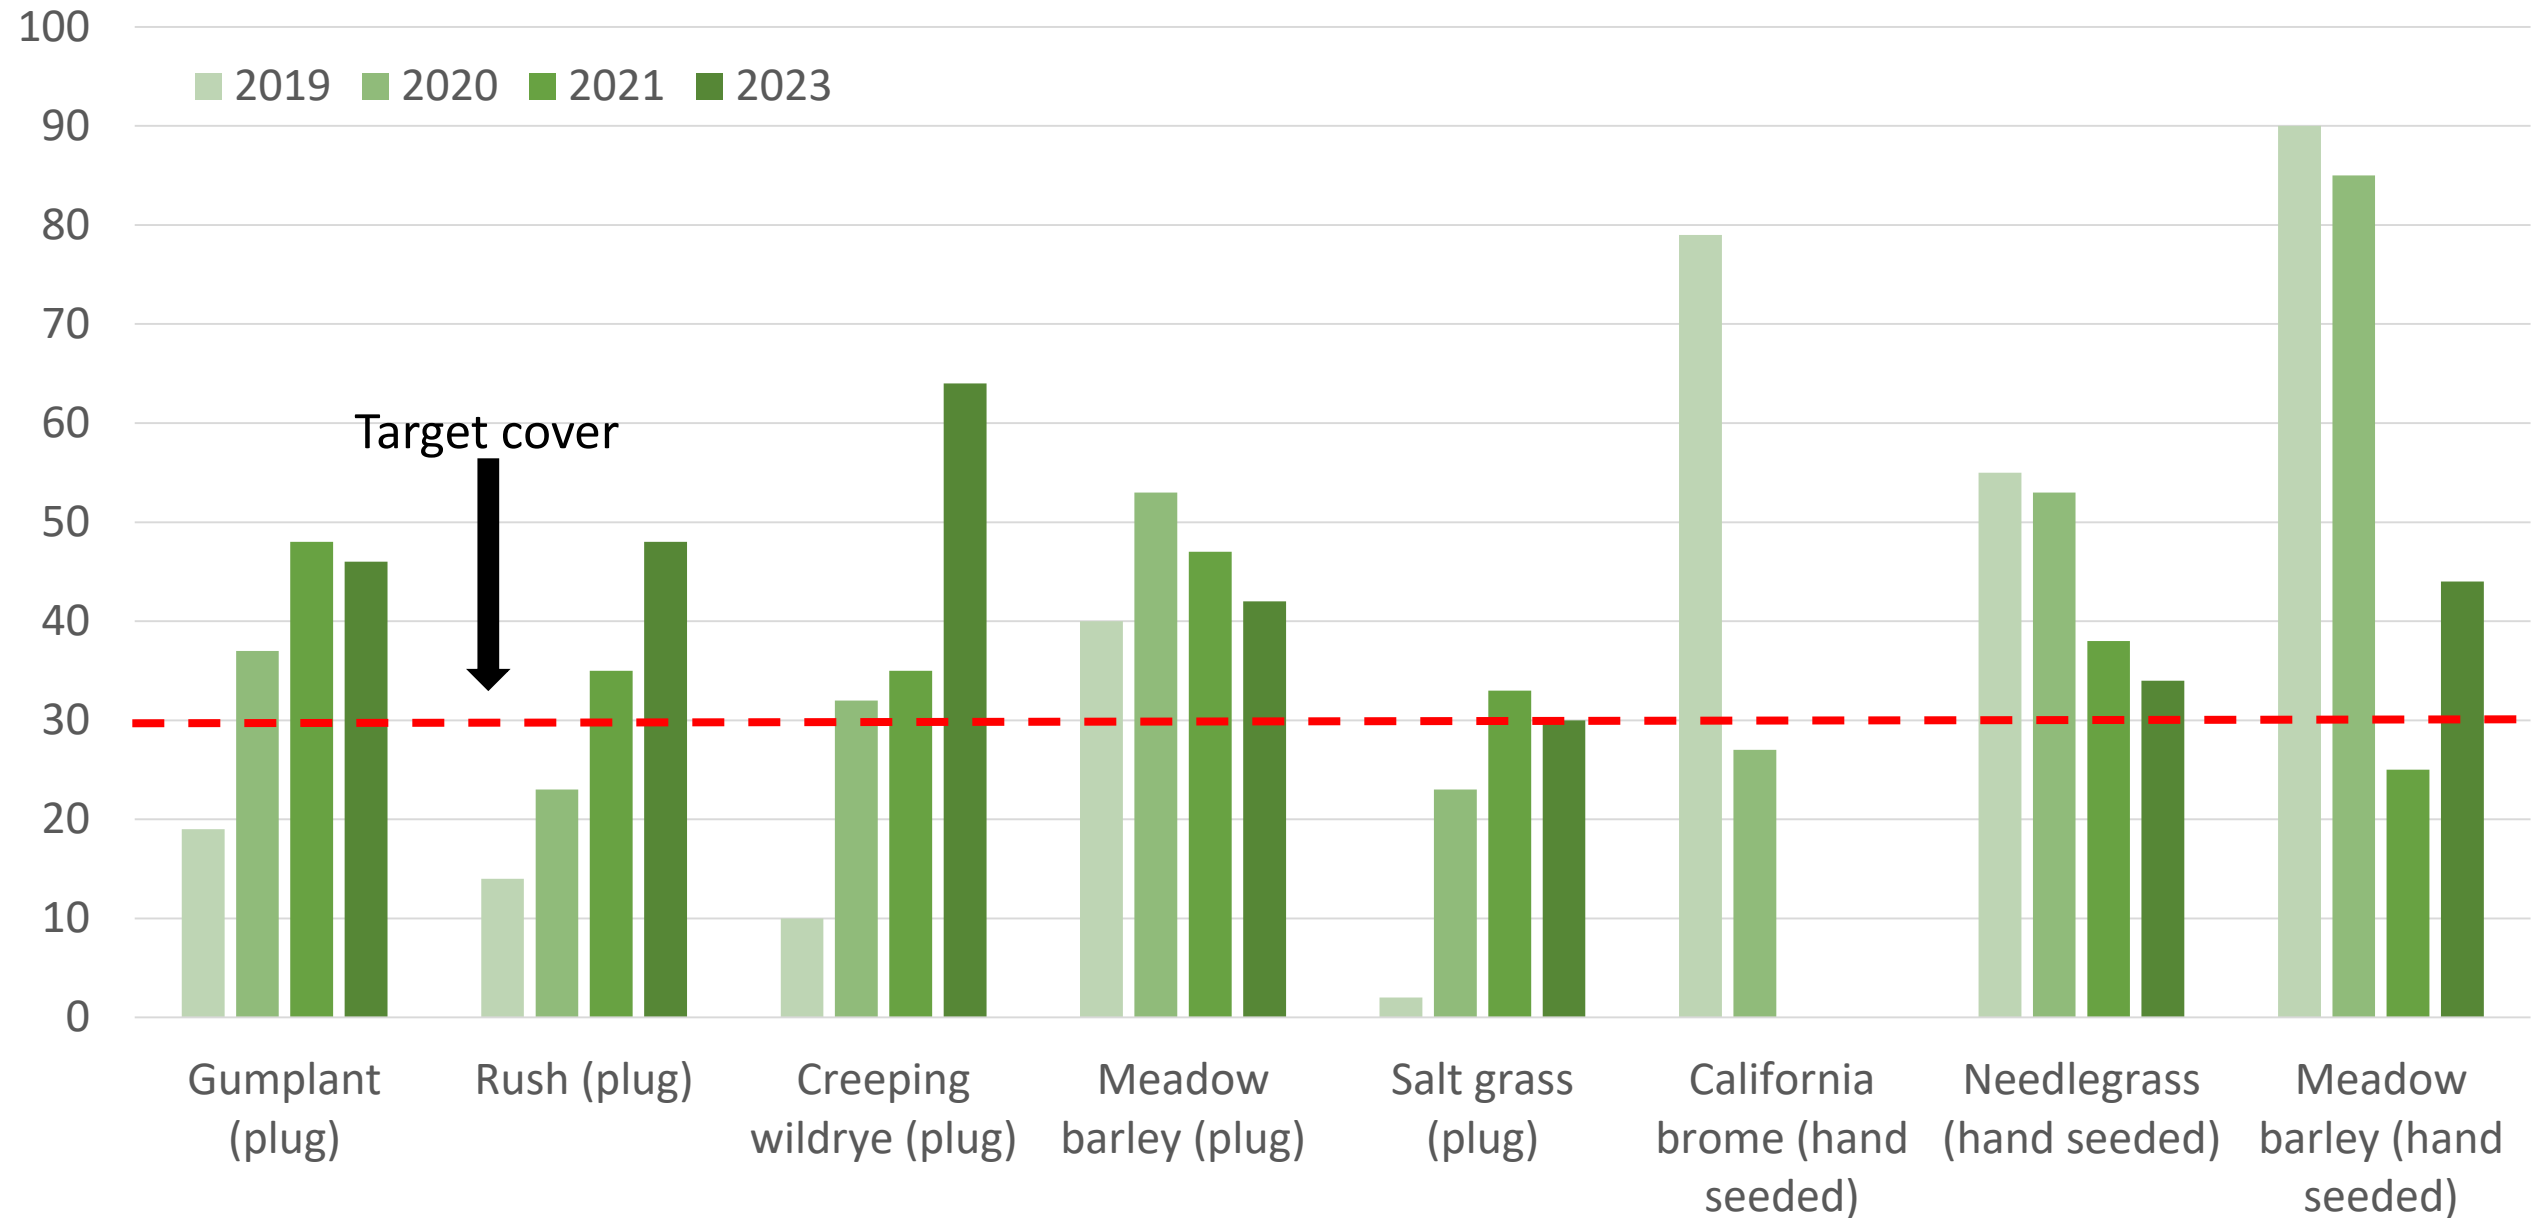
Phase 1 Area: Percent Cover of Target Native Plants (no data for 2022)

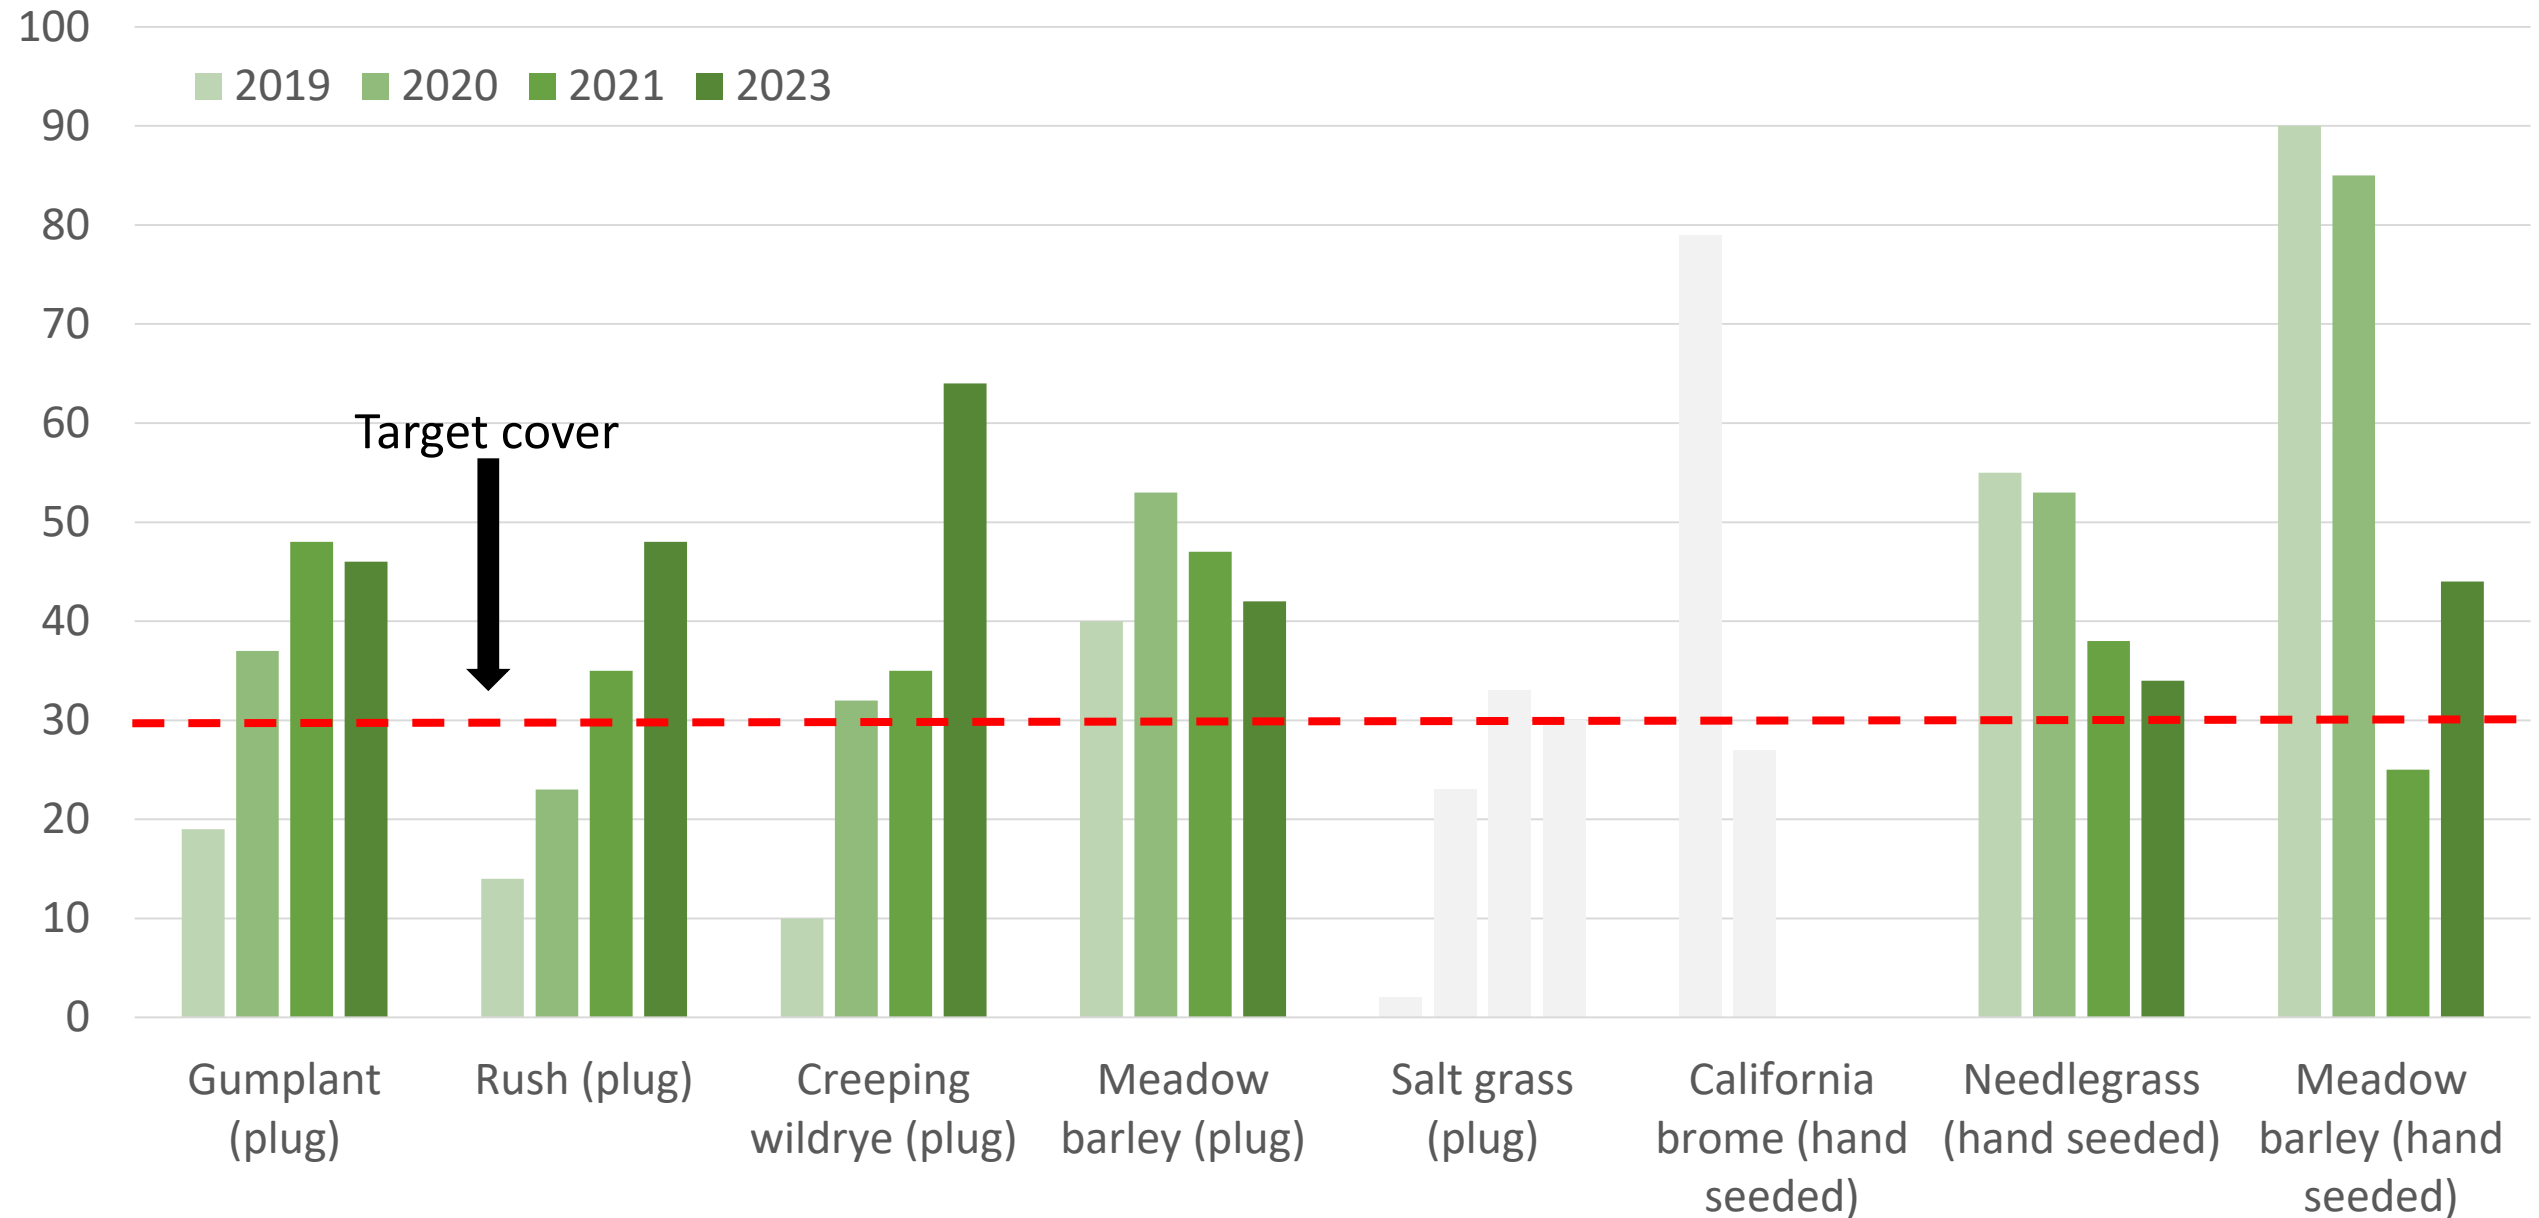
Phase 1 Area: Percent Cover of Target Native Plants (no data for 2022)

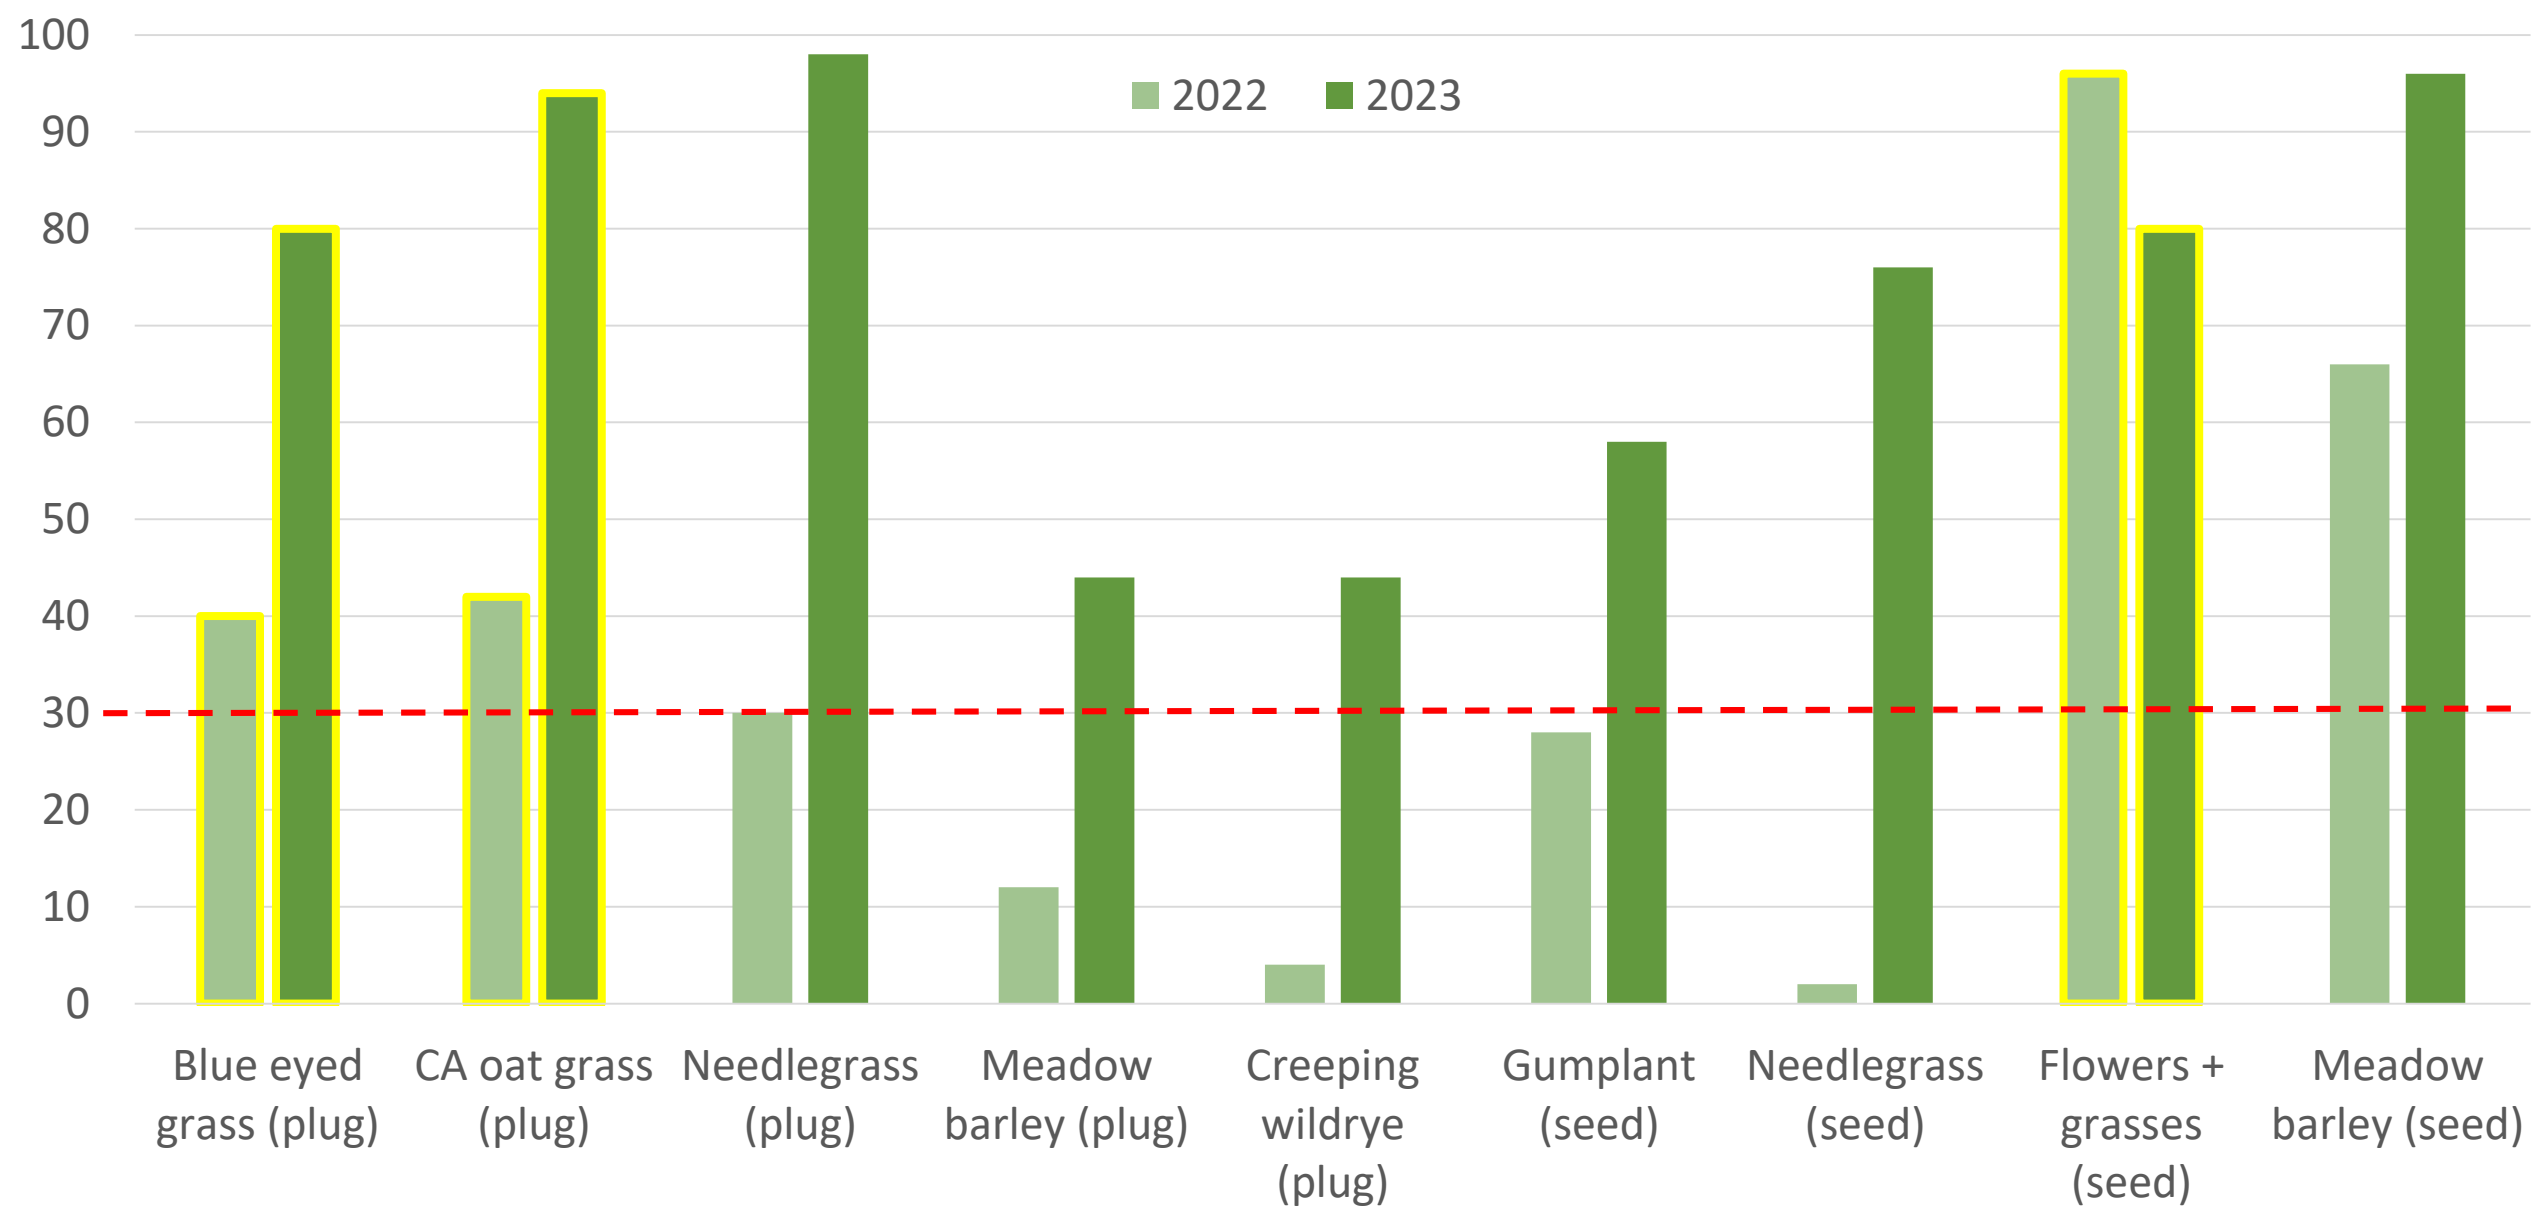
Phase 2 Area: Percent Cover of Target Native plants
